# St Kilda Marina

## Environmental & Coastal Hazard Assessment

City of Port Phillip

07 February 2018

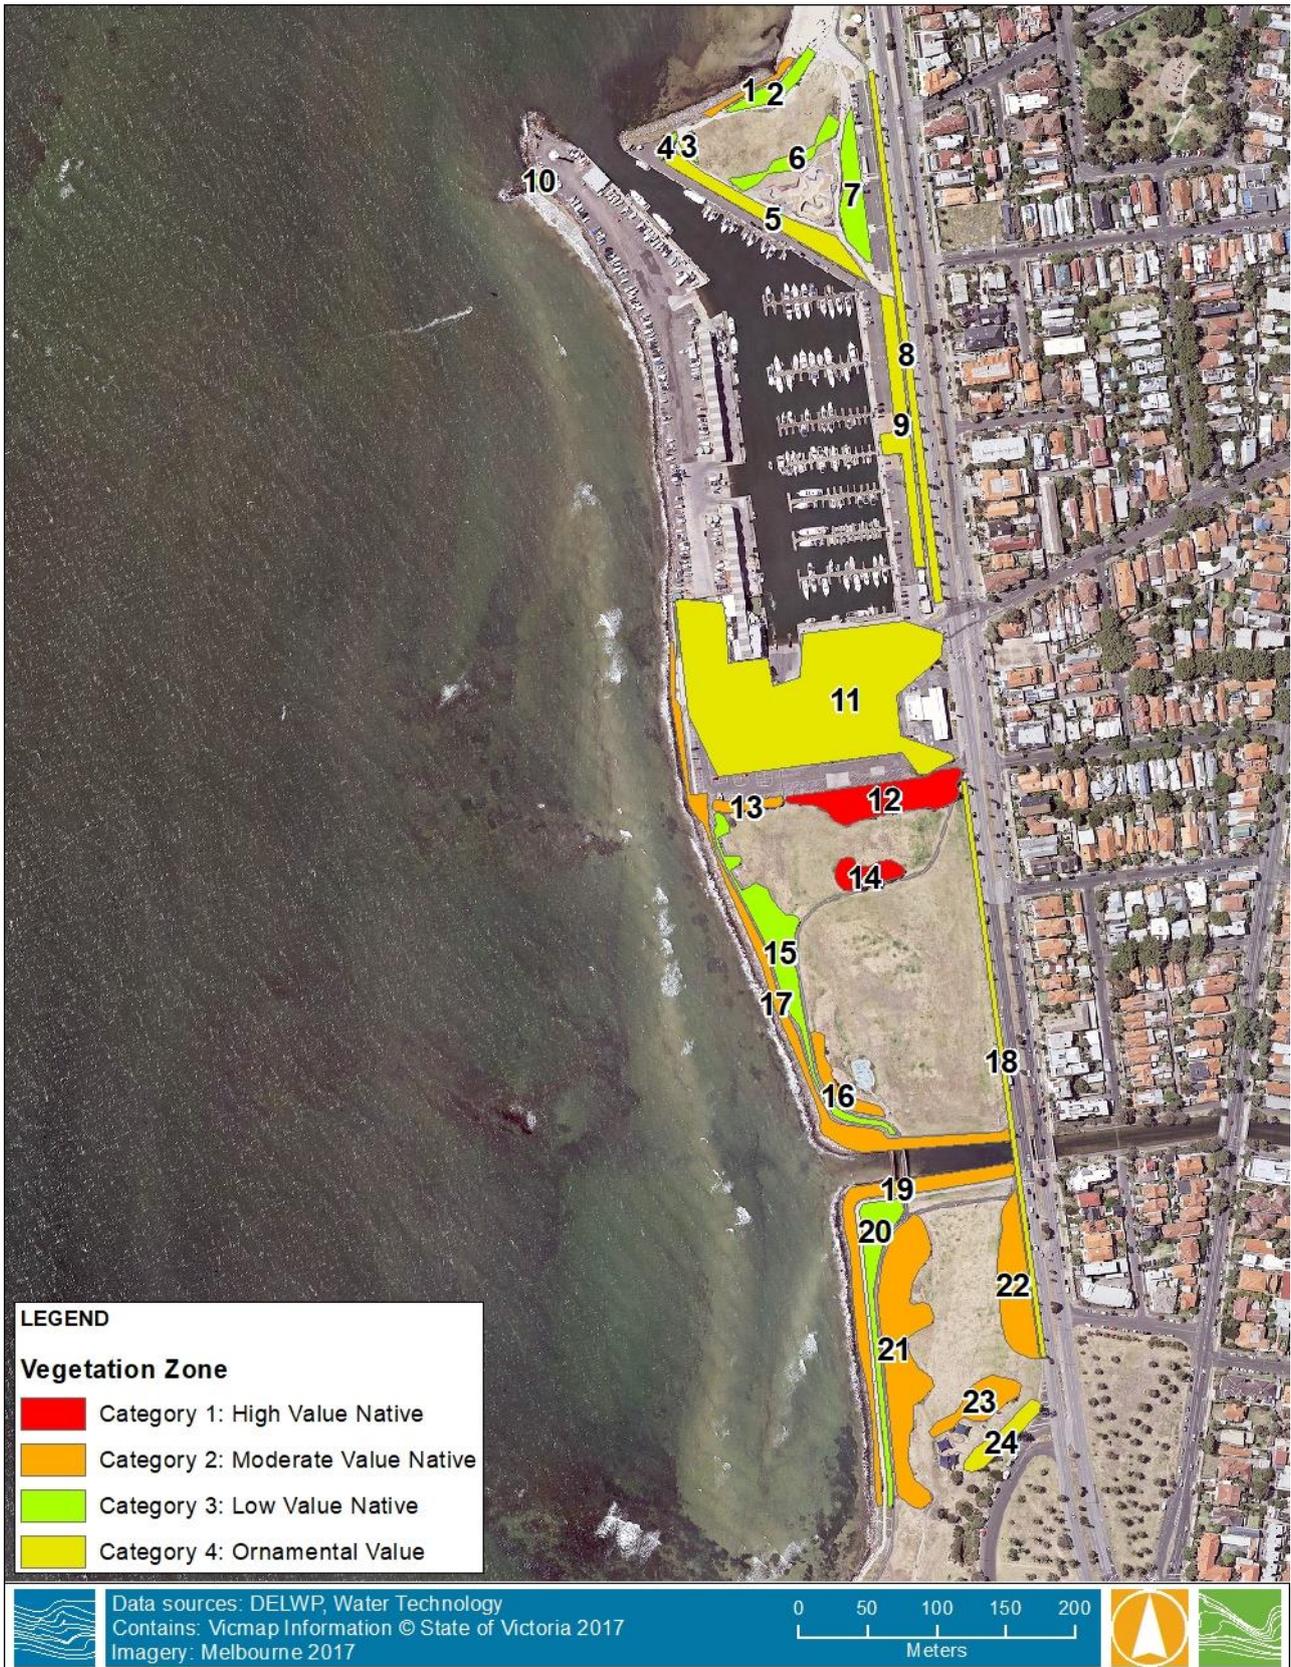
**FIGURE 4-1 VEGETATION ZONES BY CONSERVATION VALUE**

The vegetation zones have been mapped and colour coded by conservation value (Figure 4-1). This figure shows the highest conservation value coloured red, moderate value amber and low value green. Ornamental trees have been shown in yellow. It should be noted that Zone 11 covers the main carpark, boat ramp and Riva Restaurant areas and trees are only scattered to patchy within this large zone.

- Avoidance of disturbing Moderate Value Native vegetation is recommended where possible. Significant amount of work and expense has gone in to establishing these areas and they provide important vegetation links along the Bay. Any redevelopment should aim to maintain or enhance longitudinal continuity of native vegetation along the Bay.

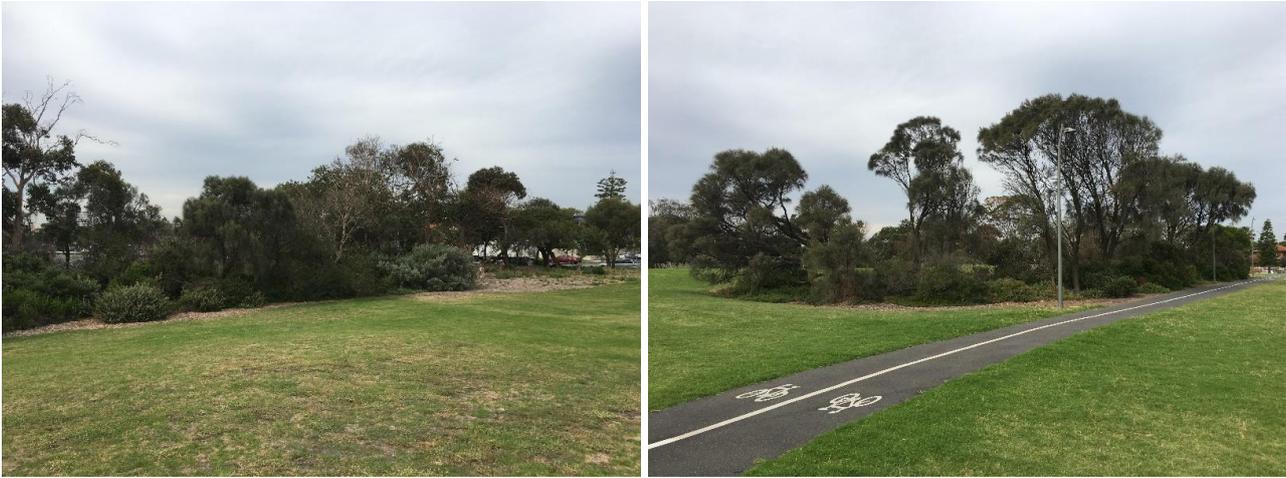
FIGURE 4-2 VEGETATION ZONES 12 AND 14

The highest value native Vegetation Zones (12 and 14) comprise a high diversity of tree, shrub and ground species. These two patches of vegetation contain relatively old/mature trees (including Coastal Banksia, Manna Gum, Swamp Gum and Drooping She-oak) and shrubs (including Coast Tea-tree, Boobialla and Coastal Wattle) and the areas show signs of ongoing active management including weed control and revegetation. At the time of assessment, it was evident that these patches provide important habitats as many species of birds were observed and heard within these areas.

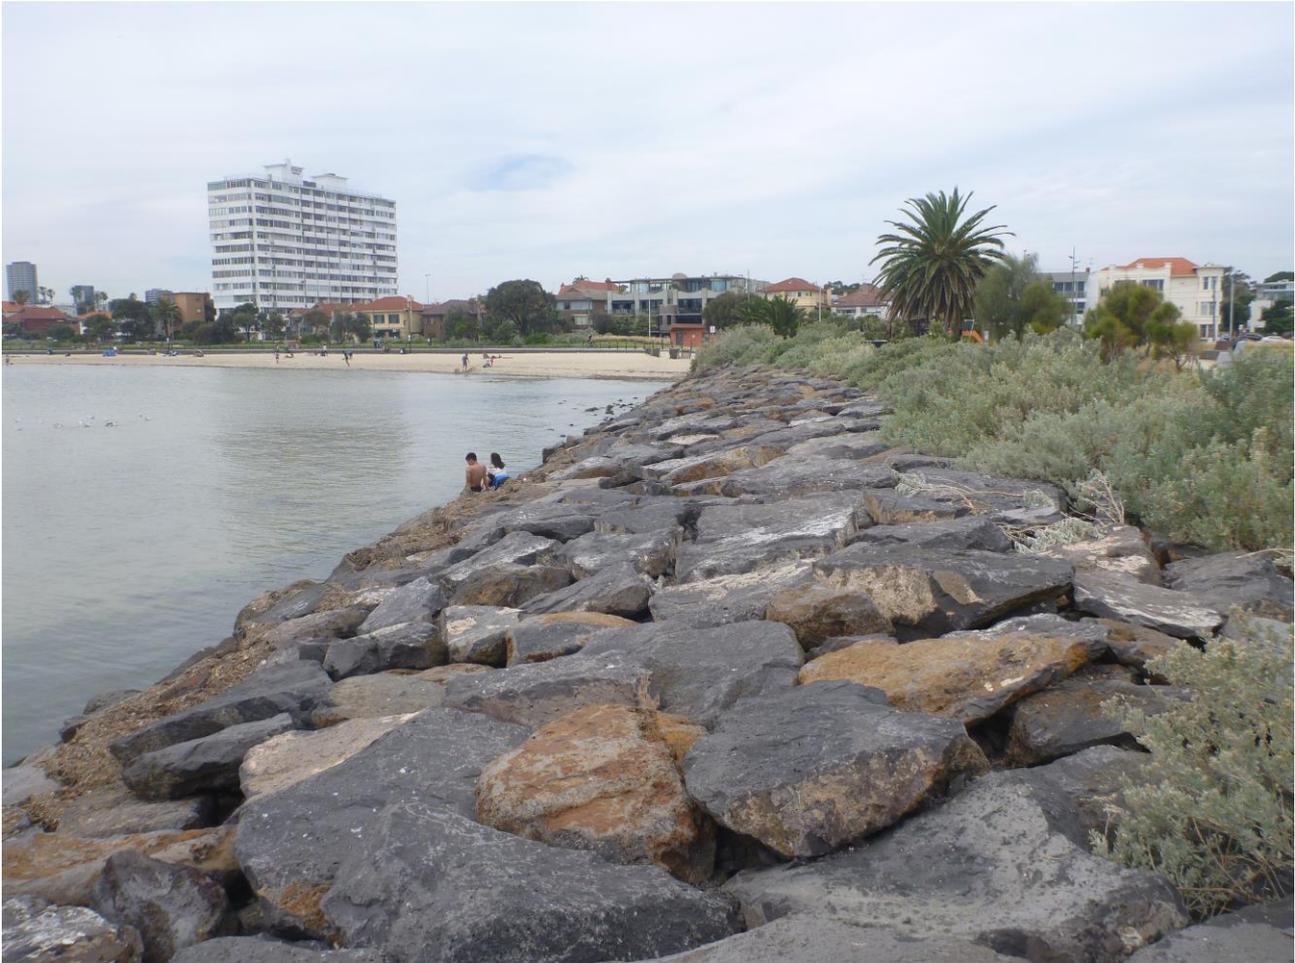
FIGURE 7-1 NORTHERN SEAWALL

The northern seawall protects the northern side of the marina, as shown in Figure 7-4. This seawall appears to be in relatively good condition. The rocks are well interlocked, there is no evidence of significant scour or overtopping. The vegetation behind the seawall is in good health. An image of the seawall taken in December 2017 is shown in Figure 7-1.

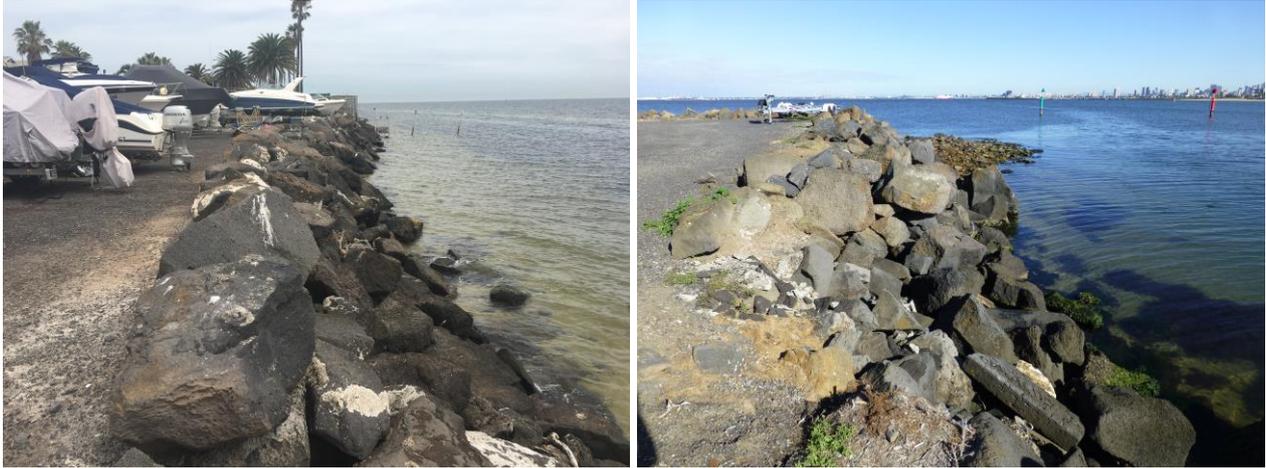
**FIGURE 7-2 WESTERN SEAWALL: SEAWARD OF HARDSTAND AREA (LEFT) AND AT THE MARINE ENTRANCE (RIGHT)**

The Western Seawall and Groyne is of varying structural standard, being typical of a “riprap” structure. It generally comprises rocks of a wide range of sizes simply tipped onto the foreshore slope, with no apparent geotextile layer and no apparent placement to form graded layers. There also appears to be other materials mixed into the rock such as concrete debris. This means that the seawall is prone to damage by erosion of the armour layer, and this is evident at the site. The rocks are not well interlocked and appear to be unstable. An example of the typical seawall is shown in Figure 7-2. There is not a clear crest to the structure, and, in some places, this has slumped considerably.

It is not evident from the site inspection the depth of the toe rock, so the likelihood of scour is unclear. At the time of inspection, a layer of sand was evident covering the toe of the seawall. There is also evidence of an erosion scarp at the rear (landward) of the seawall, especially in the southern section, indicating that wave overtopping of the seawall has occurred during storm events in the recent past. Whilst this has caused some erosion and damage to grassed and landscaped areas, as well as along the crest of the seawall, there has been only minor structural damage attributable to this process.

Overall, this seawall is considered to be in poor condition. The seawall is currently directly protecting a large portion of the St Kilda Marina site from erosion and inundation. The seawall is in its present state under existing wave and water level conditions, and is likely to get worse, especially with sea level rise and overtopping issues, into the near future.

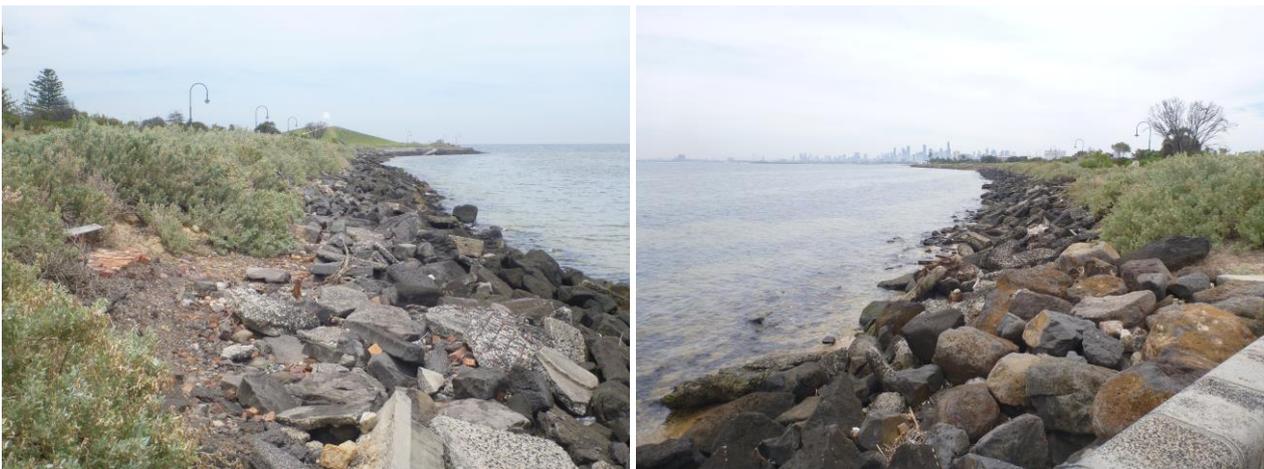
**FIGURE 7-3 SOUTHERN SEAWALL: IMMEDIATELY SOUTH OF ELWOOD CANAL (LEFT) AND AT POINT ORMOND (RIGHT)**

The southern seawall is similar in condition to the western seawall. There is no clear crest or rock placement present. In most area, the seawall would be classified as 'failed'. Water Technology recommends the investigation into repairs in the immediate term.

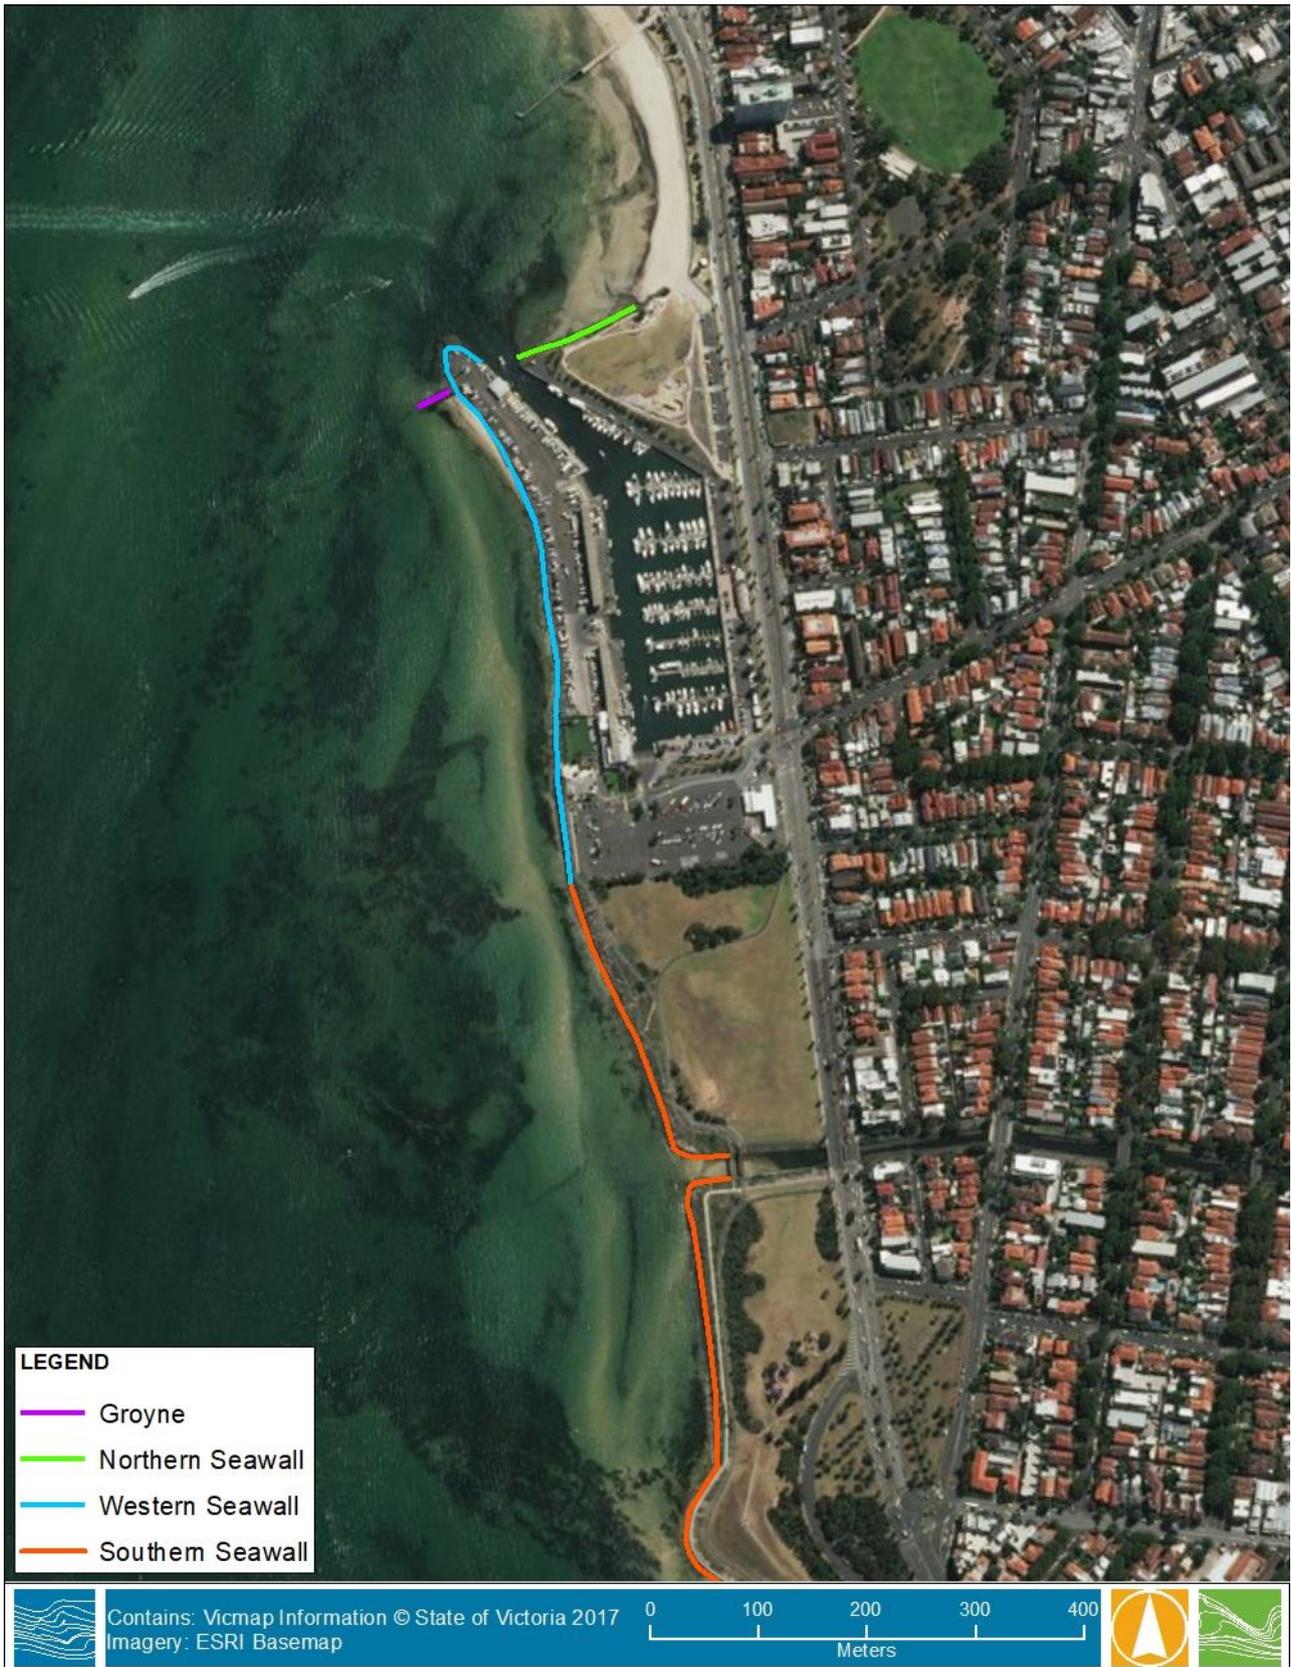
**FIGURE 7-4 SEAWALL LOCATIONS**

- The western and southern seawalls and groyne are in poor condition. However, in its current state long-term erosion is unlikely, however maintenance of the seawall is required to prevent deterioration to the point where erosion becomes an issue.
