# Access Report - Site Audit City of Port Phillip - The Avenue Children's Centre (13890)

# City of Port Phillip - The Avenue Children's Centre and Kindergarten

13890

The site audit was completed on 6/12/2021 by **Lucas Wheeler** from Architecture & Access.

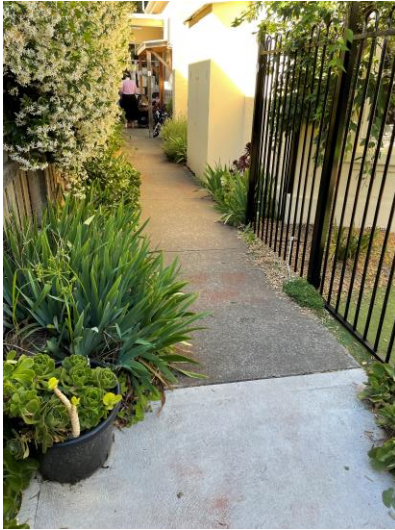
2.1	External Paths of Travel			
	Issue	Action	Rating	Comments
.1	Pathway to principal pedestrian entrance width less than 1000mm due to overgrown vegetation and positioning of verandah post which creates 870mm wide pinch point.	Ensure 1000mm minimum width provided for entire length of accessway. Trim vegetation; relocate/reinstall/remove verandah post.	R

Overgrown vegetation on accessway

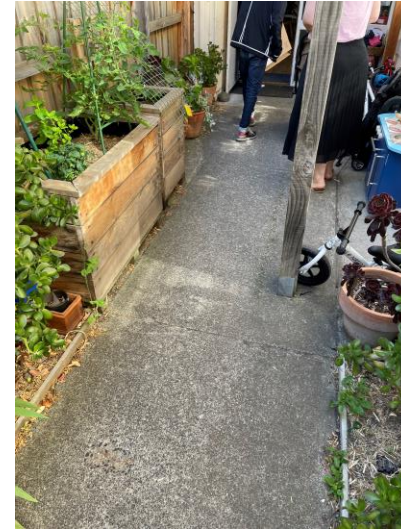
Veradah post pinch point

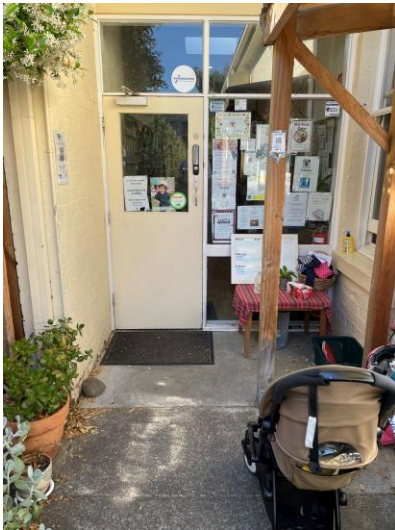
3.1	Entrances			
	Issue	Action	Rating	Comments
.1	Building entrance door clear opening width of 780mm is not compliant with current Standard, AS1428.1 2009.	Provide minimum 850mm clear opening width.	R

Narrow building entry door

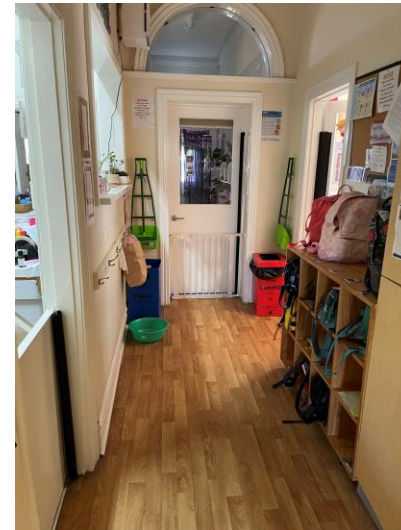
.2	Doors to office, kitchen, toddler room, kids toilet room, laundry have non-compliant latchside clearance.	Provide min 510mm - 530mm latchside clearance, depending on swing direction of door.	R

Lack of door circ space into baby room

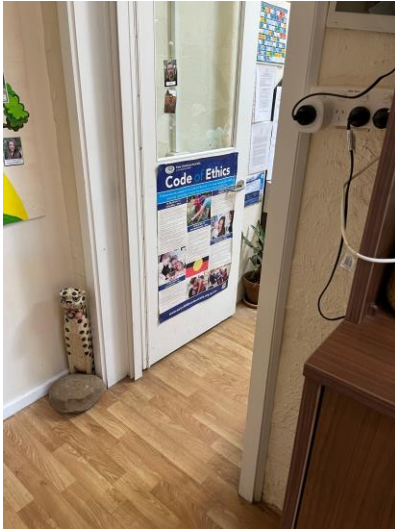
4.1	Internal Doors & Door Controls			
	Issue	Action	Rating	Comments
.1	Internal doors to office, main activity room, kitchen, toddler/baby room, toilet, kids toilets all provide door clear opening width of between 760mm - 780mm.	Provide min. 850mm clear opening width.  Internal clear opening widths are commensurate with the age of the building, however this is well below current version of the mandated relevant Australian Standard AS1428.1 2009.	R

Narrow internal doors

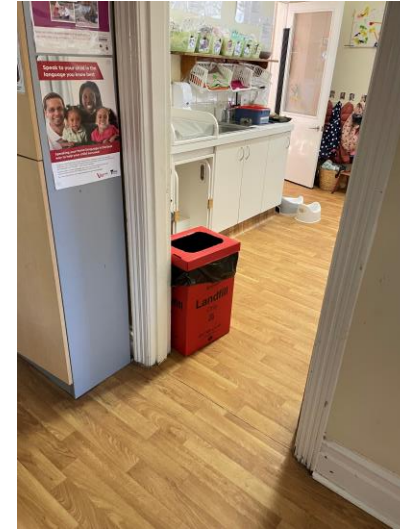
Narrow internal door;  
lack of latchside clearance

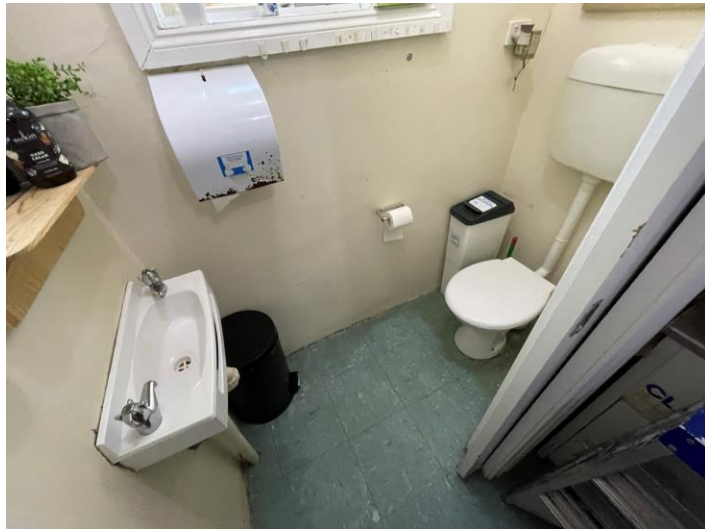
10.1	Accessible WC (Acc WC)			
	Issue	Action	Rating	Comments
.1	Lack of unisex accessible WC within the building. Standard unisex WC provided for staff; standard kids toilets also available.	<p>Provide unisex accessible WC with layout which complies with AS1428.1:2009 Cl 15, including circulation space of 1900x2300mm and appropriate fitout.</p> <p>Given the age and type of the building, provision of a compliant accessible toilet was not expected to be provided. Should the building undergo a change of use, toileting</p>	R

Lack of unisex accessible toilet
