Access Audit

Elwood Children's Centre – 46 Tennyson Street, Elwood

19 December 2021

Prepared for **City of Port Phillip**

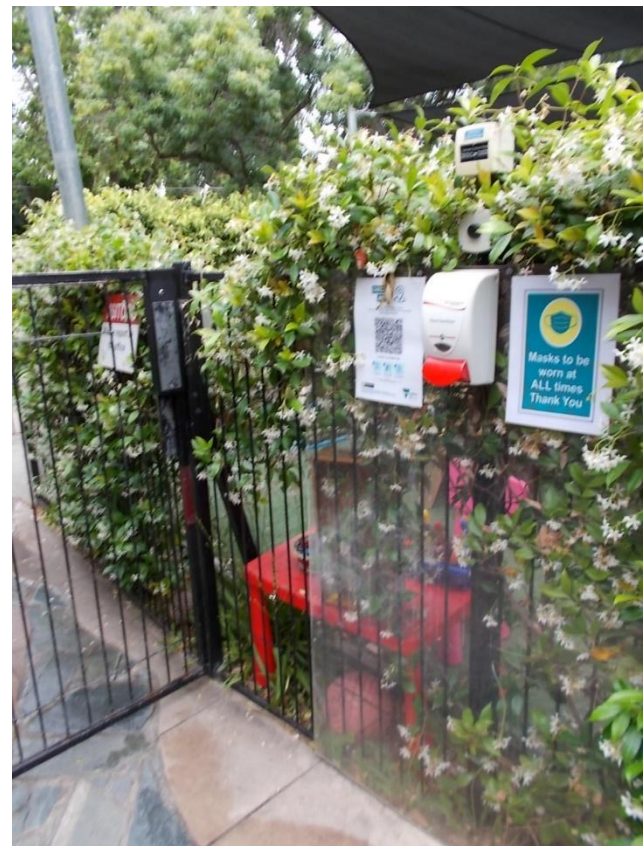
009

12	7/12/21	Side Yard	Cross Falls	General access and external paths	P13	Camber or crossfall not provided to walkway and landings with a gradient gentler than 1:33 (3%) in direction travel to allow for the shedding of water (1:40 (2.5%) max)	AS1428.1, clause 10.1(d)	Modify the walkway or landing to ensure that there is a 1:40 (max) camber or crossfall		Cross falls are up to 1:29	BCA - Medium
13	7/12/21	G02(Gate between Side Yard and Allotment Boundary)	Circulation	Doors	D2	Door latch clearance insufficient	AS1428.1, clause 13.3.1	Modify doorway to achieve the required latch side clearance or fully automate the door	9	No latch side clearance present	BCA - High
14	7/12/21		Gradient and crossfall	Doors	D5	Circulation space in front of door has a gradient or crossfall greater than 1:40 (2.5%)	AS1428.1, clause 13.3.1	Modify the area in front of the doorway to comply	9		BCA - High

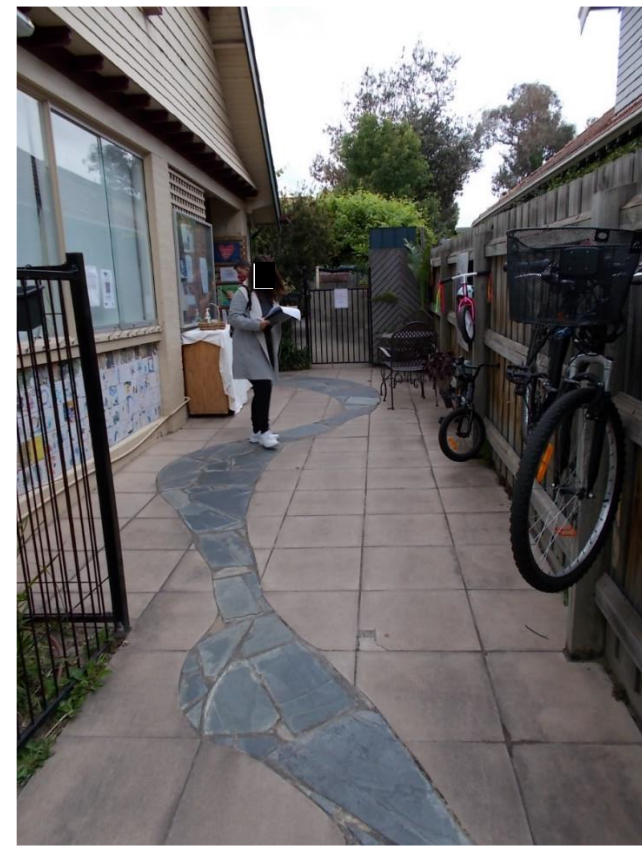
010

Item	Date	Room no. or location	Item	Access Element	Code	Identified shortfall	Access standard or BCA	Recommendations	Photo no.	Comments or measurements	Priority
15	7/12/21		Luminance Contrast	Doors	D6	Doorway does not appear to have sufficient luminance contrast	AS1428.1, clause 13.1	Repaint or recoat the door leaf, jamb, adjacent wall or architrave or provide a 50 mm wide contrasting edge treatment around the doorway	9	The gate lacks luminance contrast with the surrounding fence	BCA - Medium
16	7/12/21		Door control	Doors	D14	Control that needs to be pushed is outside of the range of 900 mm and 1200 mm AFFL	AS1428.1, clause 13.5.3(b)	Reposition door hardware to comply	10	The door control (child proof gate) is too high, only first door from allotment boundary is permitted to have higher door controls	BCA - Medium
17	7/12/21		Break Glass	Controls	CT1	Switches and controls not located between 900 mm and 1100 mm AFFL	AS1428.1, clause 14.1	Reposition switches or controls	10	The breakglass is too high at 1740mm above the FFL	BCA - High

18	7/12/21		Push to open	Controls	CT1	Switches and controls not located between 900 mm and 1100 mm AFFL	AS1428.1, clause 14.1	Reposition switches or controls	10	The push to exit button is too high at 1580mm above the FFL	BCA - High
19	7/12/21			Controls	CT6	Other			10	The push to exit button is too small with a 15mm approx diameter and not sitting proud of surface	
20	7/12/21		Hand sanitiser	Controls	CT6	Other			10	The hand sanitiser is too high at 1277mm	
21	7/12/21	G03(Gate between Side Yard and South Yard)	Luminance Contrast	Doors	D6	Doorway does not appear to have sufficient luminance contrast	AS1428.1, clause 13.1	Repaint or recoat the door leaf, jamb, adjacent wall or architrave or provide a 50 mm wide contrasting edge treatment around the doorway	11	The gate lacks luminance contrast with the surrounding fence	BCA - Medium
22	7/12/21		Door control	Doors	D13	Door handle located outside the range of 900 mm and 1100 mm AFFL	AS1428.1, clause 13.5.3(a)	Reposition door hardware to comply	11	The door control (child proof gate) is too high, only first door from allotment boundary is permitted to have higher door controls	BCA - Medium

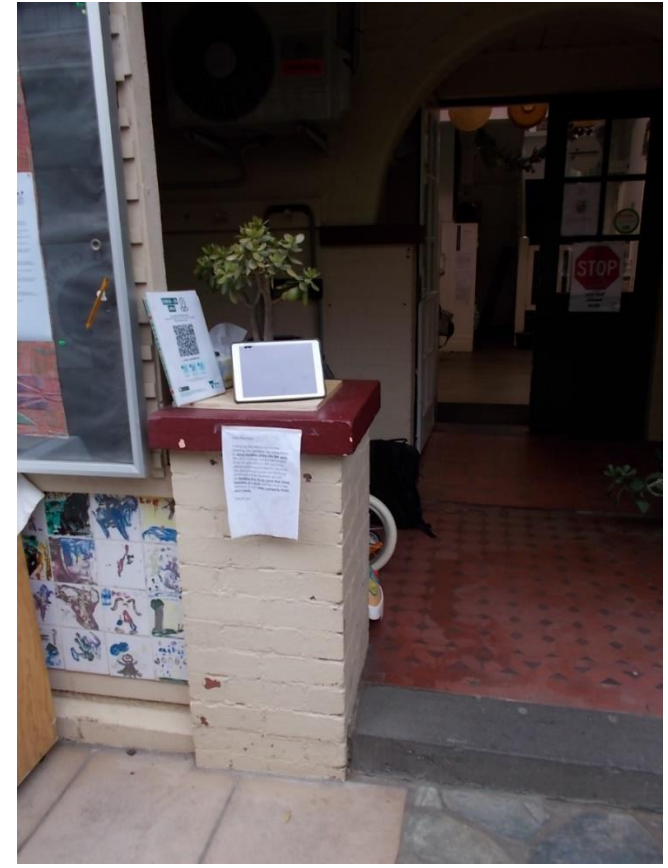
014

26	7/12/21		Luminance Contrast	Doors	D6	Doorway does not appear to have sufficient luminance contrast	AS1428.1, clause 13.1	Repaint or recoat the door leaf, jamb, adjacent wall or architrave or provide a 50 mm wide contrasting edge treatment around the doorway	13	The doors have no luminance contrast with the walls on the inside	BCA - Medium
27	7/12/21		Threshold Ramp	Doors	D19	The threshold ramp at the doorway does not comply	AS1428.1, clause 10.5 and Figure 21	Replace threshold ramp with a compliant type	13	The door has a ramp on one side with no landing and excessive length of 940mm and gradients of up to 1:6	BCA - High
28	7/12/21		Ligthswitch	Controls	CT1	Switches and controls not located between 900 mm and 1100 mm AFFL	AS1428.1, clause 14.1	Reposition switches or controls	14	Lightswitch is too high at 1350mm above FFL	BCA - High
29	7/12/21		Ligthswitch	Controls	CT2	Switches and controls located less than 500 mm from an internal corner	AS1428.1, clause 14.1	Reposition switches or controls	14	Lightswitch is 450mm from the internal corner	BCA - High

30	7/12/21		Keypad	Controls	CT1	Switches and controls not located between 900 mm and 1100 mm AFFL	AS1428.1, clause 14.1	Reposition switches or controls	14	Keypad is too high at 1500mm	BCA - High

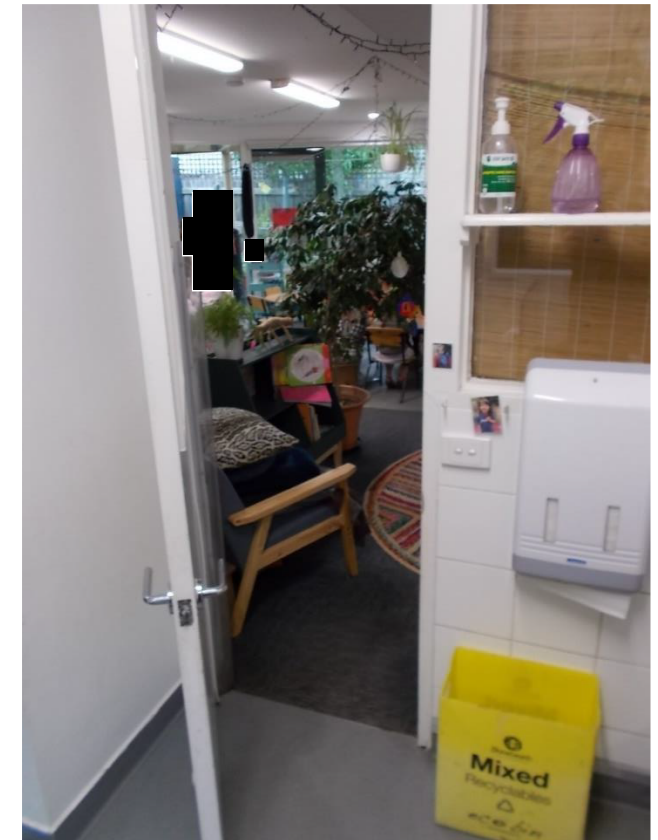
020

Item	Date	Room no. or location	Item	Access Element	Code	Identified shortfall	Access standard or BCA	Recommendations	Photo no.	Comments or measurements	Priority
43	7/12/21	D04(Door to Kinder Playroom 2)	Clear Opening Width	Doors	D1	Door clear opening including active leaf for double door is less than 850 mm	AS1428.1, clause 13.2	Modify doorway and provide new accessible door	20	The leafs on the double doors provide a clear opening width of 752mm each.	BCA - High
44	7/12/21		Luminance Contrast	Doors	D6	Doorway does not appear to have sufficient luminance contrast	AS1428.1, clause 13.1	Repaint or recoat the door leaf, jamb, adjacent wall or architrave or provide a 50 mm wide contrasting edge treatment around the doorway	20	The doors have no luminance contrast with the walls on both sides	BCA - Medium
45	7/12/21		Door handle	Doors	D13	Door handle located outside the range of 900 mm and 1100 mm AFFL	AS1428.1, clause 13.5.3(a)	Reposition door hardware to comply	20	The door handle is too low at 780mm	BCA - Medium

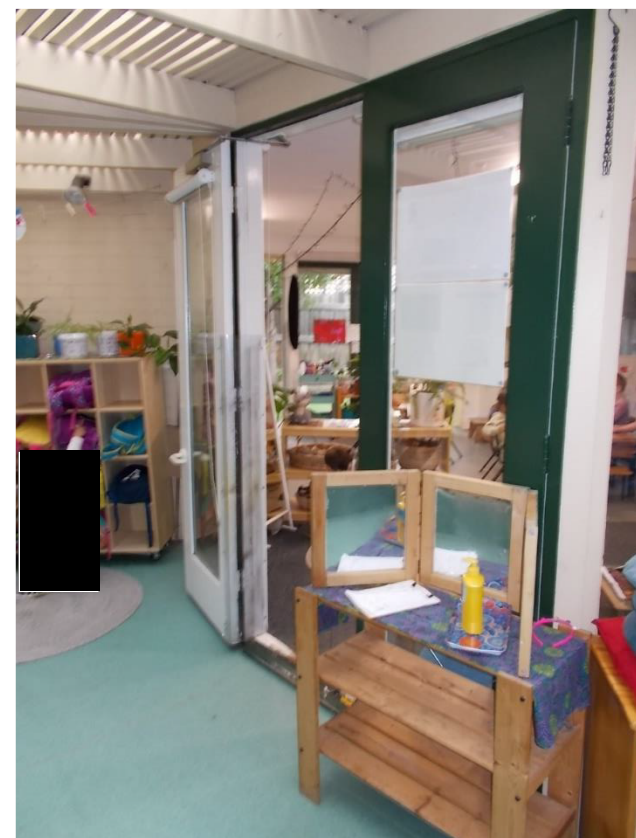
021

49	7/12/21		Door handle	Doors	D13	Door handle located outside the range of 900 mm and 1100 mm AFFL	AS1428.1, clause 13.5.3(a)	Reposition door hardware to comply	21	The door handle is too low at 796mm	BCA - Medium

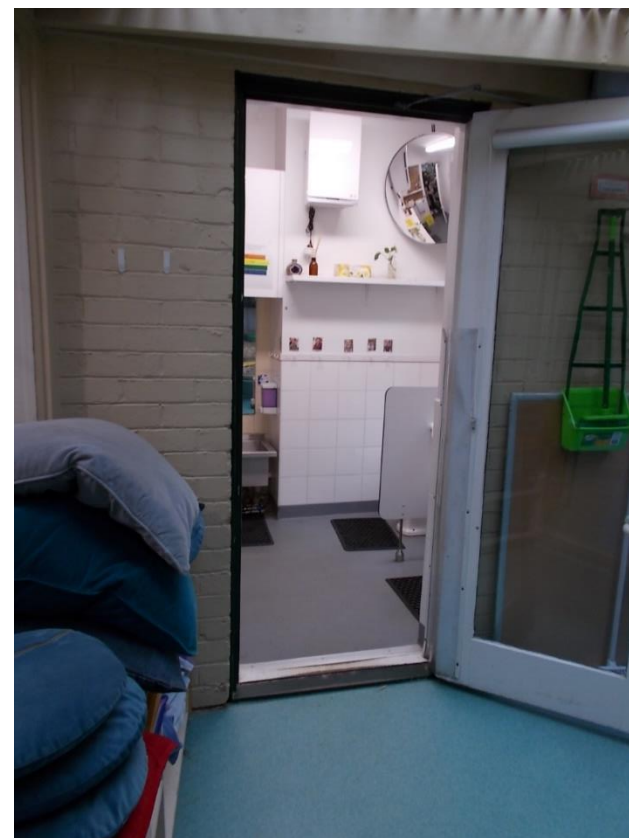
022

Item	Date	Room no. or location	Item	Access Element	Code	Identified shortfall	Access standard or BCA	Recommendations	Photo no.	Comments or measurements	Priority
50	7/12/21	D06 (First set of Double doors from Kinder	Clear Opening Width	Doors	D1	Door clear opening including active leaf for double door is less than 850 mm	AS1428.1, clause 13.2	Modify doorway and provide new accessible door	22	The clear opening width provided by each door leaf is 710mm	BCA - High
51	7/12/21		Luminance Contrast	Doors	D6	Doorway does not appear to have sufficient luminance contrast	AS1428.1, clause 13.1	Repaint or recoat the door leaf, jamb, adjacent wall or architrave or provide a 50 mm wide contrasting	22	The doors have no luminance contrast with the walls on in the internal side	BCA - Medium
52	7/12/21		Door handle	Doors	D13	Door handle located outside the range of 900 mm and 1100 mm AFFL	AS1428.1, clause 13.5.3(a)	Reposition door hardware to comply	22	The door handle is too low at 800mm	BCA - Medium

53	7/12/21		Threshold Lip	Doors	D19	The threshold ramp at the doorway does not comply	AS1428.1, clause 10.5 and Figure 21	Replace threshold ramp with a compliant type	22	There is a 40mm high lip at the door	BCA - High
54	7/12/21		Door finish	Doors	D22	Either visual indicators have not been installed to glass doors or side panels or installed visual indicators do not comply	AS1428.1, clause 6.6	Install compliant visual indicators	22	The doors are glass but there are no decals	BCA - Medium
55	7/12/21	D07 (Door from Children's	Clear Opening Width	Doors	D1	Door clear opening including active leaf for double door is less than 850 mm	AS1428.1, clause 13.2	Modify doorway and provide new accessible door	23	The clear opening width is 789mm	BCA - High
56	7/12/21		Luminance Contrast	Doors	D6	Doorway does not appear to have sufficient luminance contrast	AS1428.1, clause 13.1	Repaint or recoat the door leaf, jamb, adjacent wall or architrave or provide a 50 mm wide contrasting edge treatment around the	23	The doors have no luminance contrast with the walls on in the internal side	BCA - Medium

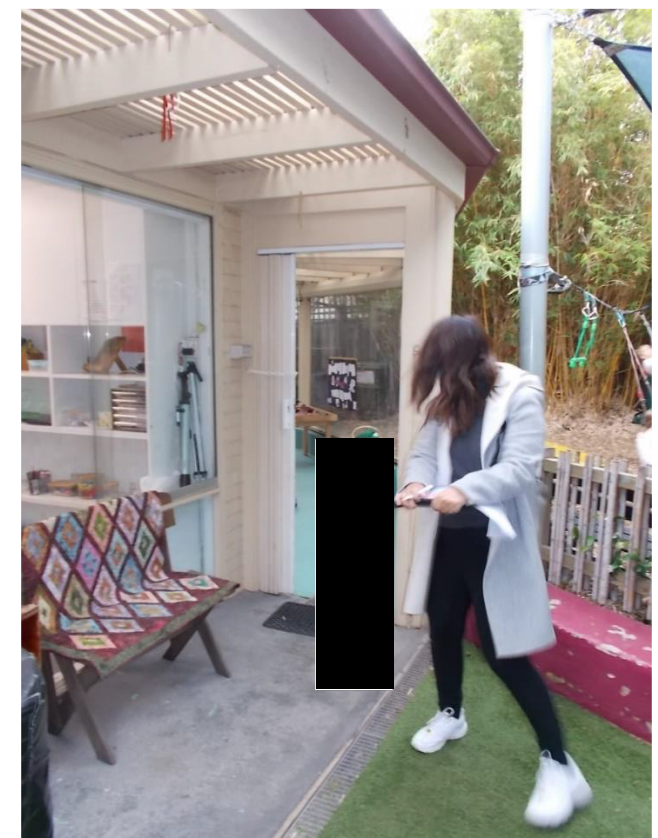
023

57	7/12/21		Door handle	Doors	D13	Door handle located outside the range of 900 mm and 1100 mm AFFL	AS1428.1, clause 13.5.3(a)	Reposition door hardware to comply	23	The door handle is too low at 818mm	BCA - Medium
58	7/12/21		Threshold Lip	Doors	D19	The threshold ramp at the doorway does not comply	AS1428.1, clause 10.5 and Figure 21	Replace threshold ramp with a compliant type	23	There is a 40mm high lip at the door	BCA - High

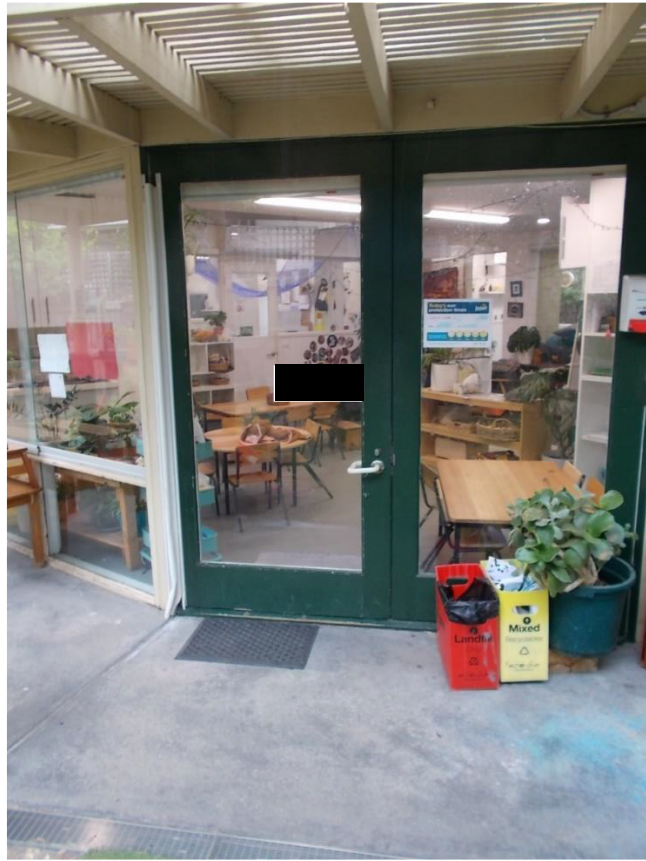
024

62	7/12/21		Door handle	Doors	D8	Door handle and related hardware cannot be opened by one hand	AS1428.1, clause 13.5.2(a)	Replace door hardware with a compliant type	24	Door handle is not D-pull type	BCA - Medium
63	7/12/21		Door Snib	Doors	D12	Door snib does not have a lever handle that is at least 45 mm long	AS1428.1, clause 13.5.3(d)	Replace door hardware with a compliant type	24	The door snib is too small	BCA - Medium
64	7/12/21		Switch	Controls	CT1	Switches and controls not located between 900 mm and 1100 mm AFFL	AS1428.1, clause 14.1	Reposition switches or controls	24	The switch located externally close to the door is at 1520mm high	BCA - High
65	7/12/21	D9 (Second set of Double doors from Kinder Playroom 2	Luminance Contrast	Doors	D6	Doorway does not appear to have sufficient luminance contrast	AS1428.1, clause 13.1	Repaint or recoat the door leaf, jamb, adjacent wall or architrave or provide a 50 mm wide contrasting edge treatment around the doorway	25	The doors have no luminance contrast with the walls on in the internal side	BCA - Medium

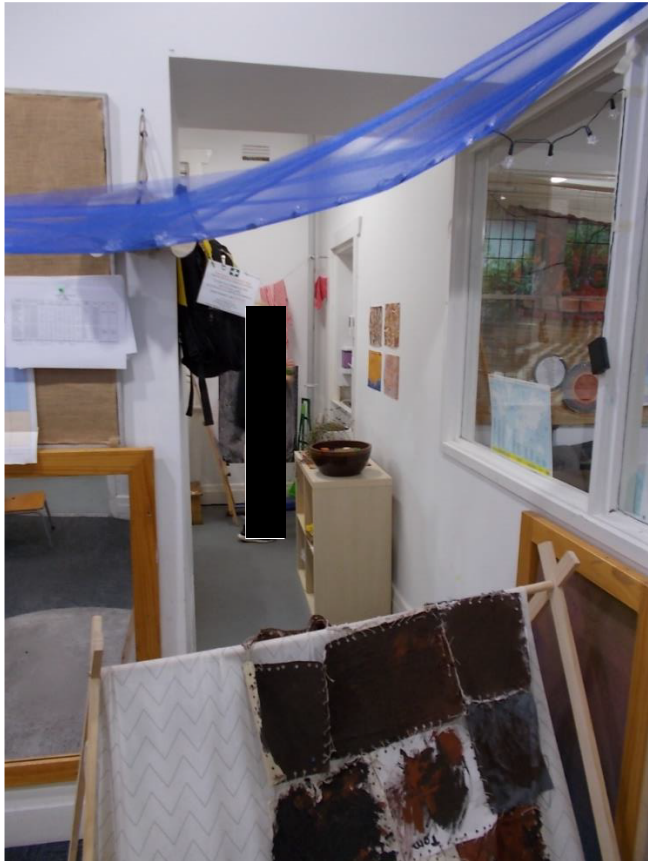
025

Item	Date	Room no. or location	Item	Access Element	Code	Identified shortfall	Access standard or BCA	Recommendations	Photo no.	Comments or measurements	Priority
66	7/12/21		Door handle	Doors	D13	Door handle located outside the range of 900 mm and 1100 mm AFFL	AS1428.1, clause 13.5.3(a)	Reposition door hardware to comply	25	The door handle is too low at 801mm	BCA - Medium
67	7/12/21		Threshold Lip	Doors	D19	The threshold ramp at the doorway does not comply	AS1428.1, clause 10.5 and Figure 21	Replace threshold ramp with a compliant type	25	There is a 40mm high lip at the door	BCA - High
68	7/12/21		Door finish	Doors	D22	Either visual indicators have not been installed to glass doors or side panels or installed visual indicators do not comply	AS1428.1, clause 6.6	Install compliant visual indicators	25	The doors are glass but there are no decals	BCA - Medium
69	7/12/21		Hand sanitiser	Controls	CT6	Other			25	The hand sanitiser is near this door is too high at 1488mm

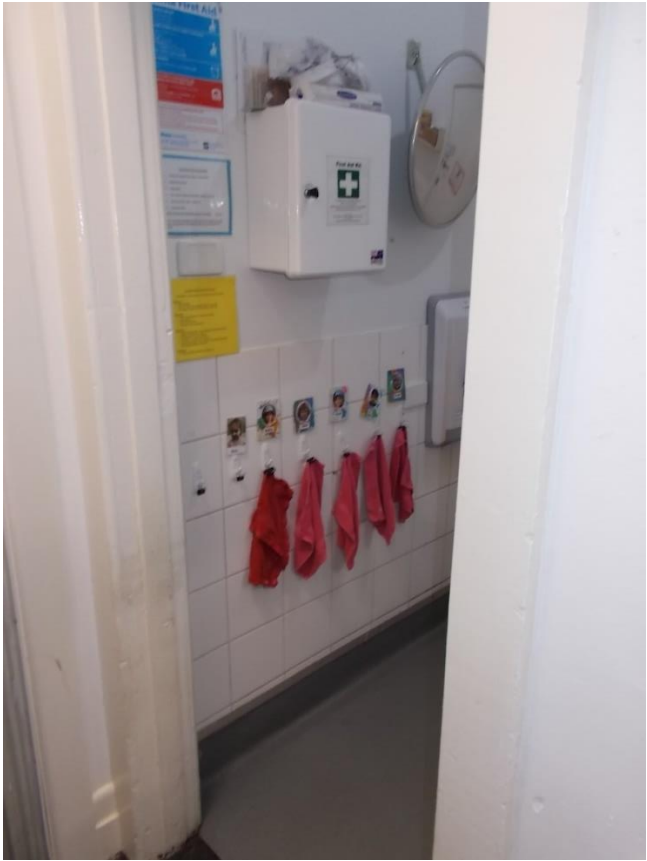
026

70	7/12/21	Kinder Playroom 1	Path of travel						26	The opening at this location is too narrow at 960mm only	
71	7/12/21		Switch	Controls	CT1	Switches and controls not located between 900 mm and 1100 mm AFFL	AS1428.1, clause 14.1	Reposition switches or controls		The light switch is too high at 1346mm	BCA - High
72	7/12/21		Switch	Controls	CT2	Switches and controls located less than 500 mm from an internal corner	AS1428.1, clause 14.1	Reposition switches or controls		The light switch is 291mm within the internal corner	BCA - High

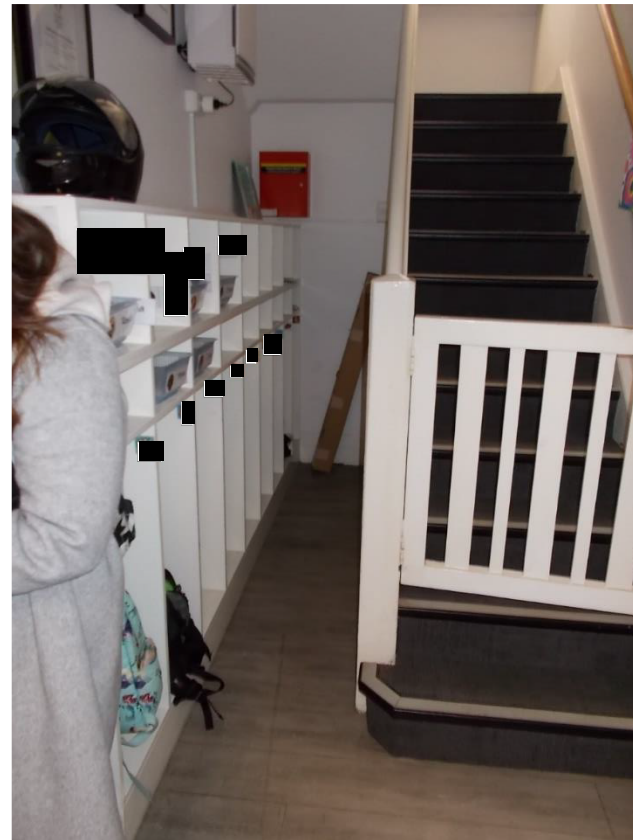
030

Item	Date	Room no. or location	Item	Access Element	Code	Identified shortfall	Access standard or BCA	Recommendations	Photo no.	Comments or measurements	Priority
79	7/12/21	D12 (Door from Hall to Entry)	Clear Opening Width	Doors	D1	Door clear opening including active leaf for double door is less than 850 mm	AS1428.1, clause 13.2	Modify doorway and provide new accessible door	30	The clear opening width is 767mm	BCA - High
80	7/12/21		Luminance Contrast	Doors	D6	Doorway does not appear to have sufficient luminance contrast	AS1428.1, clause 13.1	Repaint or recoat the door leaf, jamb, adjacent wall or architrave or provide a 50 mm wide contrasting edge treatment around the doorway	30	The doors have no luminance contrast with the walls on both sides	BCA - Medium
81	7/12/21		Door handle	Doors	D13	Door handle located outside the range of 900 mm and 1100 mm AFFL	AS1428.1, clause 13.5.3(a)	Reposition door hardware to comply	30	The door handle is too low at 764mm	BCA - Medium

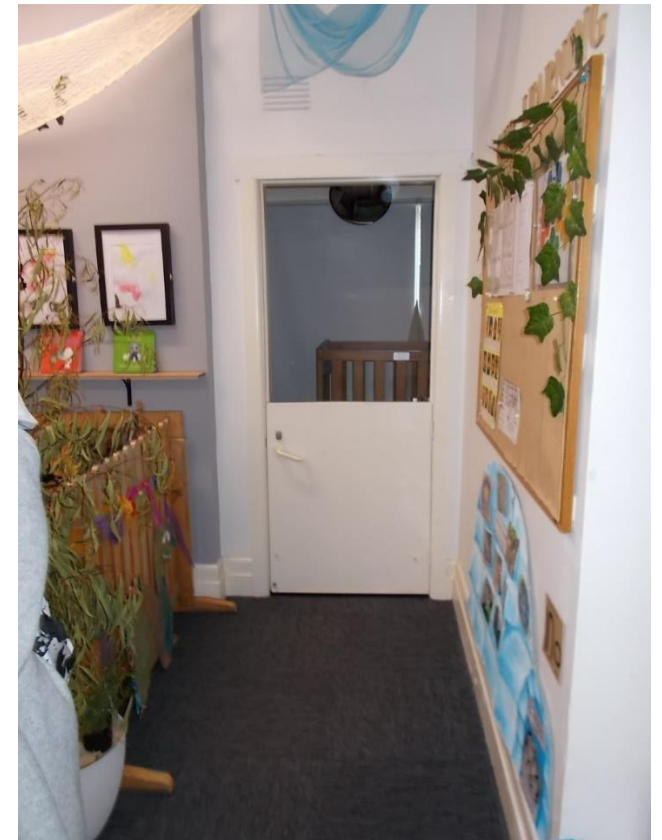
032

Item	Date	Room no. or location	Item	Access Element	Code	Identified shortfall	Access standard or BCA	Recommendations	Photo no.	Comments or measurements	Priority
84	7/12/21		Door Circulation	Doors	D2	Door latch clearance insufficient	AS1428.1, clause 13.3.1	Modify doorway to achieve the required latch side clearance or fully automate the door	30	150mm approx.	BCA - High
85	7/12/21		Luminance Contrast	Doors	D6	Doorway does not appear to have sufficient luminance contrast	AS1428.1, clause 13.1	Repaint or recoat the door leaf, jamb, adjacent wall or architrave or provide a 50 mm wide contrasting edge treatment around the doorway	32	The doors have no luminance contrast with the walls on both sides	BCA - Medium
86	7/12/21		Door handle	Doors	D13	Door handle located outside the range of 900 mm and 1100 mm AFFL	AS1428.1, clause 13.5.3(a)	Reposition door hardware to comply	32	The door handle is too low at 797mm	BCA - Medium

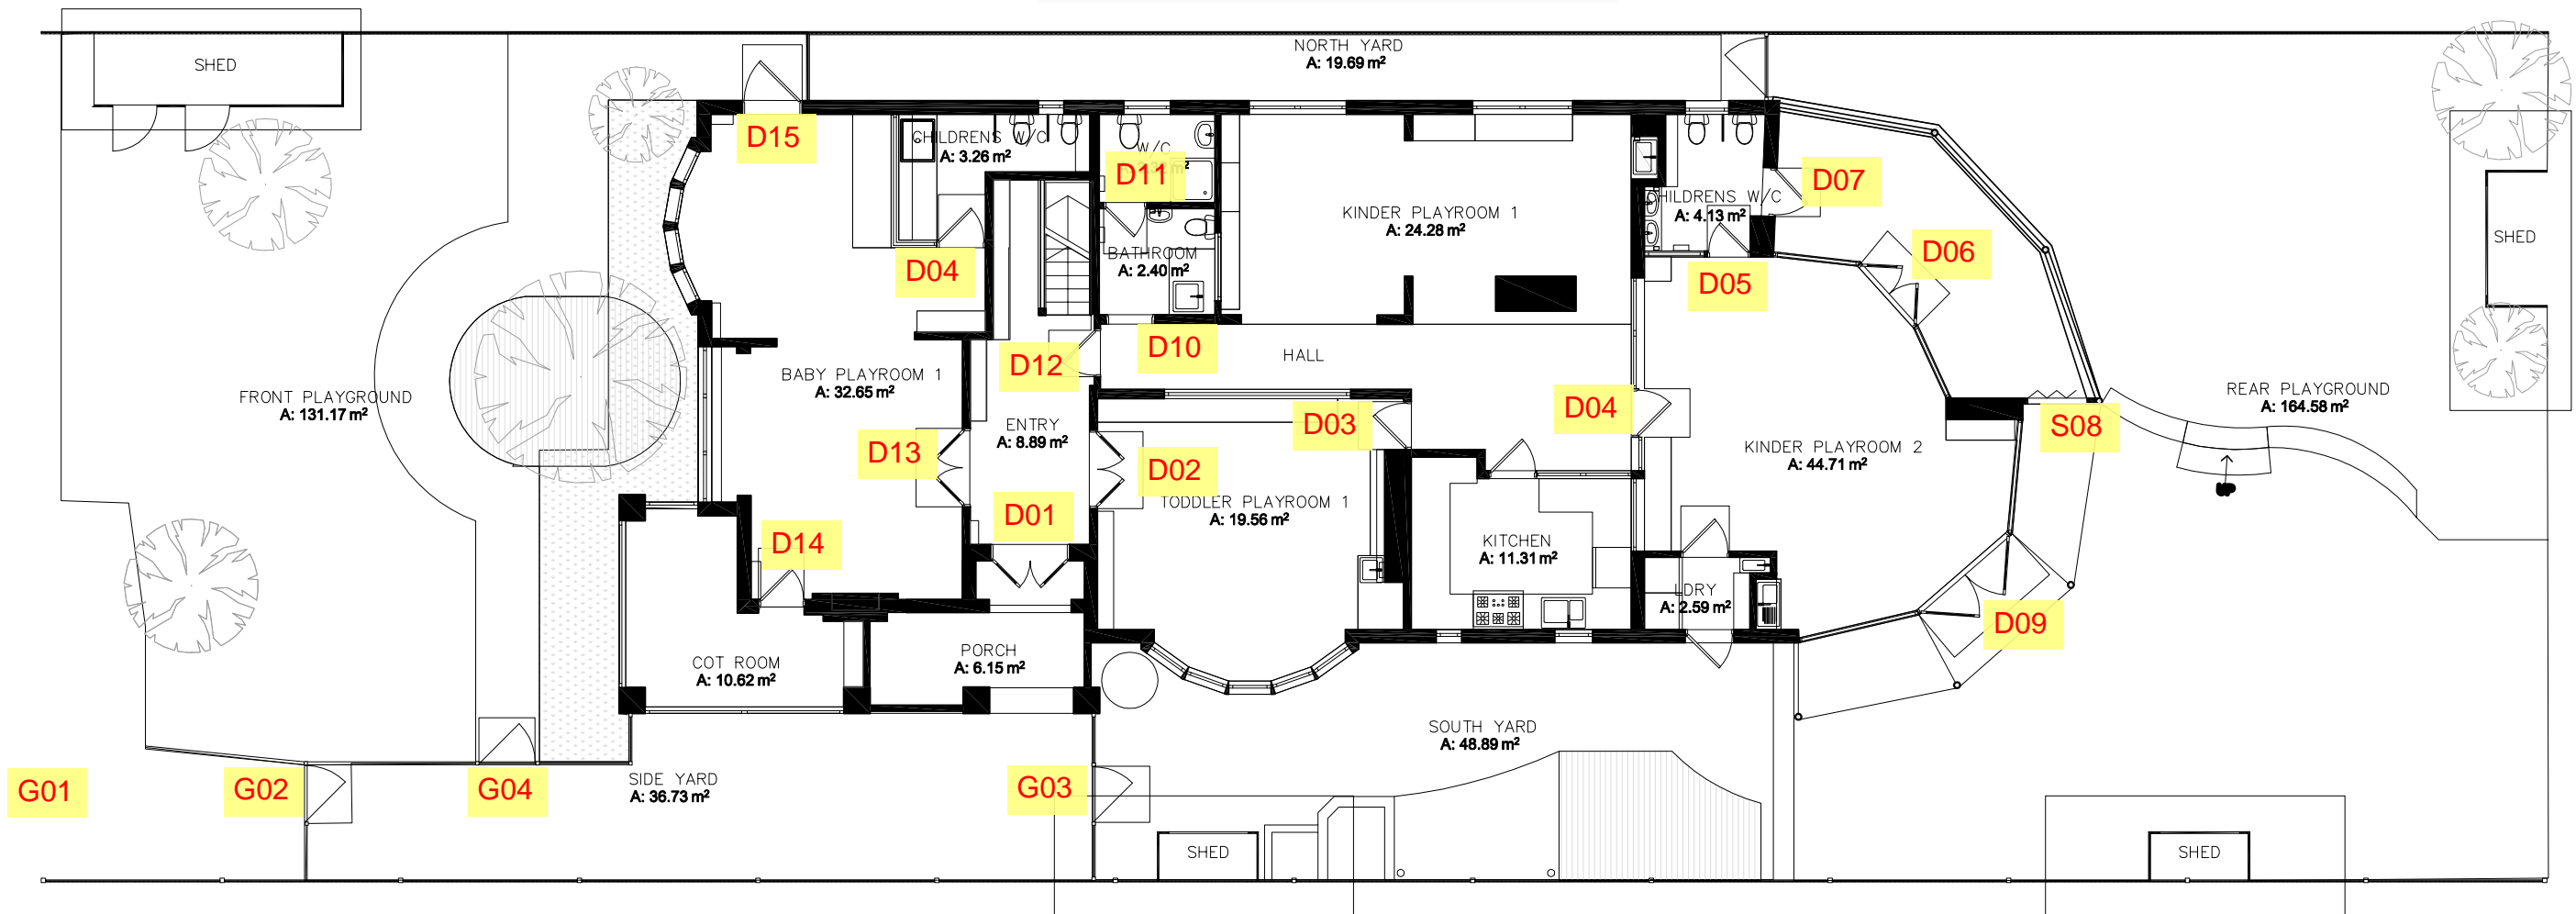
6.0 Door numbering plan

Section 6.0 includes the floor plans provided by the City of Port Phillip with door numbers (labelled by Functional Access Solutions/Think Access) to help identify each door in the access audit schedule.
