PROJECT
CITY OF PORT PHILLIP
CONDITION AUDITS
46 TENNYSON STREET,
ELWOOD 3184
PROJECT NUMBER
1614

3.00 TENNYSON STRET- ELWOOD CHILDCARE CENTRE

3 46 Tennyson st, Elwood

3.4 Observations

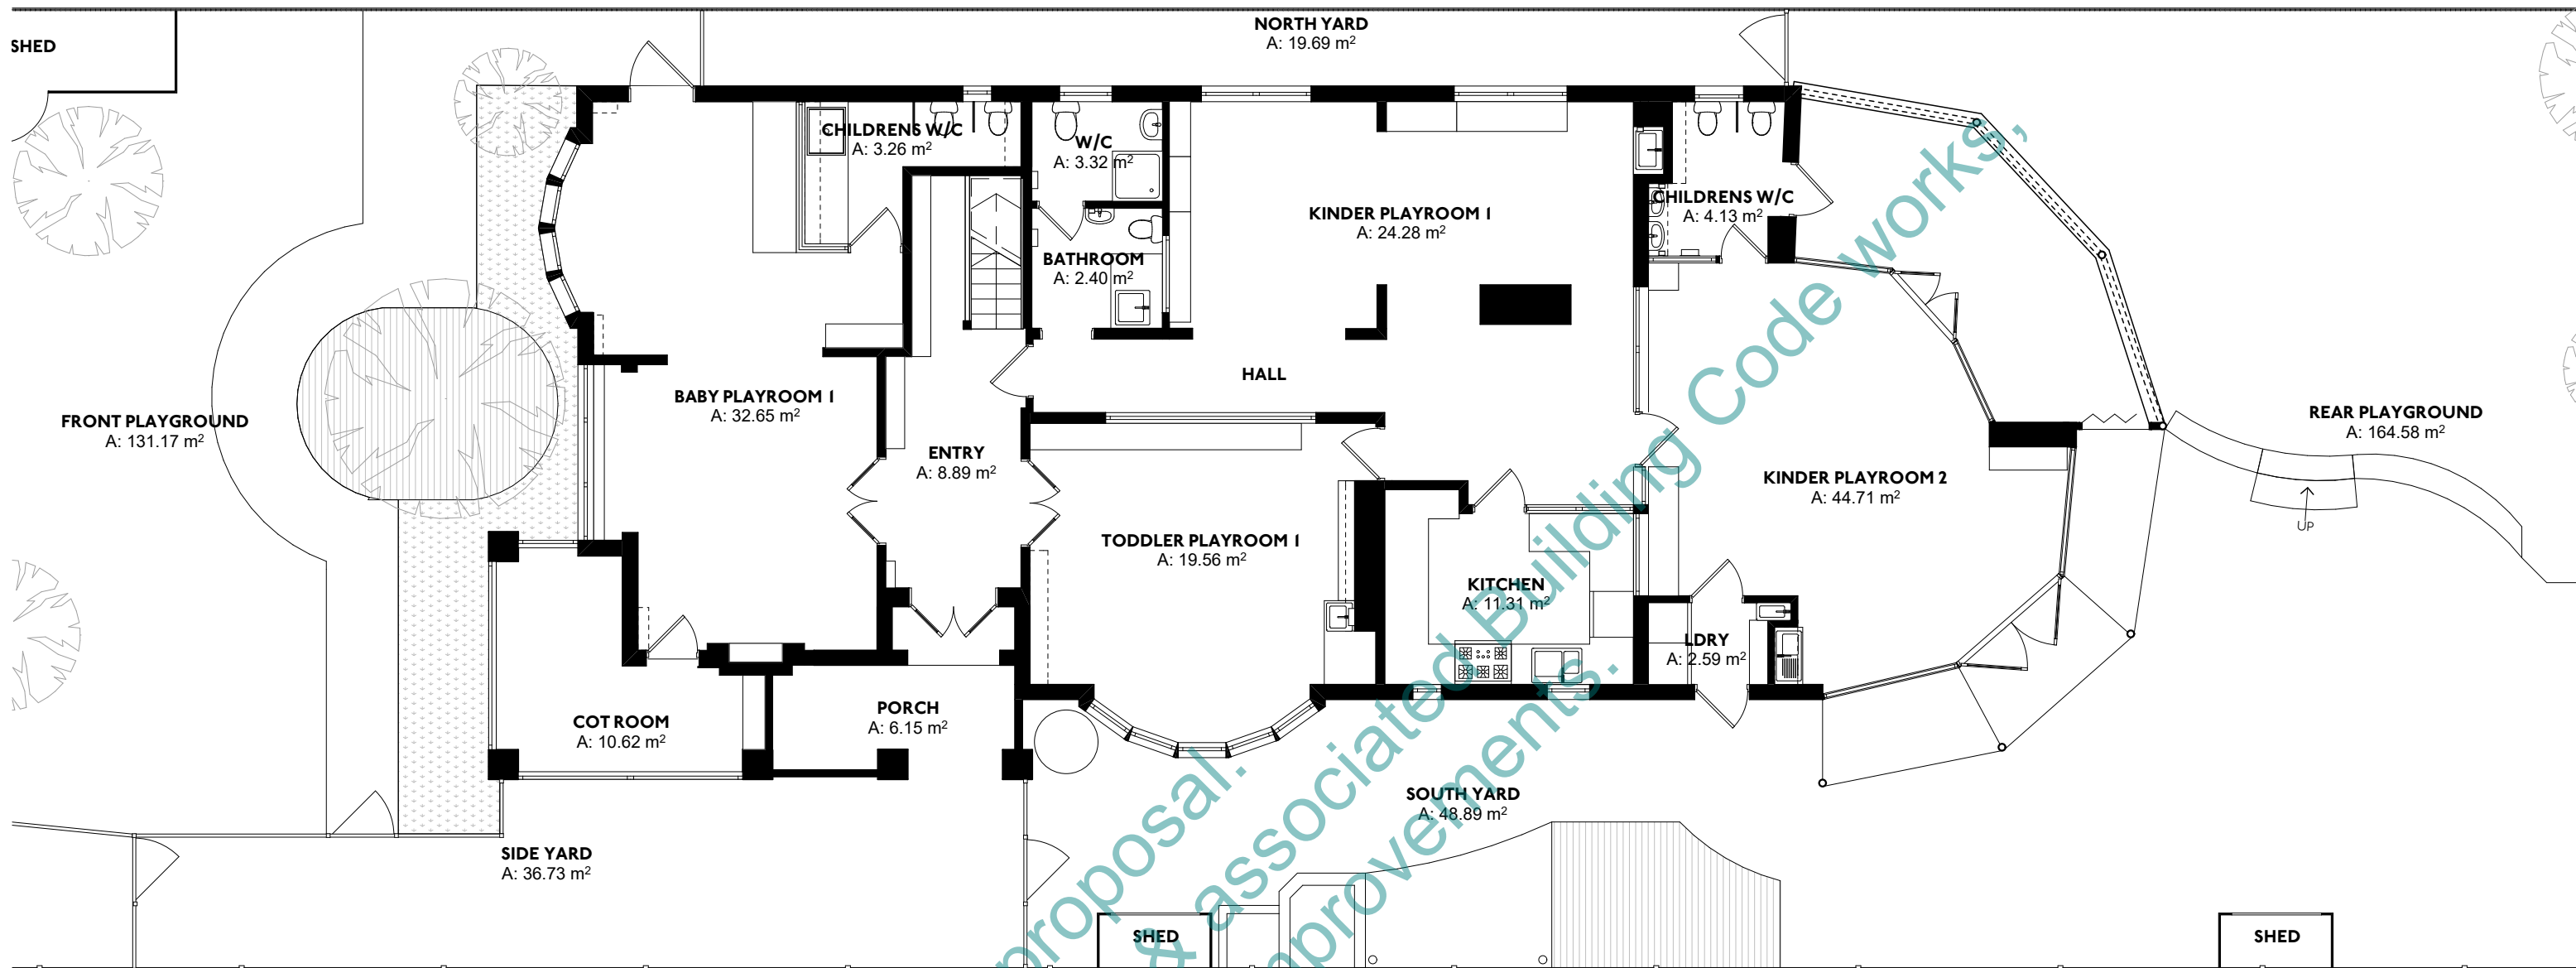
FS02.0

1 GROUND FLOOR PLAN - EXISTING
1:100
