Tree assessment & management plan Proposed fence works Eildon Road Children's Centre 17 Eildon Road, St Kilda

23rd April 2021 | Tree Logic Ref. 011520

Prepared for Jason Sim. Project Manager. Construction, Contracts and Operations. City of Port Phillip.

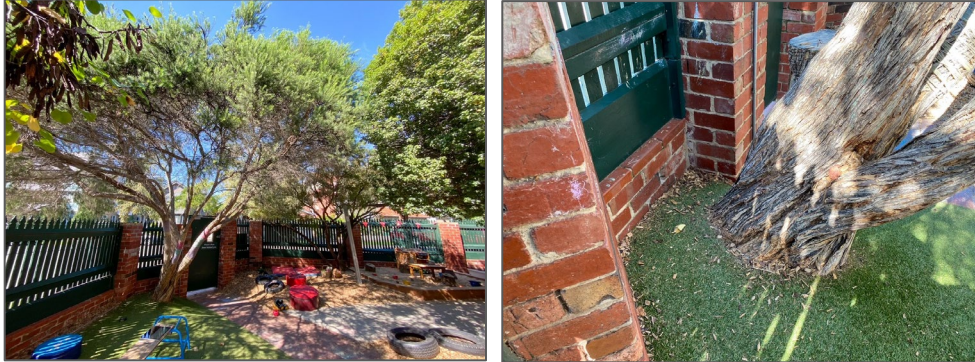
Based on the proposal, there are not many options that could be utilised to avoid impacting the tree. Fixing the steel posts extensions to the existing pillars would offset the requirement for excavation, however, this may not meet the engineering requirements for fence stability.

Figure 1. Shows Tree No. 3 Bracelet Honey Myrtle in the landscape and right shows the location of the base of the tree to the existing fence.

Unless design modifications to the proposed fence extension can be implemented to avoid any excavation within the SRZ, then the tree should be considered for removal (a permit would be required as the tree is greater than 150 cm circumference at the base).

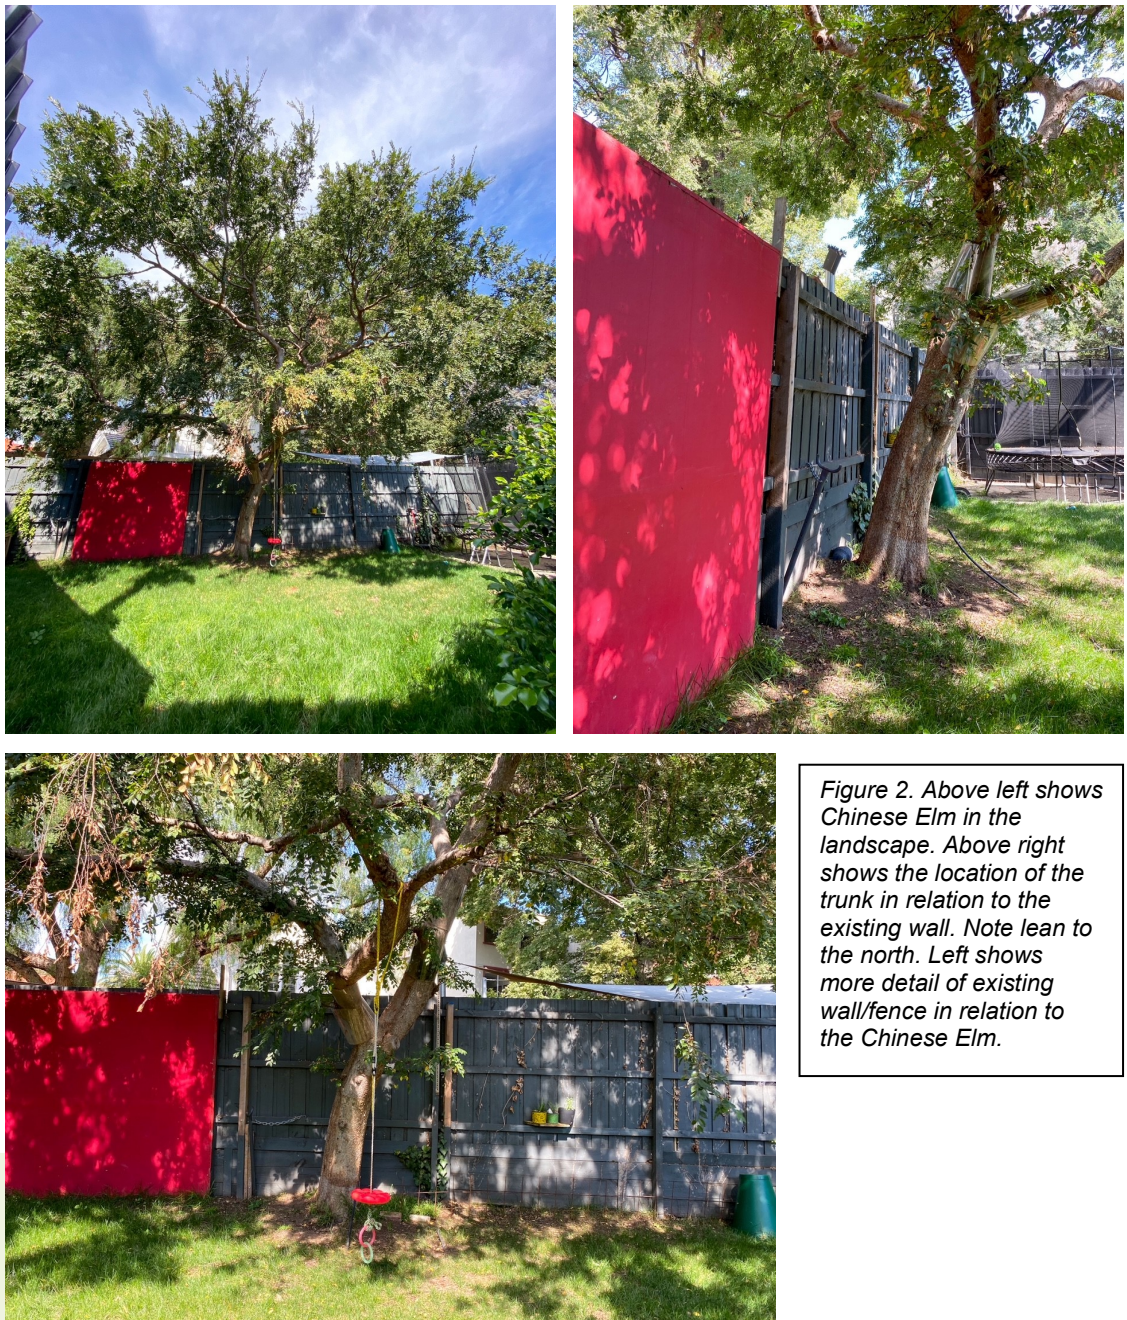
The base of trunk of the Chinese Elm is 0.34 m from the existing retaining wall. The SRZ for the Chinese Elm is 2.5 m. Any works, as outlined in the Adams Drawing number S002 Rev A, has the potential to impact on roots within the SRZ of Tree No. 9.

Figure 2. Above left shows Chinese Elm in the landscape. Above right shows the location of the trunk in relation to the existing wall. Note lean to the north. Left shows more detail of existing wall/fence in relation to the Chinese Elm.

There is a high likelihood that roots would have grown under the existing wall and up into the rear of 17 Eildon Road. These roots will be assisting in tree stability. The tree also leans towards the north and the canopy weight is biased to the north and away from the wall.

As far as is practicable, the roots within the allocated SRZ should be preserved. The proposed new retaining wall should emulate existing conditions as far as is achievable with no additional excavation within the SRZ. This includes any excavation works on the 17 Eildon Road side of the wall, such as back of wall drainage. As an alternative to back of wall drainage, is it possible to have weep holes in the SRZ section (approximately 4.8 m length).

Any foundations must be located outside of the SRZ. The distance between the piers must be spanned by a structural component that is placed above the existing grade within 1 Inverleith Court. The structural component could be bedded into the topsoil, after the removal of the organic matter layer (no more than 50 mm depth). See Figure 3 for an indicative design for spanning a root zone with a fence.

Within the SRZ distance of the tree, utilise existing back of wall drainage if present and still functioning. If new drainage is required, consideration should be given to weep holes in the SRZ section of the wall.

- The proposed footings for the H beam posts must be placed outside of the SRZ.

- Tree No. 9 - Due to the construction of a retaining wall within the SRZ of Tree No. 9 Chinese Elm (located on the adjoining property), substantial construction impacts could occur. The proposed foundations for the retaining wall and fence must be located outside of the SRZ. The distance between the piers must be spanned by a structural component that is placed above the existing grade within 1 Inverleith Court. No new back of wall drainage is to be installed in the SRZ area.
