# REPORT

CONDITION ASSESSMENT:  
17 EILDON RD, ST KILDA, VIC  
18 January 2022

for  
City of Port Phillip

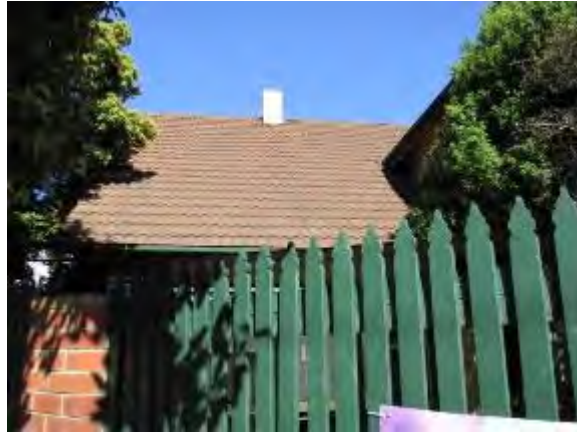
17: IMG\_0429

1.03	Façade	Main building	Generally the two storey residential property comprises of face brick masonry and shingles to the eastern elevation.	Generally in fair to poor condition mindful of age and use. There is mortar missing from pointing and what appears to be step cracking in the brick facade. Given that the facade is a rain screen, currently it is not serving its intended purpose. The structural report also highlights that brickwork wall ties may have failed. <b>Please refer to the separate Structural Report.</b>	3.5	0429, 0426, 0428, 0708, 0710, 0712, 0737, 0738,

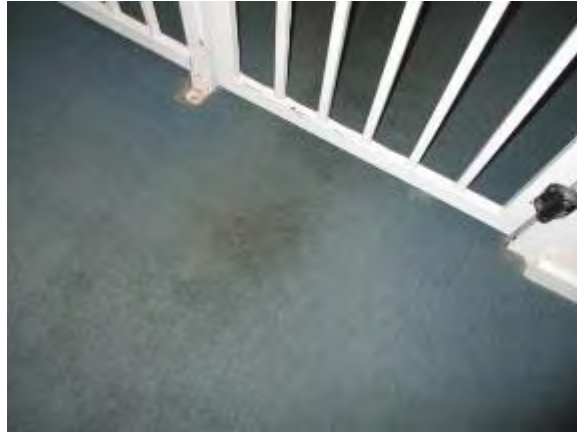
35: IMG\_0447

2.07	Floors	Lobby & short corridor (E of Classroom 4)	Floors comprise of low grade commercial carpet with painted timber skirtings. Vinyl to hallway.	Carpet showing signs of wear and tear with areas stained. Hallway vinyl heavily soiled especially and threshold to Nursery.	3.5	0447,0448, 0547, 0549, 0551

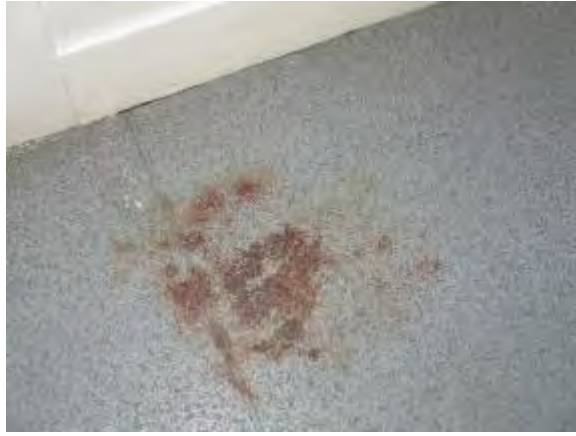
47: IMG\_0459

2.11	Floors	Classroom 1	Floors comprise of fixed vinyl sheeting, brick paving, with floor heating grates.	Generally in fair condition. No1 grate is broken and requires replacement. Heaving soiling to sections requiring strip and reseal or replacement.	3	459, 460, 461

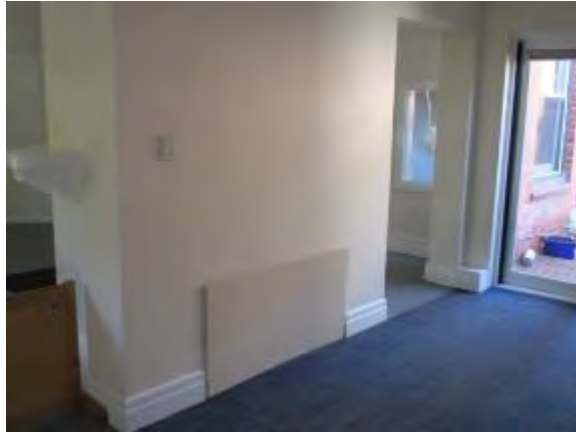
65: IMG\_0477

2.15	Floors	Classroom 2	Carpeted throughout.	Generally in good condition mindful of age and use.	2	0476, 0478
2.16	Windows & Doors	Classroom 2	Doors a painted timbers glazed with full height panels, windows are fixed with painted trim.	Generally in good condition mindful of age and use.	2	0469, 0477

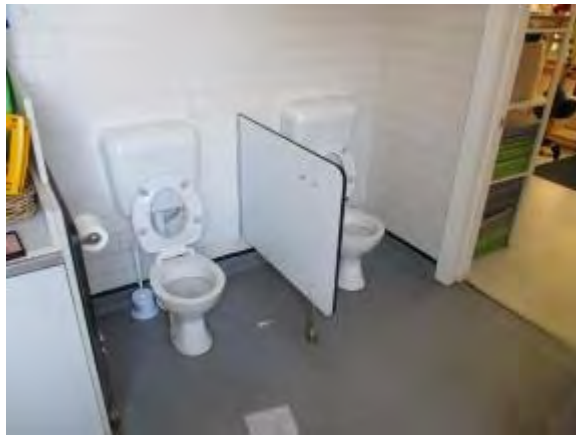
71: IMG\_0483

2.21	Fixtures and Fittings	Bathroom 1	Stainless steel sink with single mixer tap, 2 No. WC with vanity screen and 2 No. handbasins with single tap and soap dispensers.	Generally in fair condition mindful of age and use.	3	0483, 0484, 0487

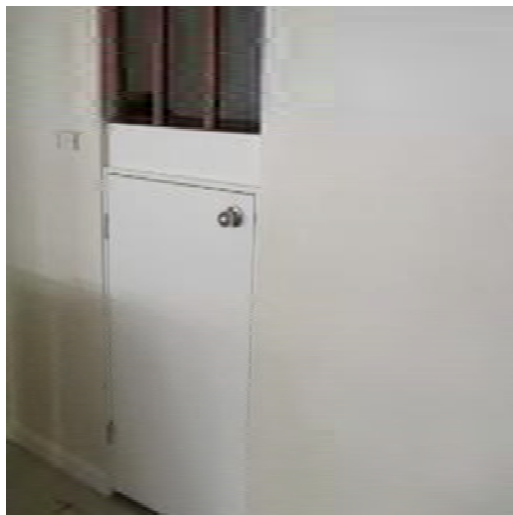
111: IMG\_0543

2.05	Ceilings	Lobby & short corridor (E of Classroom 4)	Flush fixed painted plasterboard and cornices throughout. Surface mounted batten luminaries.	Generally in fair condition mindful of age and use. Requires minors paint repairs	3.5	0543

2.06	Walls	Lobby & short corridor (E of Classroom 4)	Walls a combination of painted hard plaster and plasterboard stud. 1 No. wall mounted air purifier.	Walls generally in fair condition mindful of age and use. Requires minors paint repairs.	3.5	0543
