# Redd Zebra

17 Eildon Rd, St Kilda VIC  
18 January 2022

COST SUMMARY

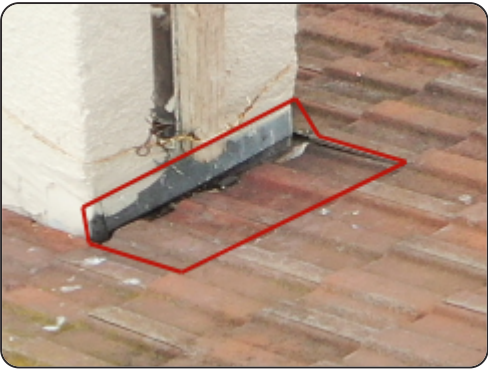
Issue #28

HIGH RISK Awaiting Action

| Defect | Missing Missing |
| Component | Flashing |
| Priority | 9 |
| Notes | Flashing appears to be missing. |

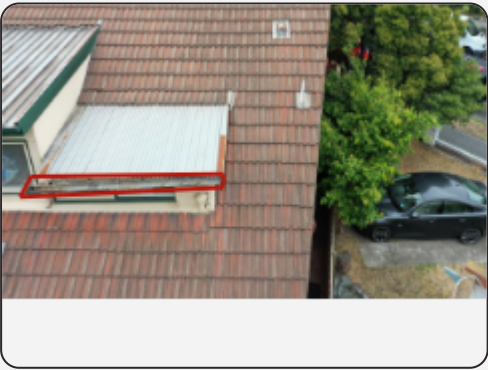
Issue #32

HIGH RISK Awaiting Action

| Defect | Damaged Warped |
| Component | Gutter - Box |
| Priority | 8 |

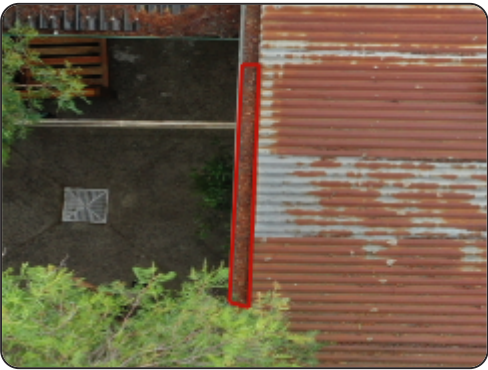
Issue #33

Medium Risk Awaiting Action

| Defect | Debris Leaves |
| Component | Gutter - Fascia |
| Priority | 6 |

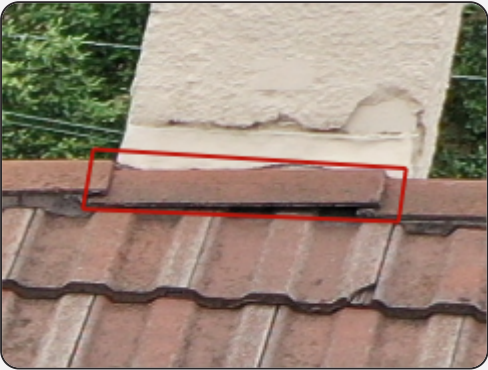
Issue #25

Medium Risk Awaiting Action

| Defect | Damaged Warped |
| Component | Tile - Terracotta/Clay |
| Priority | 6 |

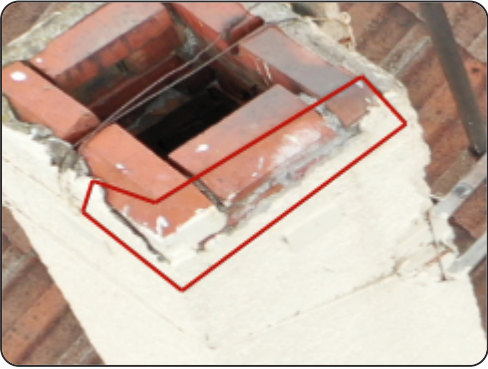
Issue #22

Medium Risk Awaiting Action

| Defect | Damaged Cracked |
| Component | Roof |
| Priority | 6 |

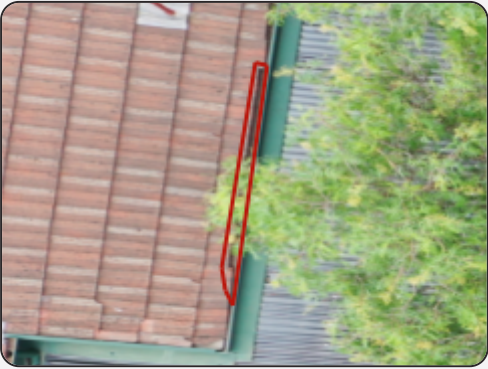
Issue #9

Medium Risk Awaiting Action

| Defect | Damaged Warped |
| Component | Tile - Terracotta/Clay |
| Priority | 6 |

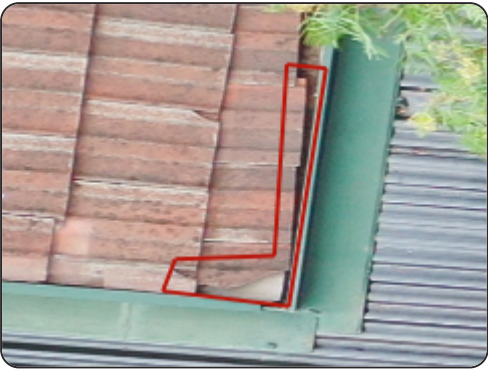
Issue #8

MEDIUM RISK   Awaiting Action

| Defect | Damaged Cracked |
| Component | Tile - Terracotta/Clay |
| Priority | 6 |

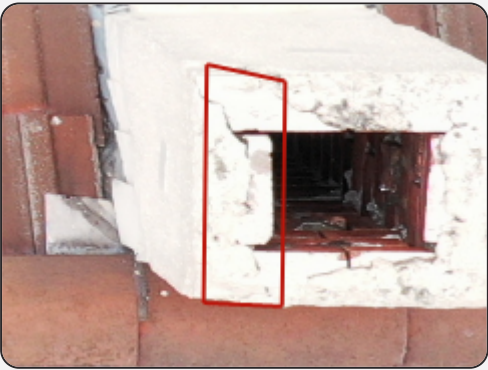
Issue #26

MEDIUM RISK   Awaiting Action

| Defect | Damaged Cracked |
| Component | Roof |
| Priority | 5 |

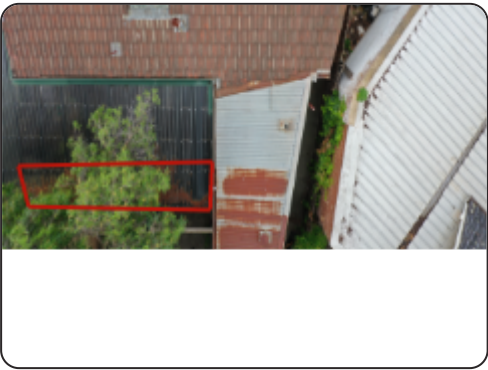
Issue #15

MEDIUM RISK   Awaiting Action

| Defect | Debris Leaves |
| Component | Sheeting - Steel |
| Priority | 5 |

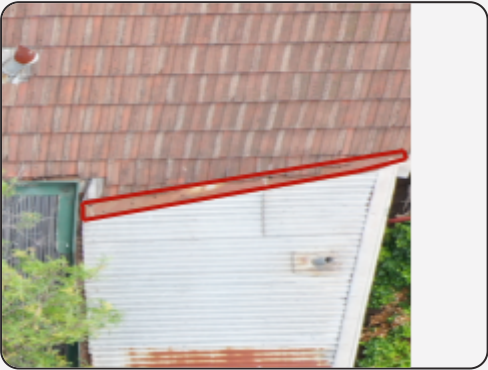
Issue #11

MEDIUM RISK   Awaiting Action

| Defect | Corrosion Surface |
| Component | Gutter - Box |
| Priority | 5 |

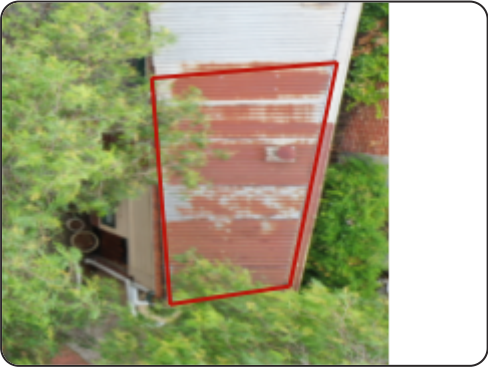
Issue #10

MEDIUM RISK   Awaiting Action

| Defect | Corrosion Surface |
| Component | Sheeting - Steel |
| Priority | 5 |

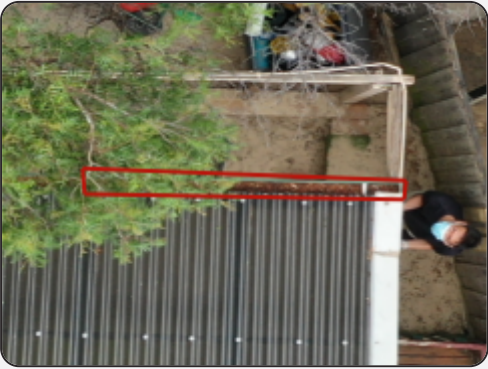
Issue #7

MEDIUM RISK   Awaiting Action

| Defect | Debris Leaves |
| Component | Gutter - Fascia |
| Priority | 5 |

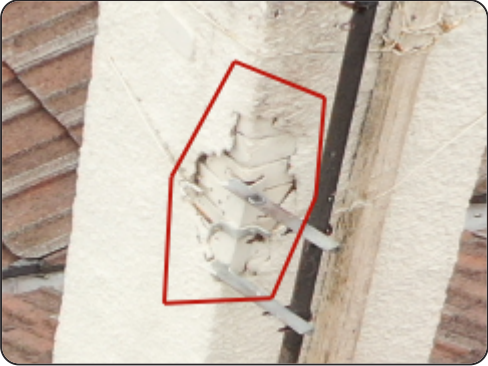
Issue #23

LOW RISK   Awaiting Action

| Defect | Damaged Cracked |
| Component | Roof |
| Priority | 6 |

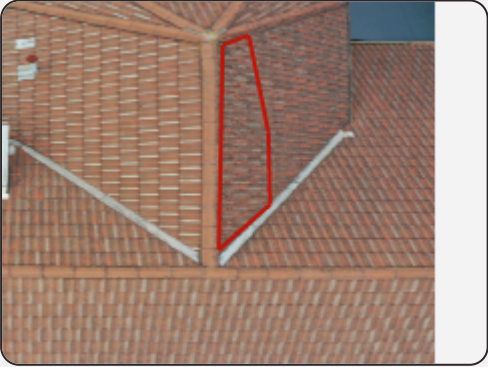
Issue #13

LOW RISK   Awaiting Action

| Defect | Deterioration Minor |
| Component | Tile - Terracotta/Clay |
| Priority | 5 |

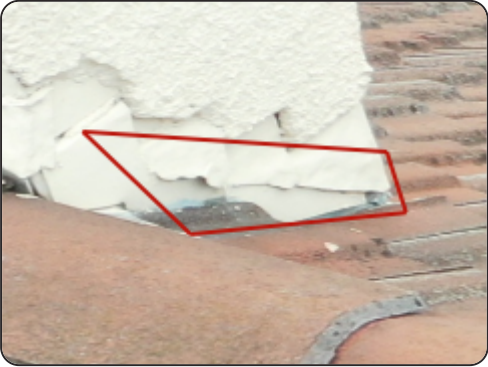
Issue #21

LOW RISK   Awaiting Action

| Defect | Damaged Chipped |
| Component | Roof |
| Priority | 4 |

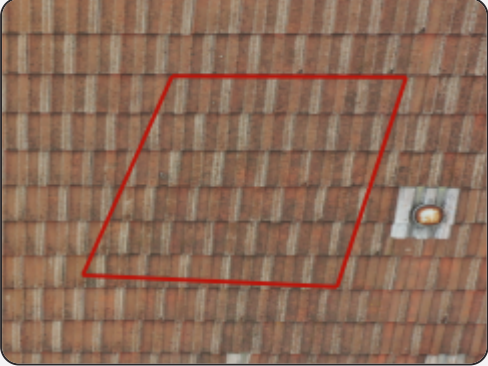
Issue #17

LOW RISK   Awaiting Action

| Defect | Deterioration Minor |
| Component | Tile - Terracotta/Clay |
| Priority | 4 |

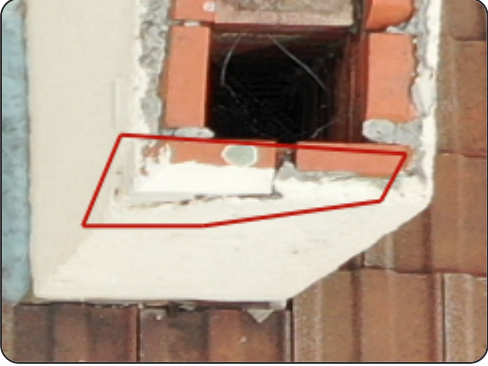
Issue #31

LOW RISK   Awaiting Action

| Defect | Damaged Cracked |
| Component | Roof |
| Priority | 3 |

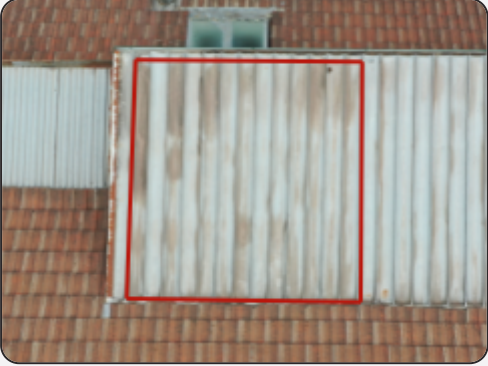
Issue #14

LOW RISK   Awaiting Action

| Defect | Discolored Staining |
| Component | Sheeting - Steel |
| Priority | 3 |

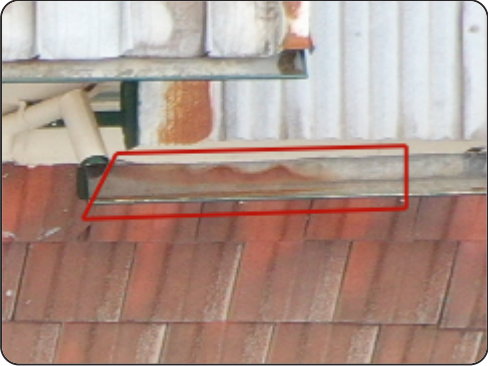
Issue #12

LOW RISK   Awaiting Action

| Defect | Corrosion Stain |
| Component | Gutter - Fascia |
| Priority | 3 |

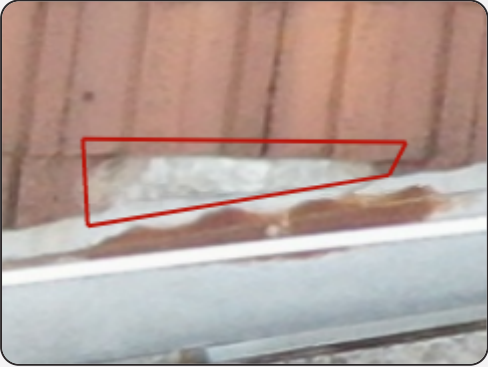
Issue #5

LOW RISK   Awaiting Action

| Defect | Discolored Staining |
| Component | Tile - Terracotta/Clay |
| Priority | 3 |

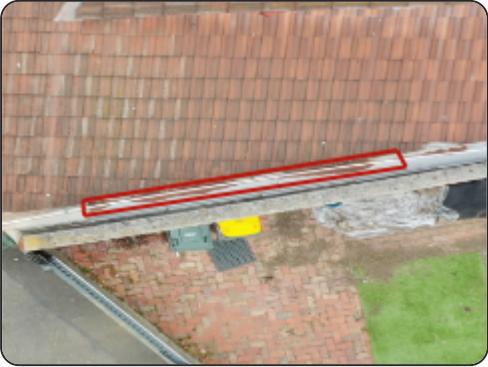
Issue #4

LOW RISK   Awaiting Action

| Defect | Corrosion Surface |
| Component | Gutter - Box |
| Priority | 3 |

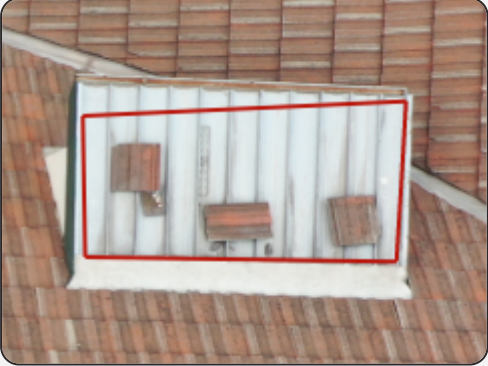
Issue #2

LOW RISK   Awaiting Action

| Defect | Debris Medium |
| Component | Sheeting - Steel |
| Priority | 3 |

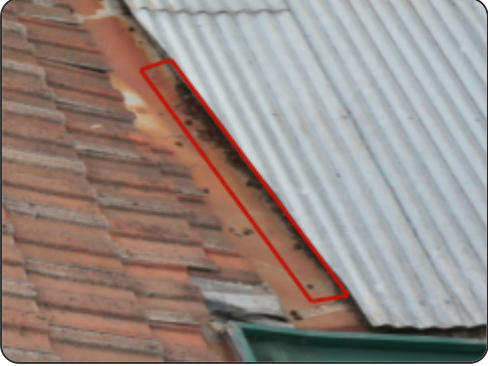
Issue #30

LOW RISK   Awaiting Action

| Defect | Debris Small |
| Component | Gutter - Box |
| Priority | 2 |

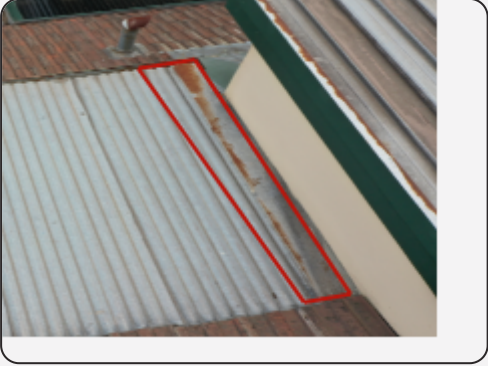
Issue #29

LOW RISK   Awaiting Action

| Defect | Corrosion Stain |
| Component | Sheeting - Steel |
| Priority | 2 |

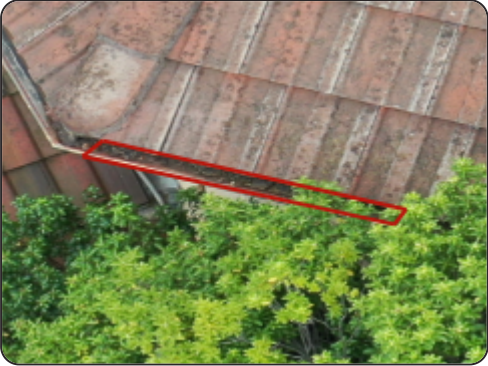
Issue #27

LOW RISK   Awaiting Action

| Defect | Debris Leaves |
| Component | Gutter - Fascia |
| Priority | 2 |

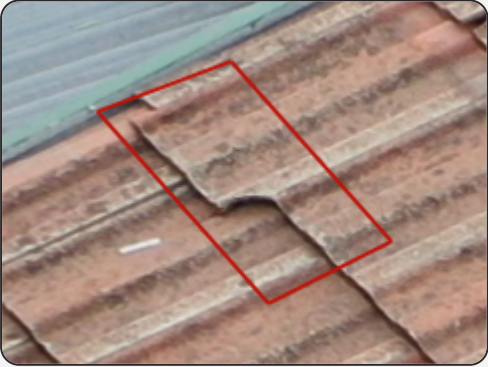
Issue #20

LOW RISK   Awaiting Action

| Defect | Damaged Warped |
| Component | Tile - Terracotta/Clay |
| Priority | 2 |

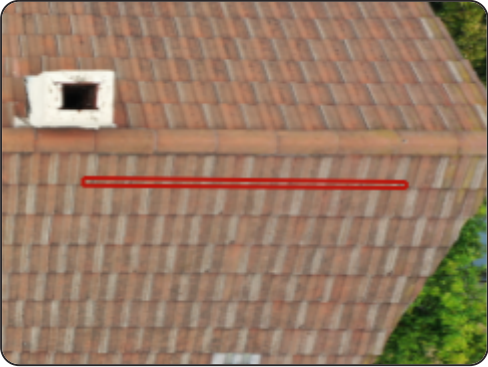
Issue #18

LOW RISK   Awaiting Action

| Defect | Damaged Chipped |
| Component | Tile - Terracotta/Clay |
| Priority | 2 |

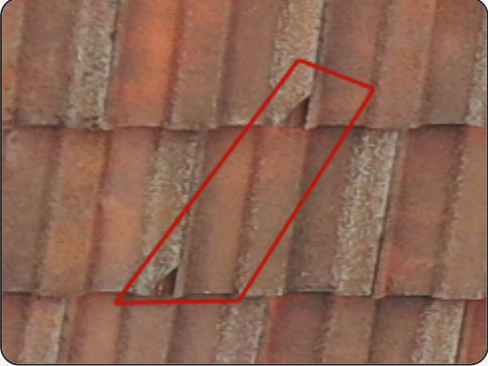
Issue #16

LOW RISK   Awaiting Action

| Defect | Damaged Chipped |
| Component | Tile - Terracotta/Clay |
| Priority | 2 |

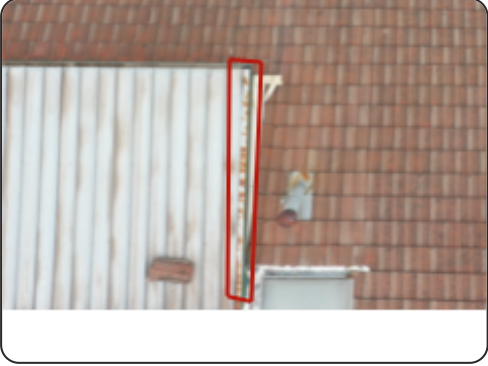
Issue #6

LOW RISK   Awaiting Action

| Defect | Corrosion Stain |
| Component | Sheeting - Steel |
| Priority | 2 |

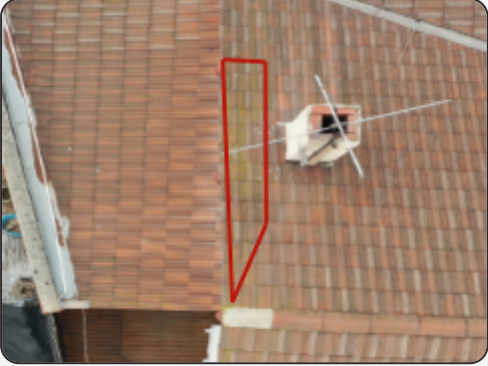
Issue #3

LOW RISK   Awaiting Action

| Defect | Discolored Staining |
| Component | Tile - Terracotta/Clay |
| Priority | 2 |

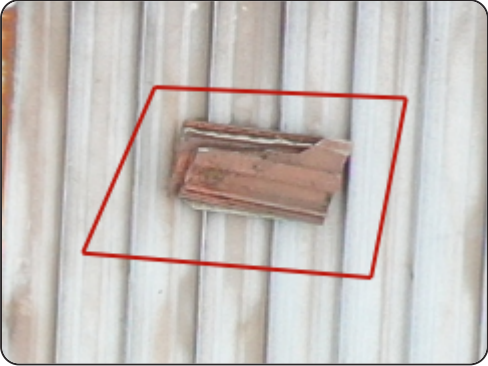
Issue #1

LOW RISK

| Defect | Debris Small |
| Component | Sheeting - Steel |
| Priority | 2 |

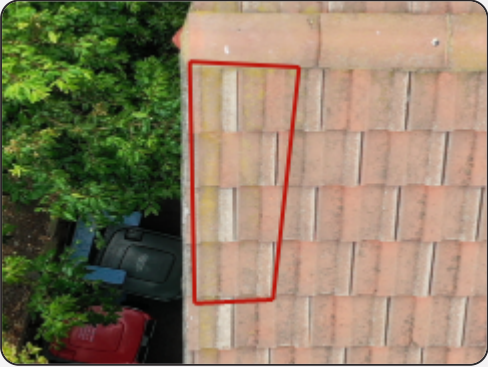
Issue #19

LOW RISK

| Defect | Discolored Staining |
| Component | Tile - Terracotta/Clay |
| Priority | 1 |
