CITY OF PORT PHILLIP – 17 EILDON ST – PROPERTY RISK ASSESSMENT

31 JANUARY 2022 | 06613-VIC-PRA

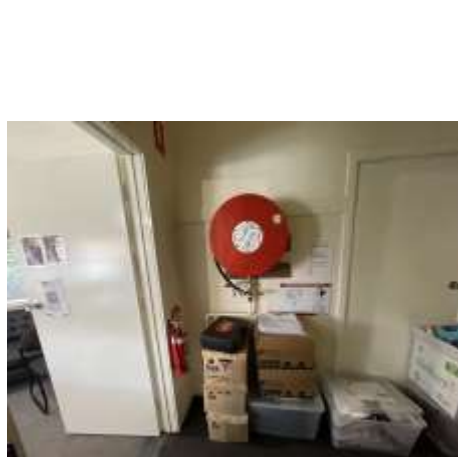
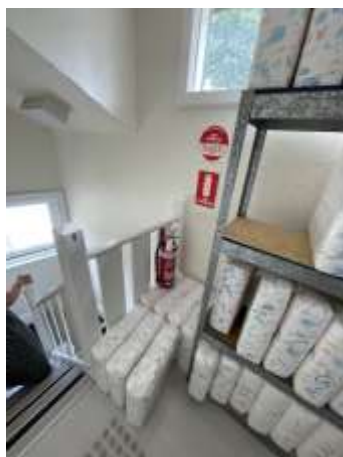
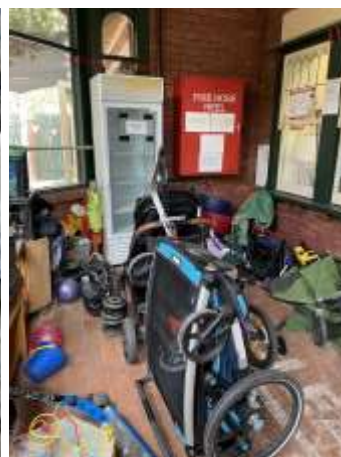
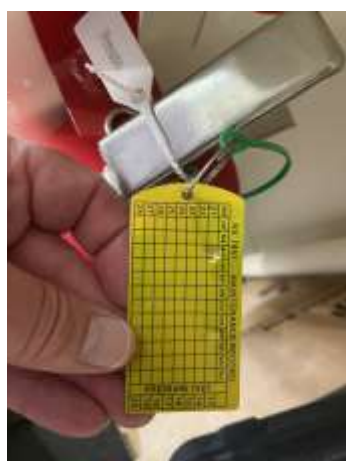
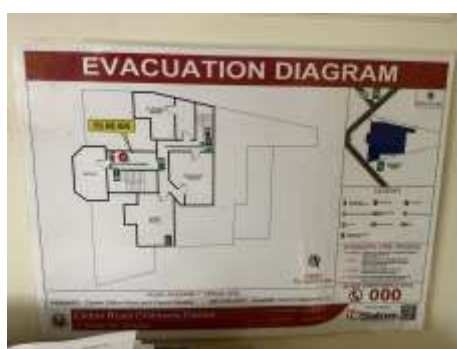
The centre does not have sufficient storage and as a result fire safety installations have been obstructed by a range of items. In the event that this fire fighting equipment were needed to fight a fire there would be a delay as the obstructions were removed. Obstructions should be removed and a policy should be introduced that provides for clear access to fire safety installations and a clear area of 2m around the fire safety installations.

Number	Matter	Recommendation
1	Fire Safety	Obstructions should be removed and a policy should be introduced that provides for clear access to fire safety installations and a clear area of 2m around the fire safety installations.
2	Fall Prevention (Slips, Trips and Falls)	Consider controlling access to the roof cavity – for example, by the use of a permit system and the entrance locked with a key controlled by management.
3	Fall Prevention (Slips, Trips and Falls)	Investigations should be carried out to determine if remediation can be done to remove the trip hazards. For example, the paved surface could be relayed. Reasonable recommendations should be actioned.
4	Fall Prevention (Slips, Trips and Falls)	Storage of mattresses in the upstairs area presents a further trip hazard and an alternative location for storage should be considered.
5	Electrical	The locking mechanism should be repaired/replaced.

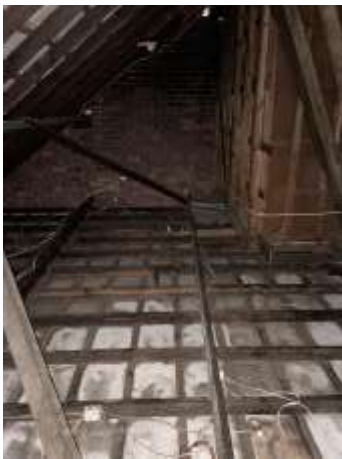
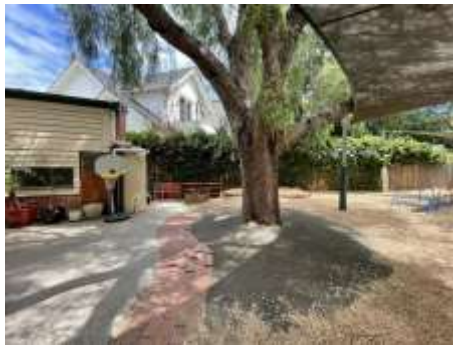
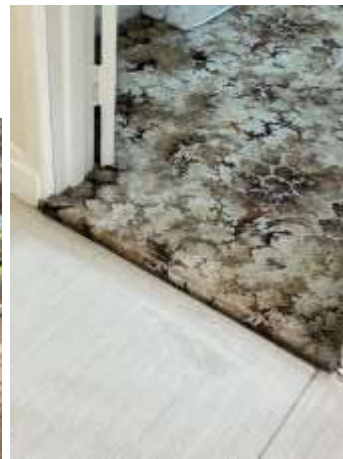
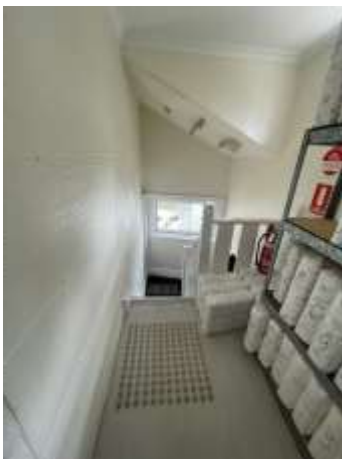
The centre has a roof cavity that is accessible. While not unusual for a roof cavity the ceiling below is able to be stood on and there is a risk of falling through the ceiling, in part or whole). Access to the roof cavity by tradespeople is necessary from time to time but access should be controlled through a permit system and the entrance locked with a key controlled by management.

There is an uneven paved surface in the playground that presents a trip hazard. Within the centre there is a change in floor surface level that presents a trip hazard. There is loose decking on the rear deck. Investigations should be carried out to determine if remediation can be done to remove the trip hazards. For example, the paved surface could be relaid. Reasonable recommendations should be actioned.

Storage of mattresses in the upstairs area presents a further trip hazard and an alternative location for storage should be considered.

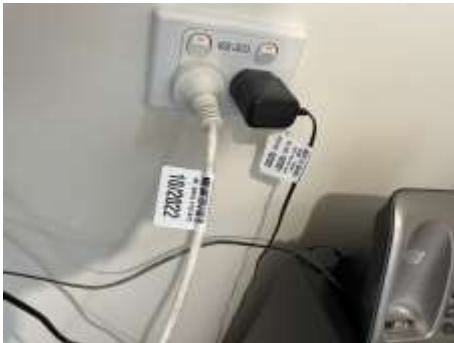
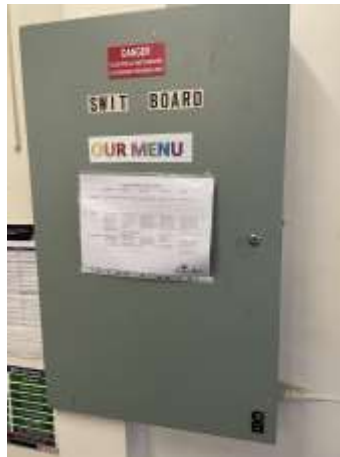
Electrical cables were tagged and tested in accordance with Australian Standards. The electrical switchboard is not capable of being locked. Although externally there appears to be a lock there is no rotating latch in the lock mechanism. The locking mechanism should be repaired/replaced.
