CITY OF PORT PHILLIP – 39 THE AVENUE – PROPERTY RISK ASSESSMENT

8 FEBRUARY 2022 | 06614-VIC-PRA

City of Port Phillip – 39 The Avenue – Property Risk Assessment

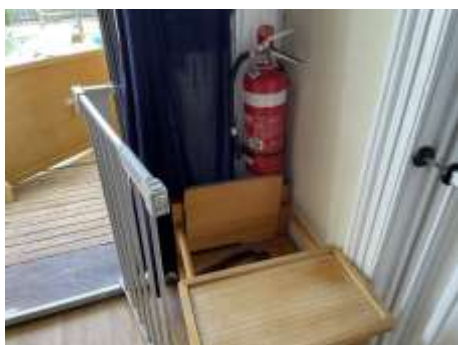
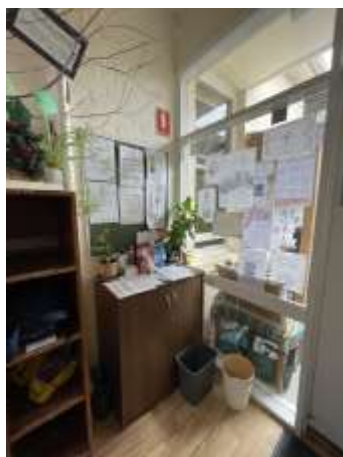
The centre does not have sufficient storage and as a result fire safety installations have been obstructed by a range of items. In the event that this fire fighting equipment were needed to fight a fire there would be a delay as the obstructions were removed. Obstructions should be removed and a policy should be introduced that provides for clear access to fire safety installations and a clear area of 2m around the fire safety installations.

Number	Matter	Recommendation
1	Fire Safety	Obstructions should be removed and a policy should be introduced that provides for clear access to fire safety installations and a clear area of 2m around the fire safety installations.
2	Emergency Management	Evacuation diagram should be securely affixed to the wall in the correct location.
3	Fall Prevention (Slips, Trips and Falls)	Investigations should be carried out to determine if remediation can be done to remove the trip hazards. Reasonable recommendations should be actioned.
4	Electrical	The electrical switchboard was unlocked and held closed with masking tape. Consider installing a locking mechanism.

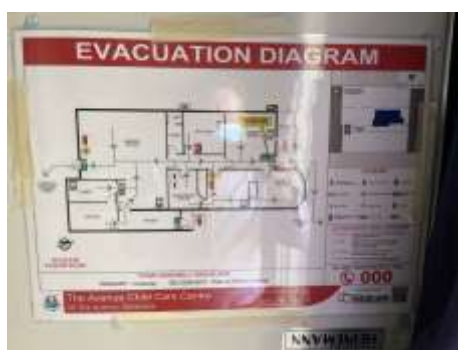
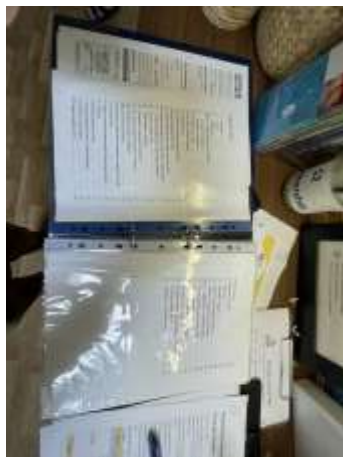
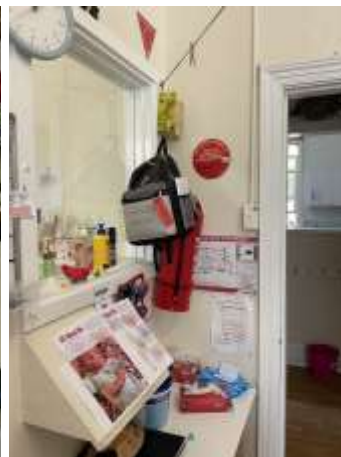
Evacuation Diagrams not securely affixed to wall (Blue-tac). In the kinder room there are signs installed in incorrect location where one diagram is installed with the wrong orientation and an additional copy of that diagram on the opposite end of the room. In the toddler room the diagram is installed very low. Evacuation diagram should be securely affixed to the wall in the correct location.

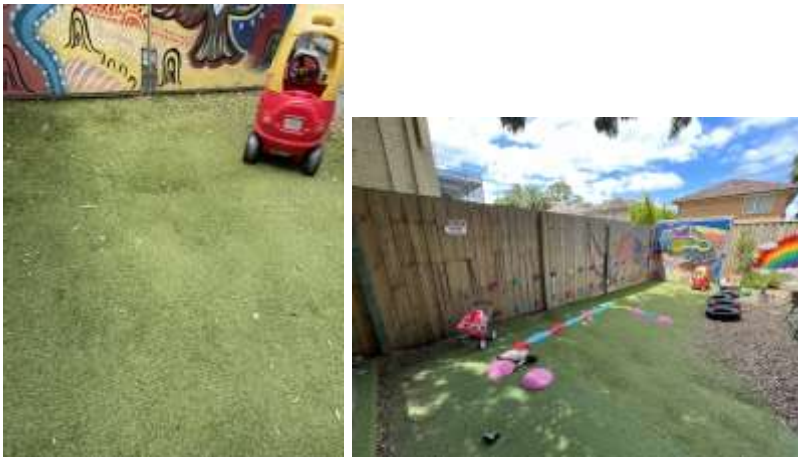
There is an uneven surface in the background playground areas that presents as trip hazards. Investigations should be carried out to determine if remediation can be done to remove the trip hazards. Reasonable recommendations should be actioned.

Investigations should be undertaken to flatten uneven surfaces. Reasonable steps to rectify uneven surfaces should be undertaken.

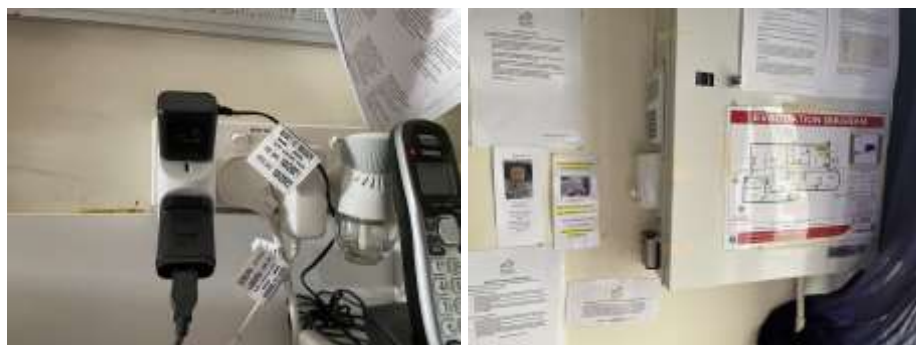
Electrical cables were tagged and tested in accordance with Australian Standards. The electrical switchboard was unlocked and held closed with masking tape. Consider installing a locking mechanism. The BCA report also noted the need for a seal within the switchboard.

The electrical switchboard is not capable of being locked. Consideration should be given to installing a locking mechanism.
