***Inspection of Building***

***17 Eildon Road***

***St Kilda***

***6<sup>th</sup> December 2021***

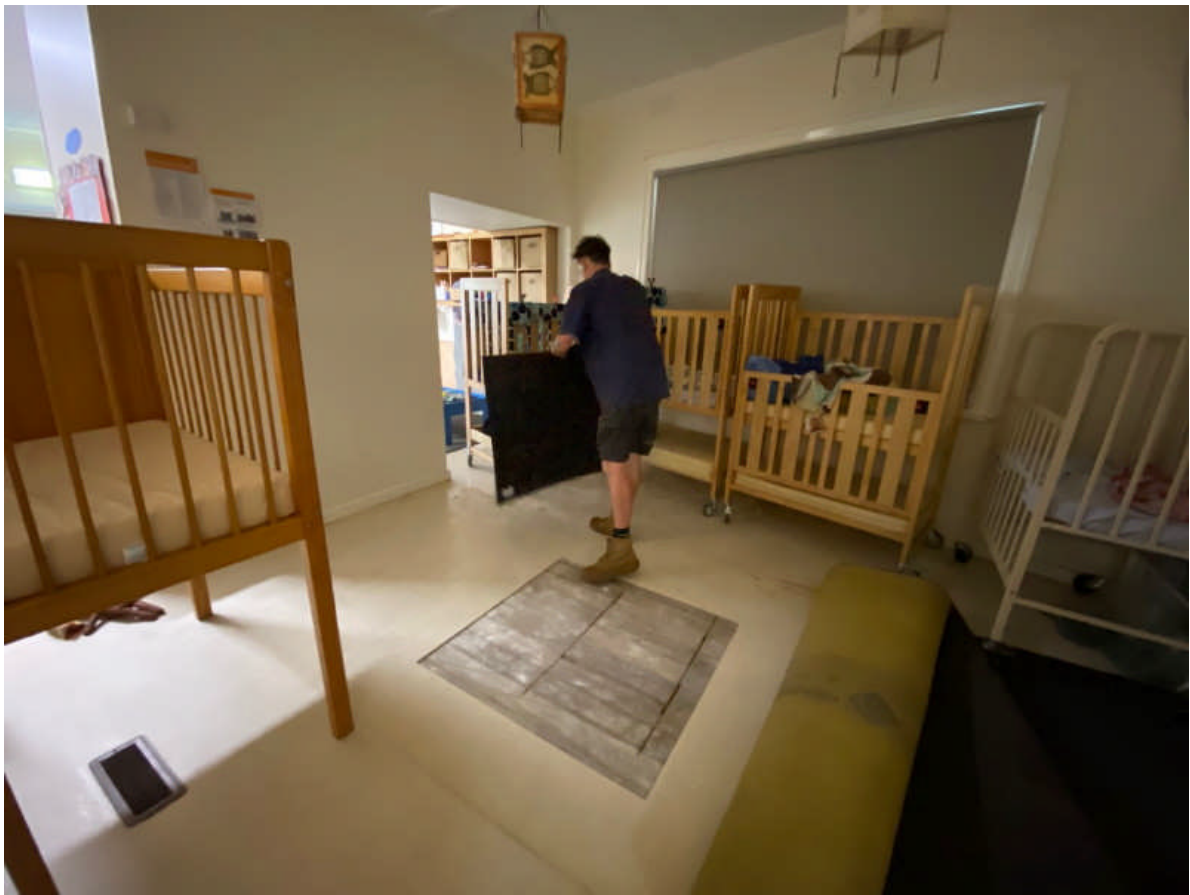
### **Photograph 1**

3.1 The sub-floor structure of the Baby's Room that was able to be inspected from the trap cut in the western room flooring revealed that the hardwood (HW) joists appeared to be in good condition and that the HW bearers had been partially (?) restumped with concrete stumps. At the edge of the trap a section of timber has split off the side of the bearer for no apparent reason. The original HW stumps that were visible had water staining just above ground level which is generally an indication of dry rot below the ground level. Refer to Photographs 1 to 3 Appendix C.

A part view of one room of the Baby's Room.

4.1 Although the Ground Floor sub-floor structure that was able to be inspected appears to be fit-for-purpose for the current loadings, we would recommend that the floor levels are monitored for long term settlement of the timber stumps, given the probable dry rot in the bases of the timber stumps. We would also recommend that if the loadings were to be increased then the load capacity of the sub-floor structures are investigated.

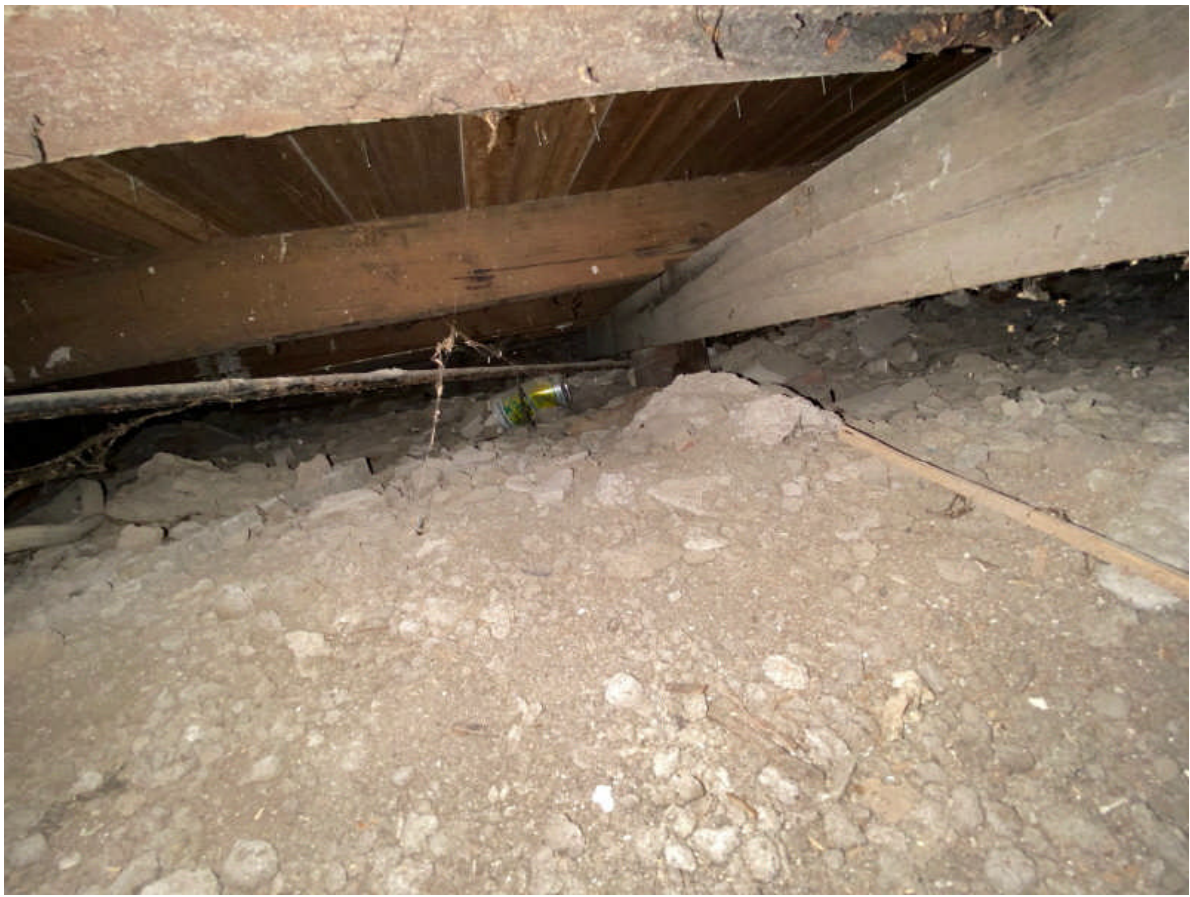
### **Photograph 2**

A view of the Baby's Room sub-floor structure showing a HW bearer and joists.

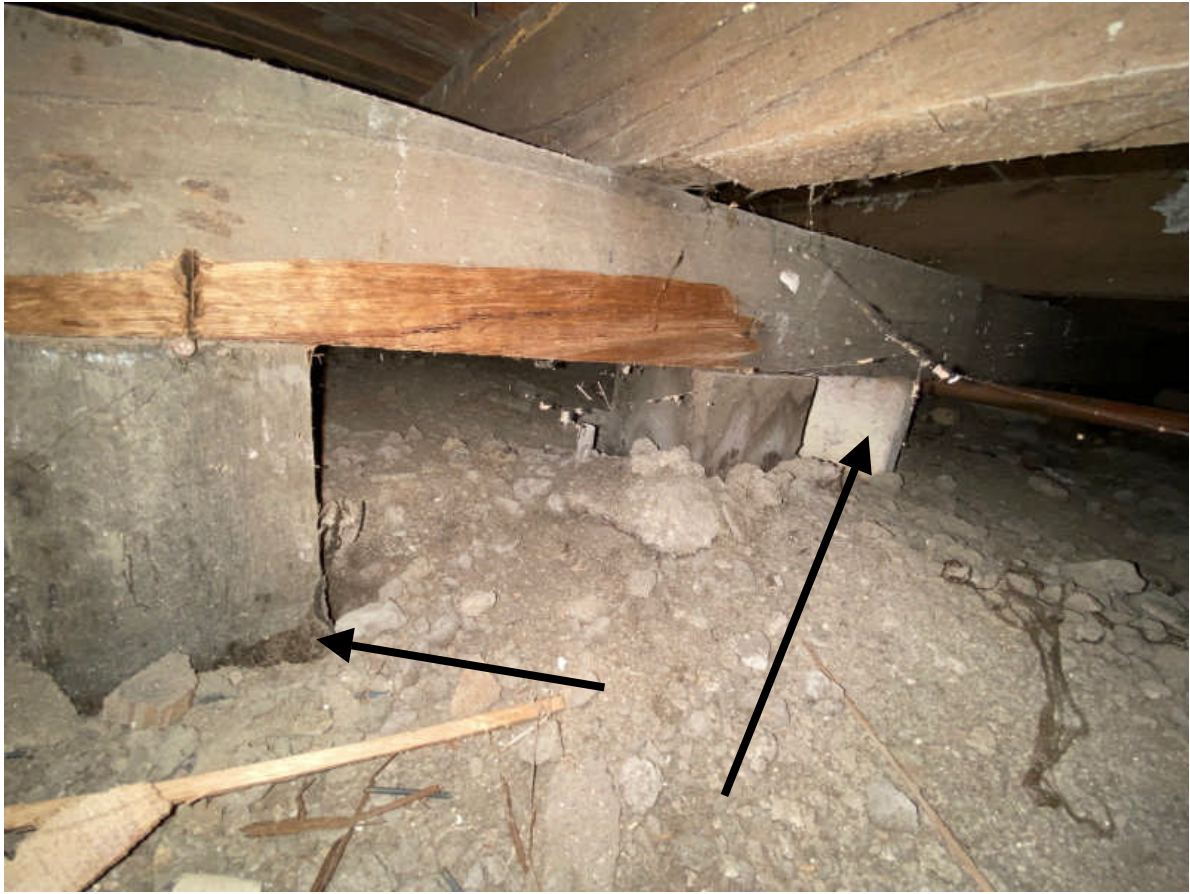
### **Photograph 3**

A view of the Baby's Room sub-floor structure showing the 'new' concrete stump, the water staining at the base of a timber stump and where the timber has split off the HW bearer.

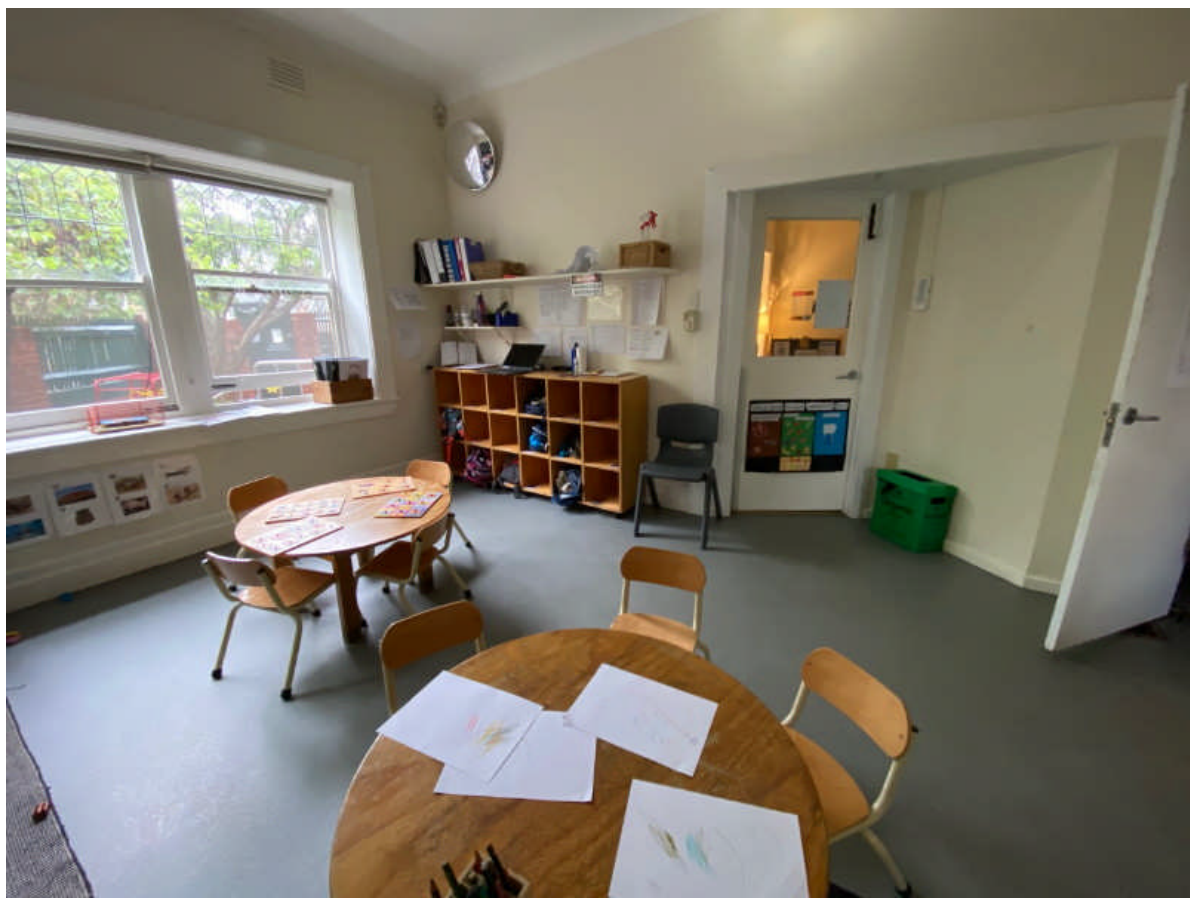
### **Photograph 4**

3.2 The sub-floor structure of the Toddler's Room that was able to be inspected from the two traps cut in the flooring revealed that the sub-floor construction was similar to that of the Baby's Room with the exception that the bearers have been restumped with 'new' HW timber stumps and both the original and new stumps have water staining just above the ground level. Refer to Photographs 4 to 7 Appendix C.

A part view of one room of the Toddler's Room.

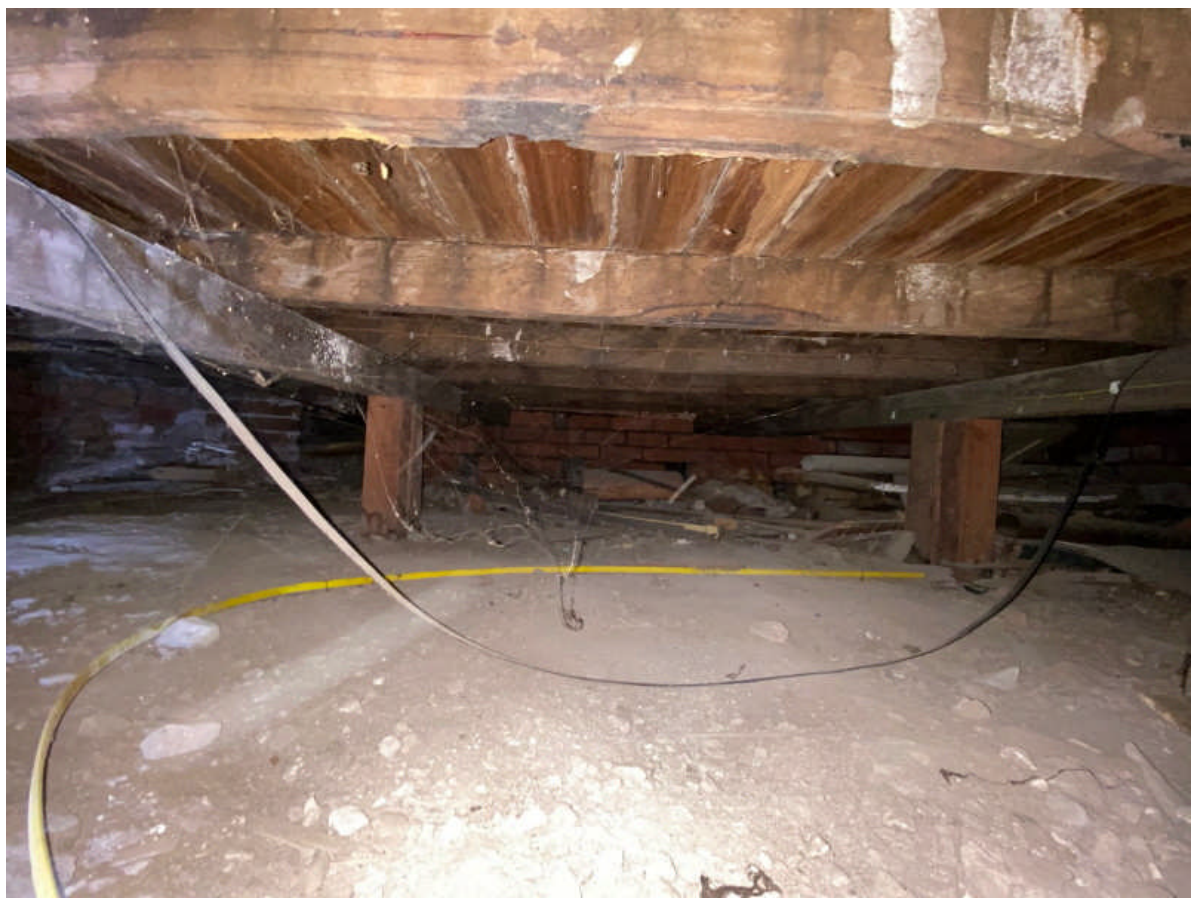
### **Photograph 5**

A view of the Toddler's Room sub-floor structure showing the HW bearers, joists and stumps.

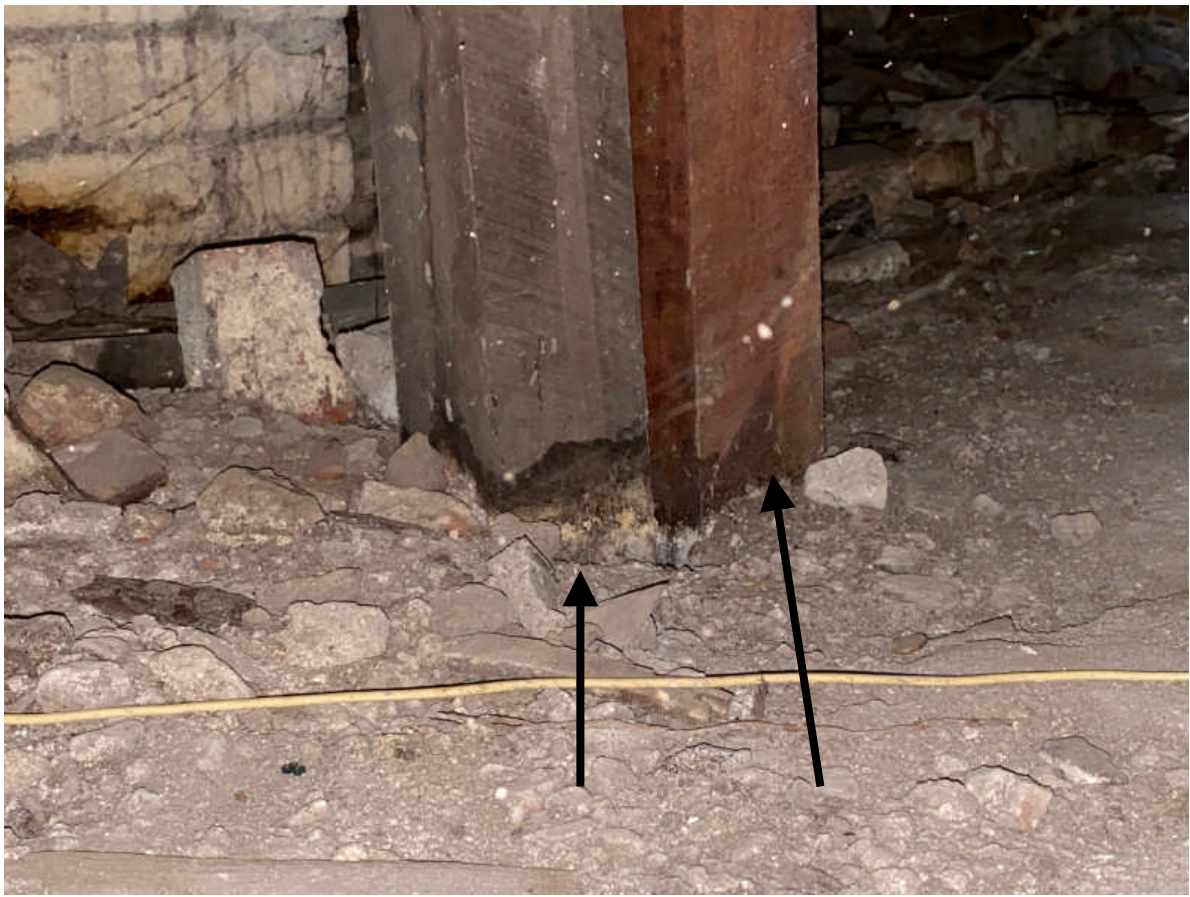
### **Photograph 6**

A view of a Toddler's Room HW stump showing the water staining at the base of the 'original' and 'new' stumps.

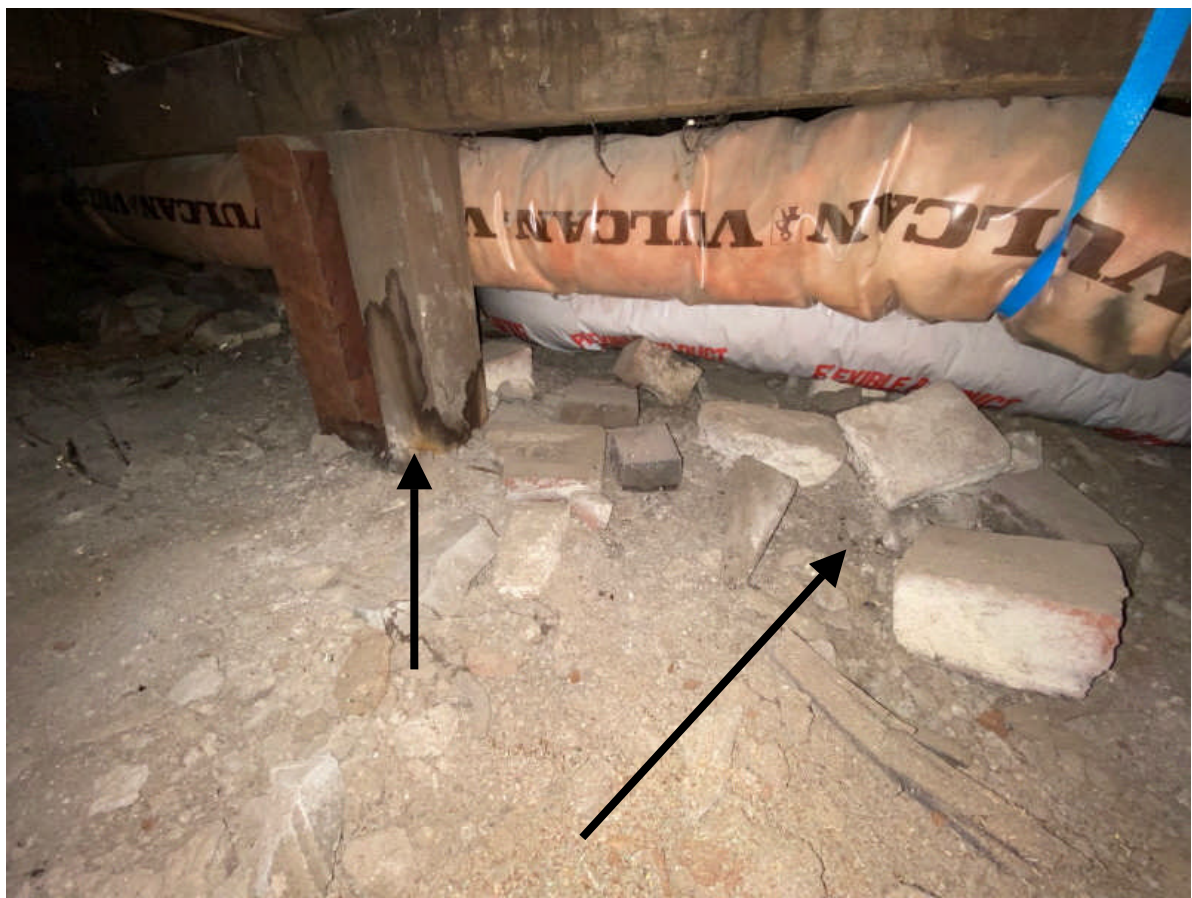
### Photograph 7

A view of a Toddler's Room HW stump showing the water staining at the base of an 'original' stump and the building debris.

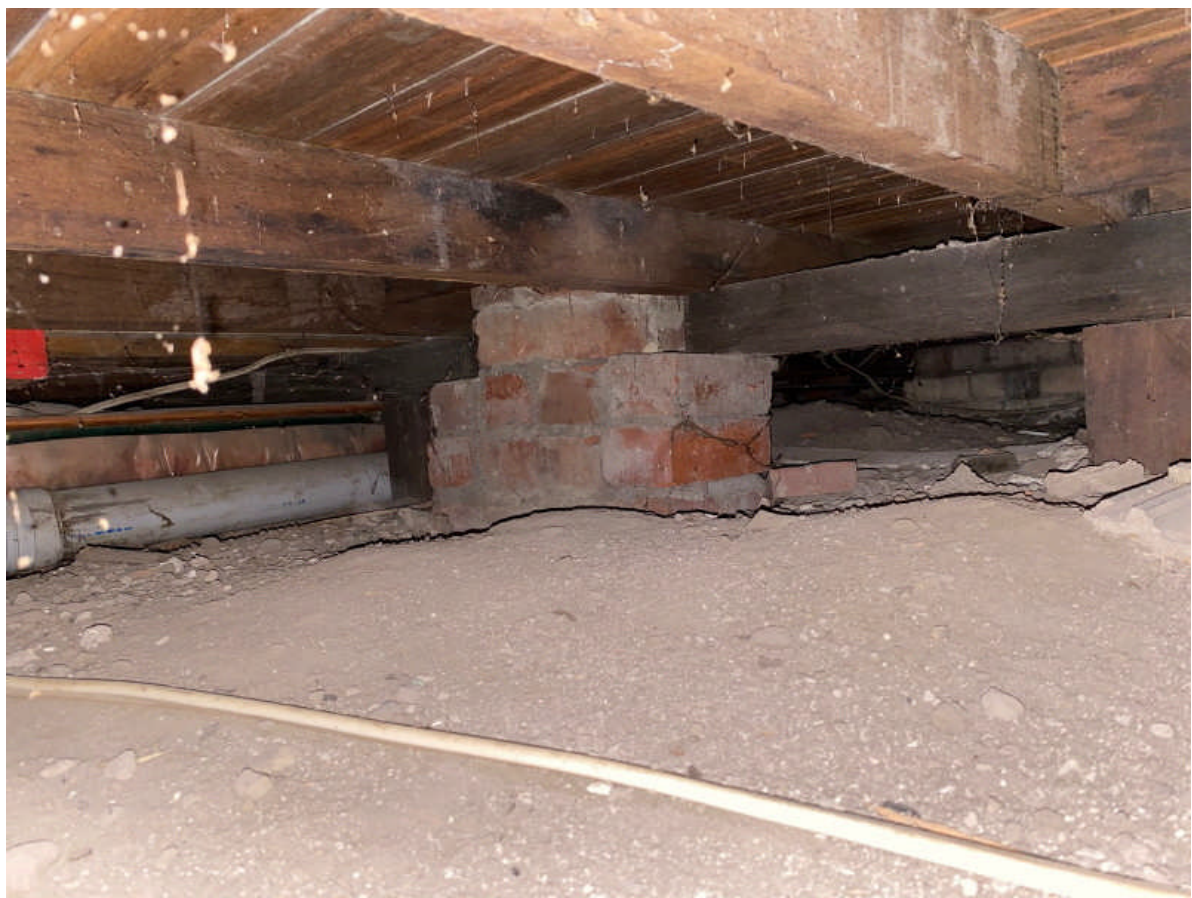
### **Photograph 8**

3.3 The sub-floor structure of the Kinder Room that was able to be inspected from the trap cut in the flooring revealed that the sub-floor construction was similar to that of the Baby's and Toddler's Rooms, with the exception that the bearers do not appear to have been restumped. Similarly the HW stumps have water staining just above the ground level. There was extensive mould on the base brickwork which is generally an indication of poor sub-floor ventilation, and there was building debris strewn and piled up within the sub-floor space. Refer to Photographs 8 to 11 Appendix C.

A view of the HW bearers and joists, a brickwork pier and HW stump, at the southern end of the Kinder Room.

4.8 We would recommend that the sub-floor ventilation is improved.

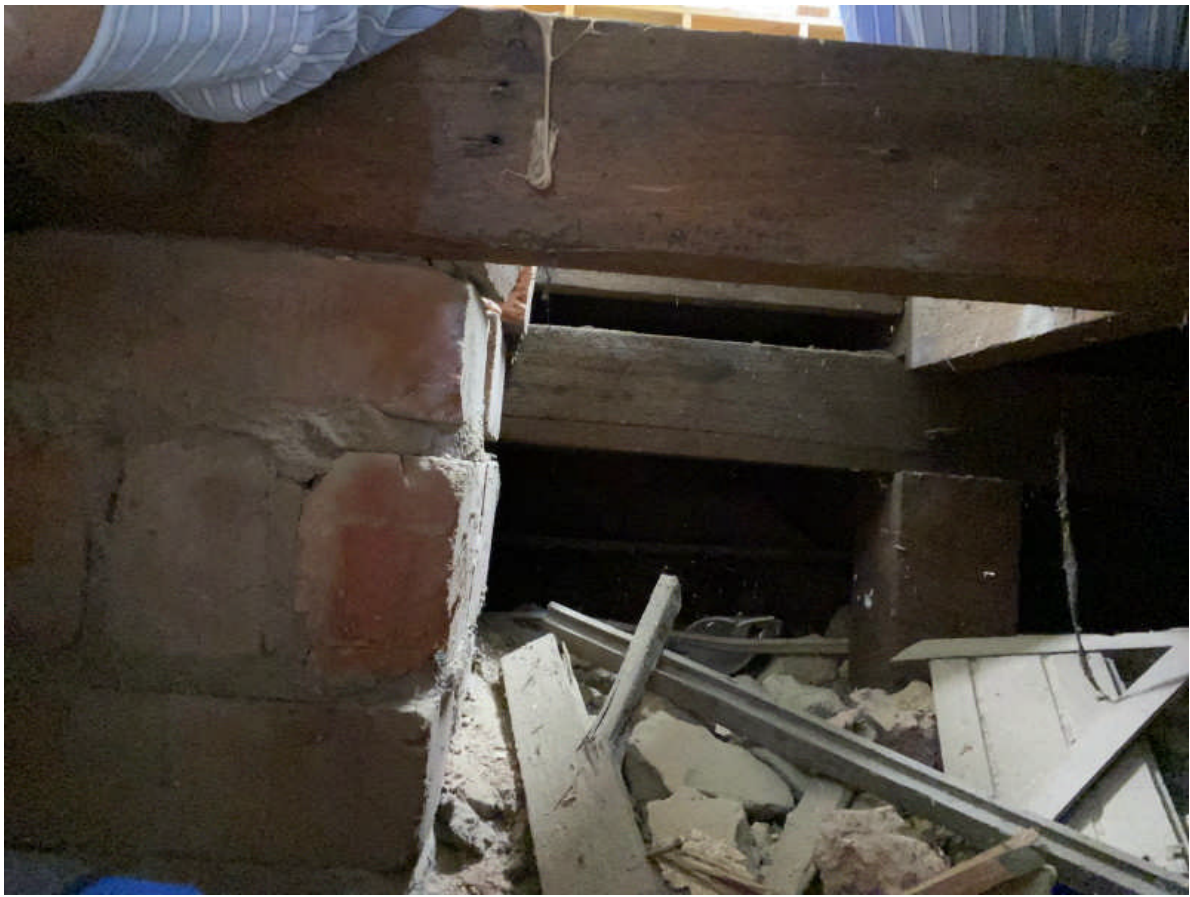
### **Photograph 9**

A view of the debris at the southern end of the Kinder Room.

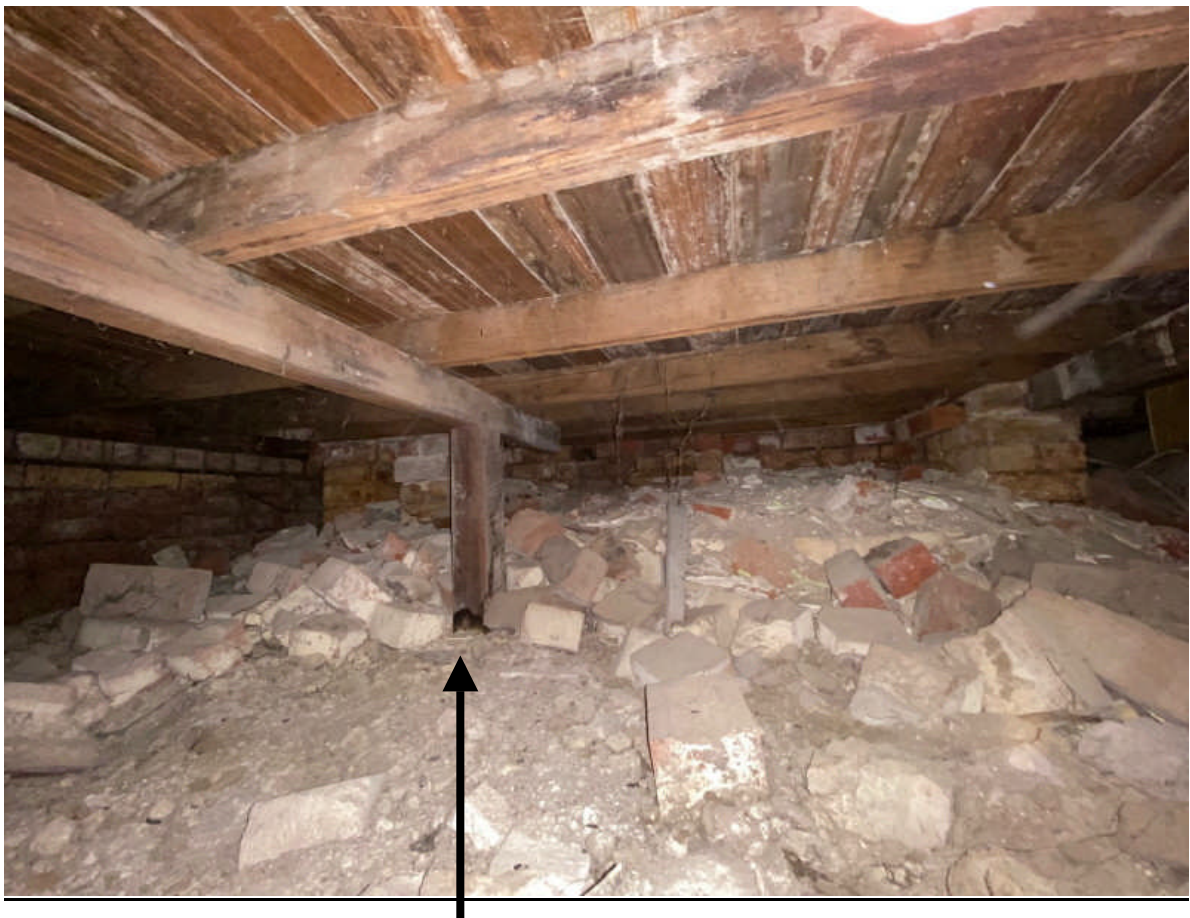
### **Photograph 10**

A view of the debris at the northern end of the Kinder Room. Note the water staining at the base of the HW stump.

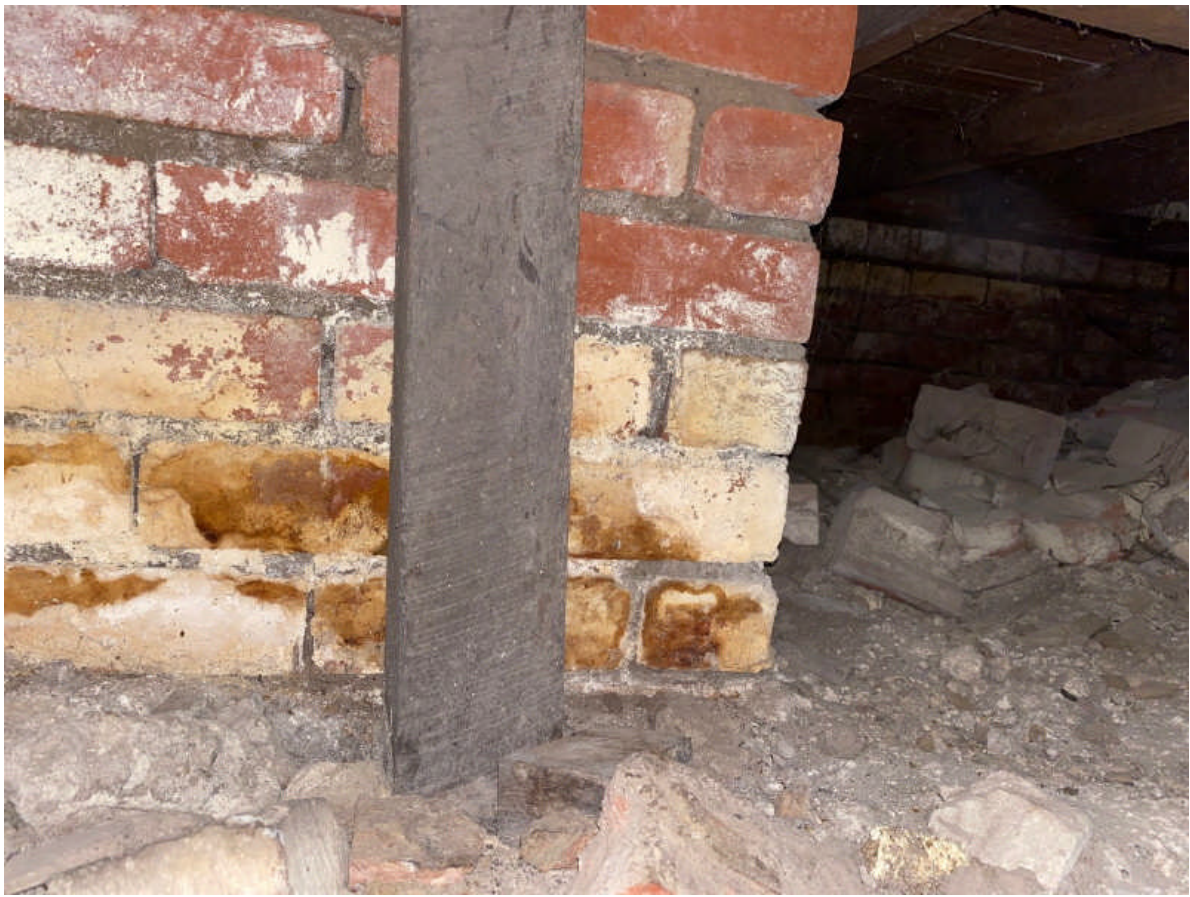
### **Photograph 11**

A view of the base brickwork mould and ad hoc HW stump.

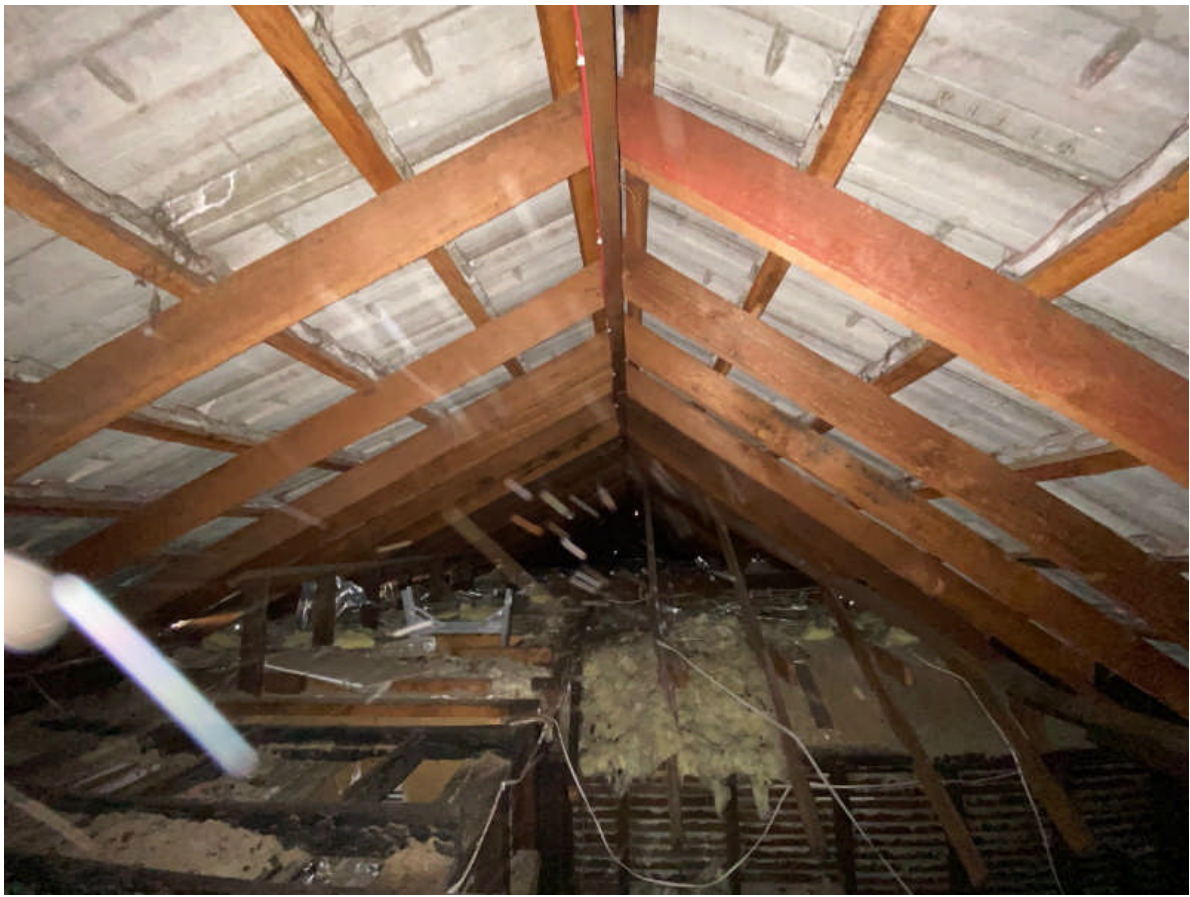
### **Photograph 12**

- The roof and ceiling framing is well constructed. Refer to Photographs 12 and 13 Appendix C.
- The timber roof framing above the eastern side of the building and the ceiling framing above a section of the western side are charred from fire, albeit they appeared to be in serviceable condition. Refer to Photographs 14 and 15 Appendix C.
- The ceiling insulation is generally very poorly laid, there is extensive possum faeces above the insulation, and there is rubbish above the ceiling of the Baby's Room. Refer to Photographs 16 to 18 Appendix C.

A view of the roof structure above the southern end of the building.

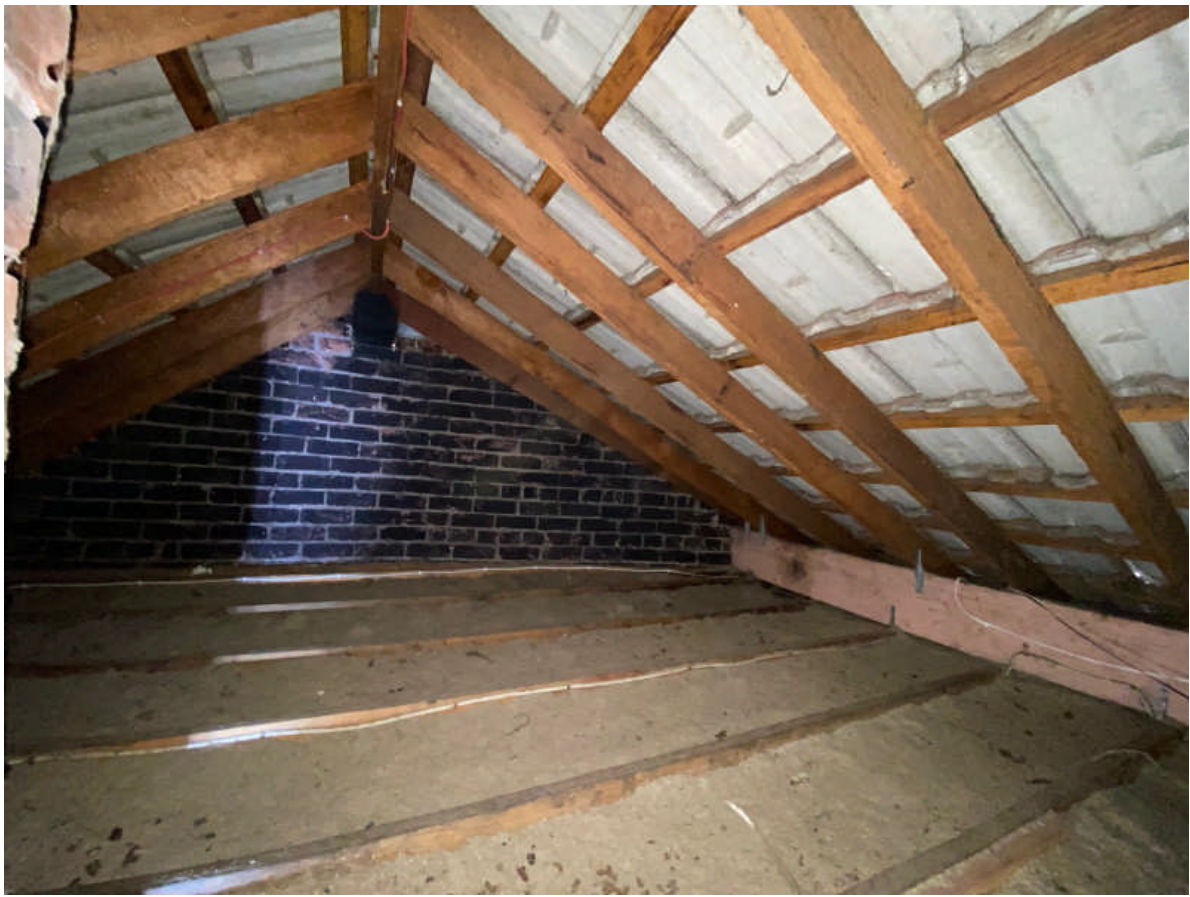
### **Photograph 13**

A view of the roof structure above the northern end of the building.

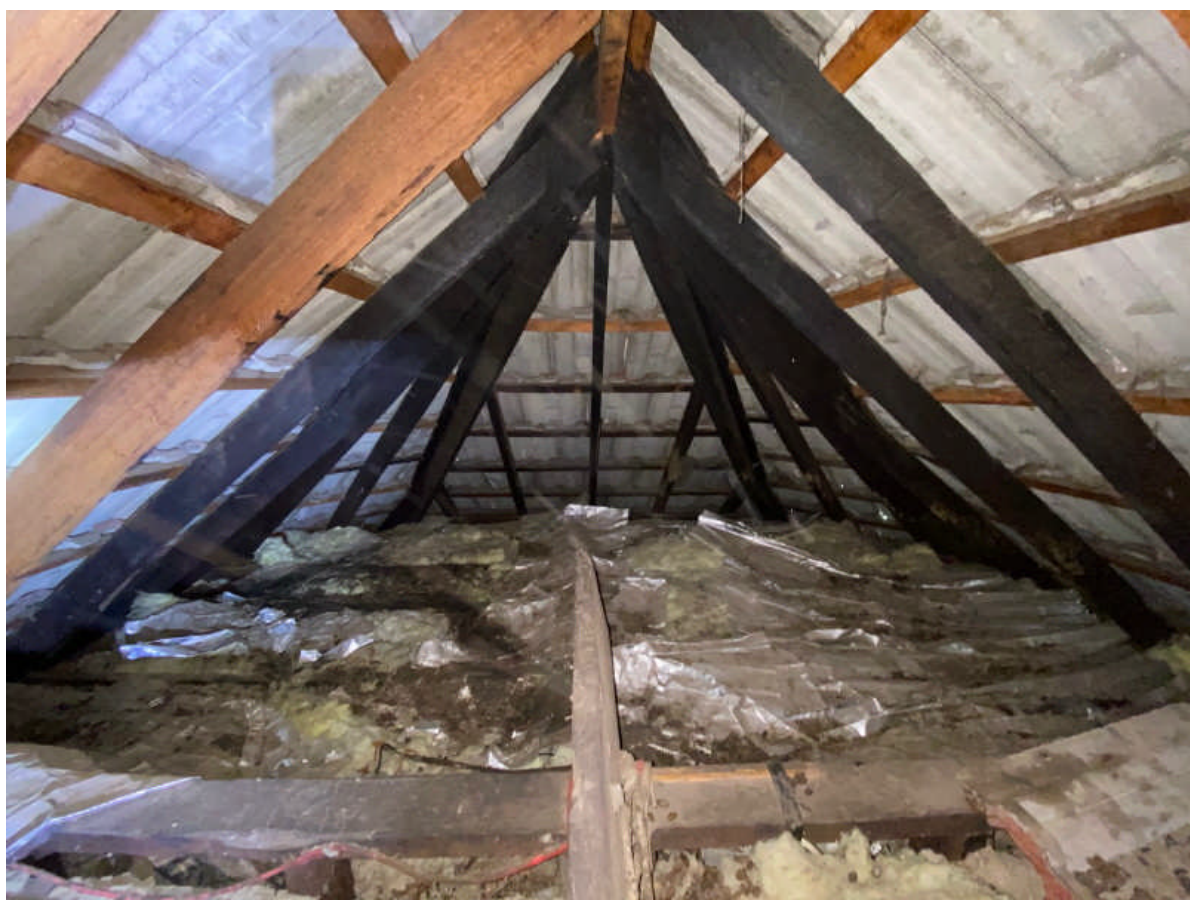
### **Photograph 14**

A view of the roof structure above the eastern side of the building showing the 'black' fire charred roofing timbers.

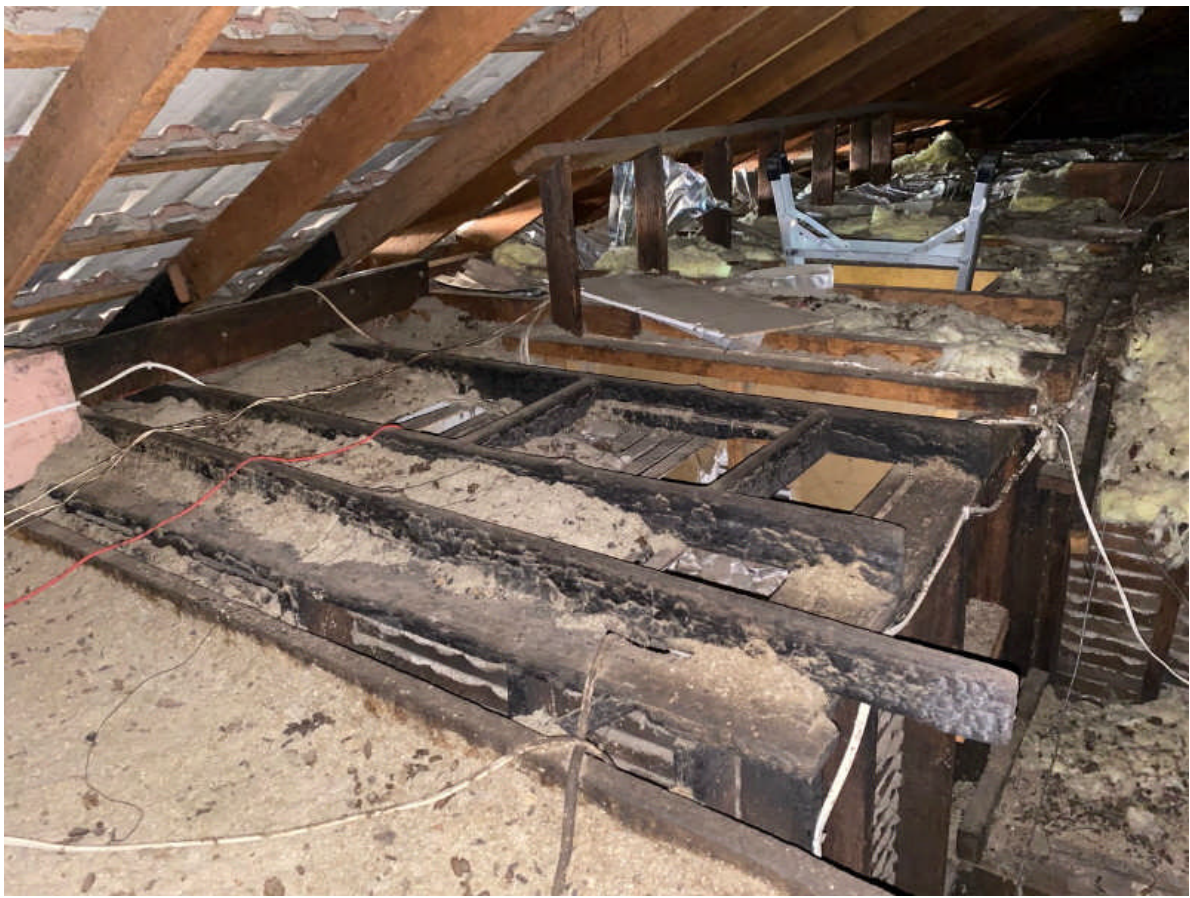
### **Photograph 15**

A view of the ceiling structure above the western side of the building showing the 'black' fire charred ceiling timbers.

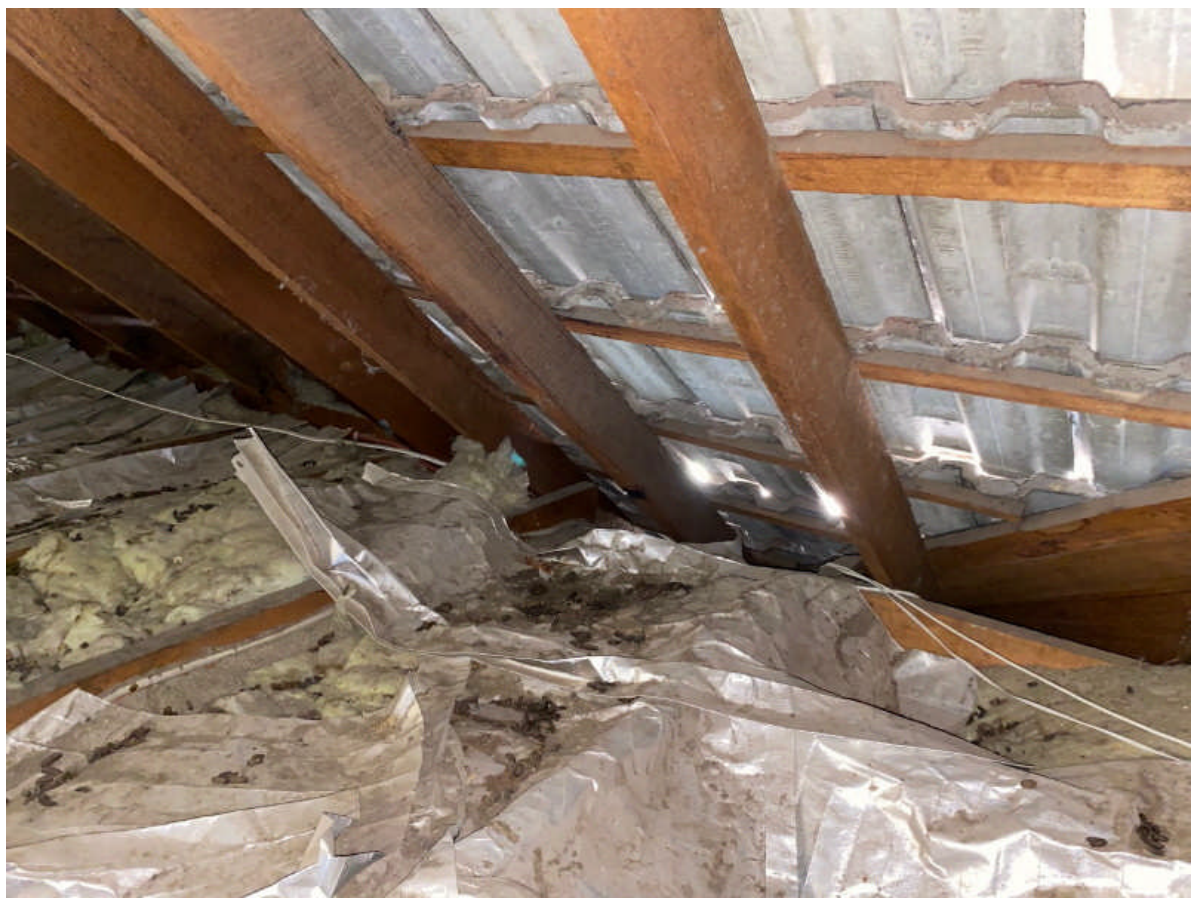
### **Photograph 16**

A view of the poorly laid insulation and possum faeces.

4.9 We would recommend that Council engage a Hygienist to report on the possum faeces within the roof space.

4.10 We would recommend that the rubbish and faeces is removed from the roof space, the insulation is re-laid and that it would also be prudent to have the electrical wiring checked by a Licensed Electrician.

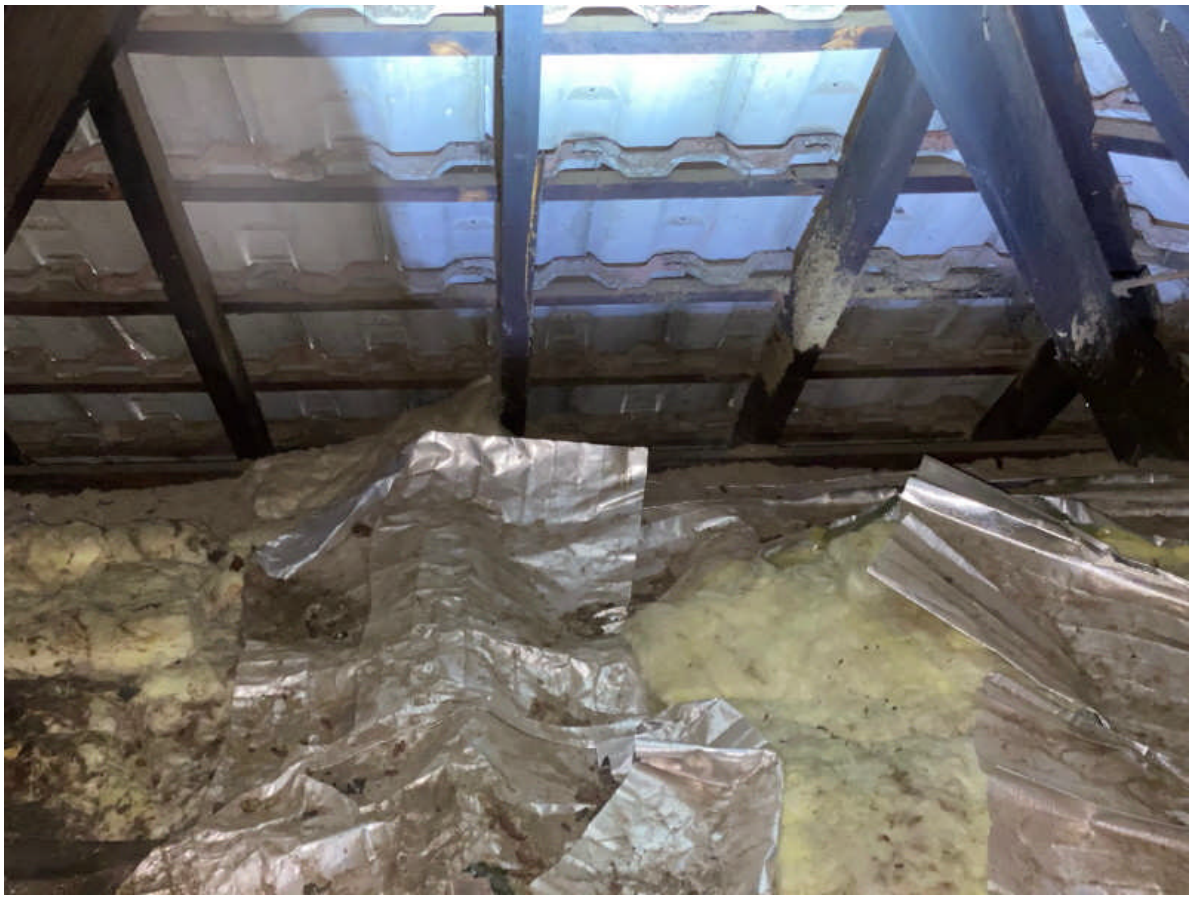
### **Photograph 17**

Another view of the poorly laid insulation and possum faeces.

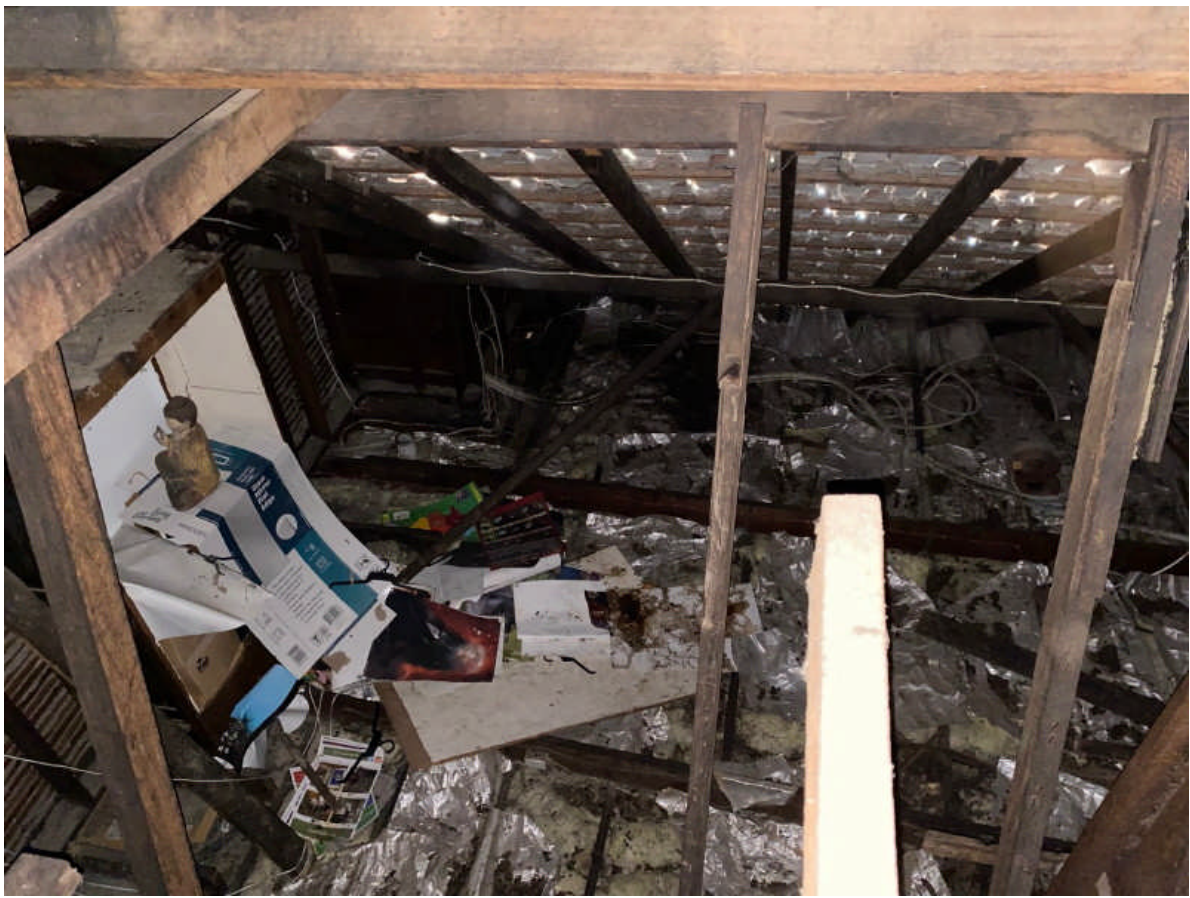
### **Photograph 18**

A view of the poorly laid insulation, rubbish and possum feces above the Baby's Room ceiling.

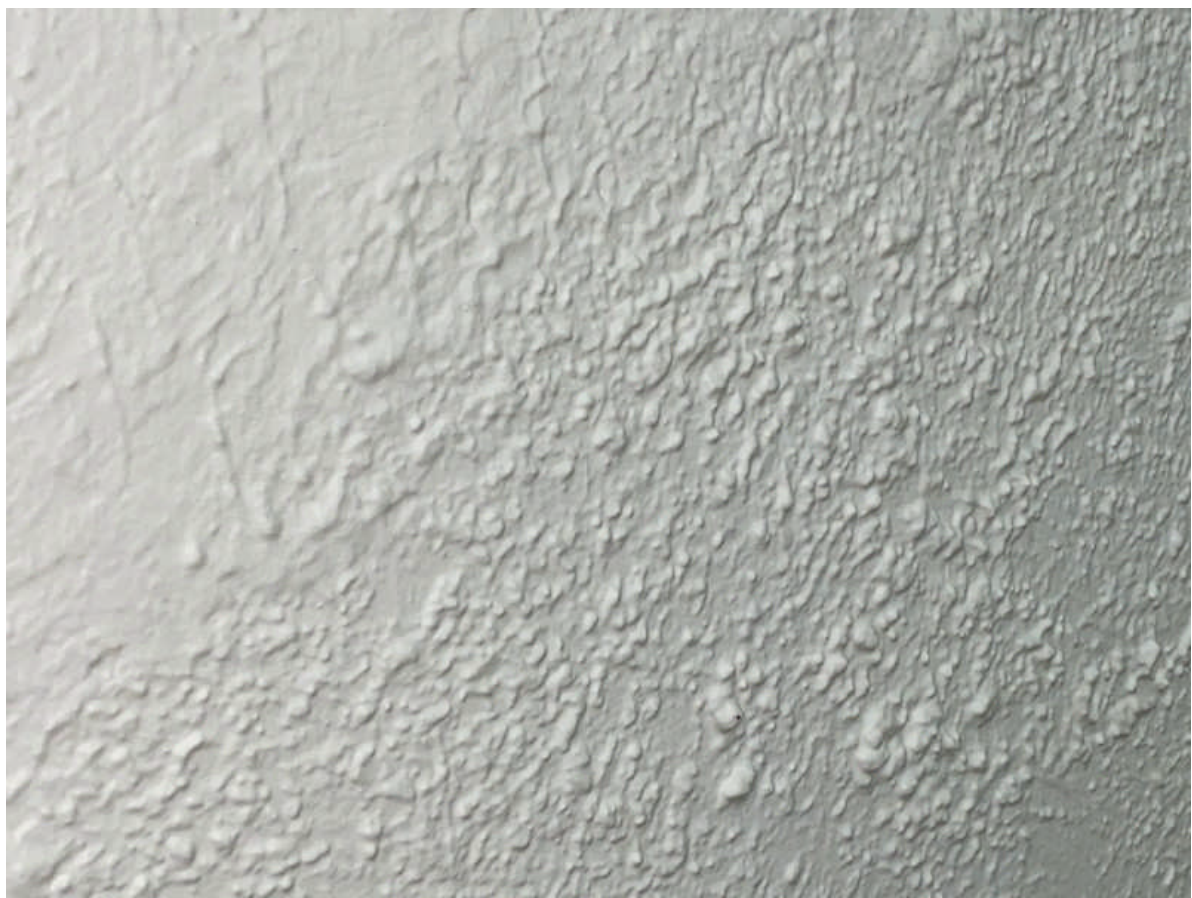
### **Photograph 19**

3.5 Our inspection of the First Floor walls revealed that textured paint has been used to disguise the old plaster sheet cracking, there was significant movement and cracking in the ceiling above the southern stair, and minor cracking and movement elsewhere. It should be noted that it is not unusual for First Floor timber walls that are supported by timber beams (rather than brickwork walls) to crack over time as the timber deflects. Refer to Photographs 19 to 22 Appendix C.

A view of the textured paint used to disguise the old plaster sheet cracking.

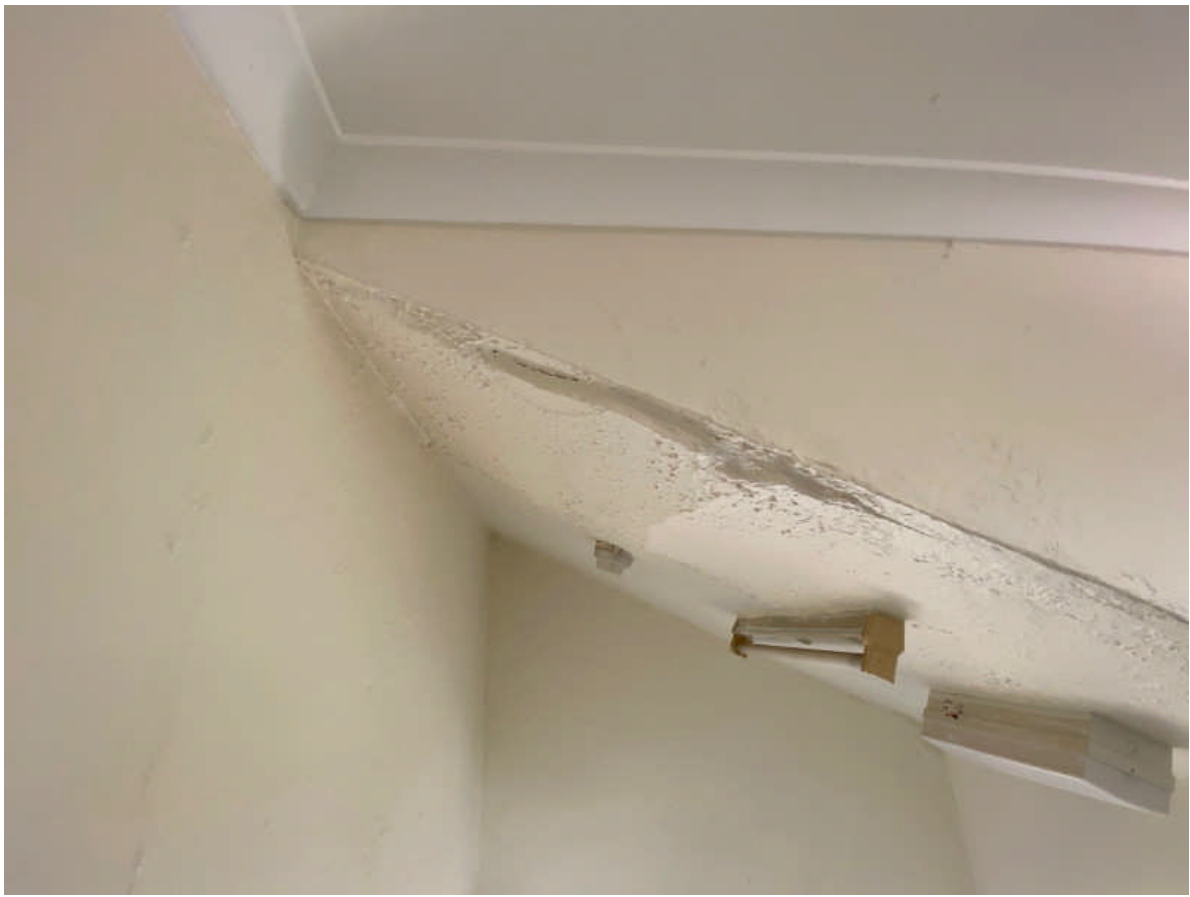
### **Photograph 20**

A view of the movement and cracking in the southern stair ceiling.

4.3 We would recommend that the long term movement and cracking in the ceiling above the southern stair be investigated by either cutting a hole in the ceiling or removing the roofing over.
