***Inspection of Building***

***17 Eildon Road***

***St Kilda***

***6<sup>th</sup> December 2021***

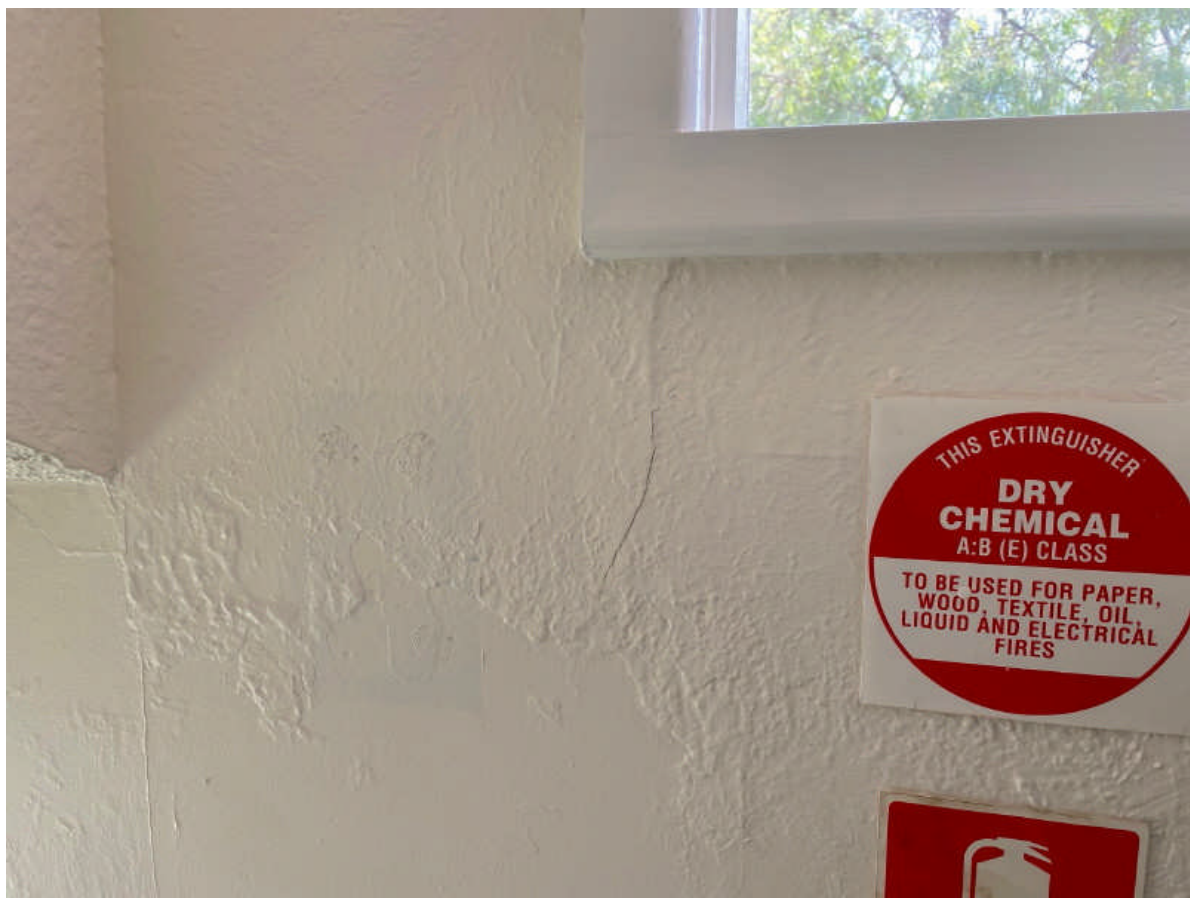
### **Photograph 21**

3.5 Our inspection of the First Floor walls revealed that textured paint has been used to disguise the old plaster sheet cracking, there was significant movement and cracking in the ceiling above the southern stair, and minor cracking and movement elsewhere. It should be noted that it is not unusual for First Floor timber walls that are supported by timber beams (rather than brickwork walls) to crack over time as the timber deflects. Refer to Photographs 19 to 22 Appendix C.

A view of the cracking in the wall to the north of the southern stair.

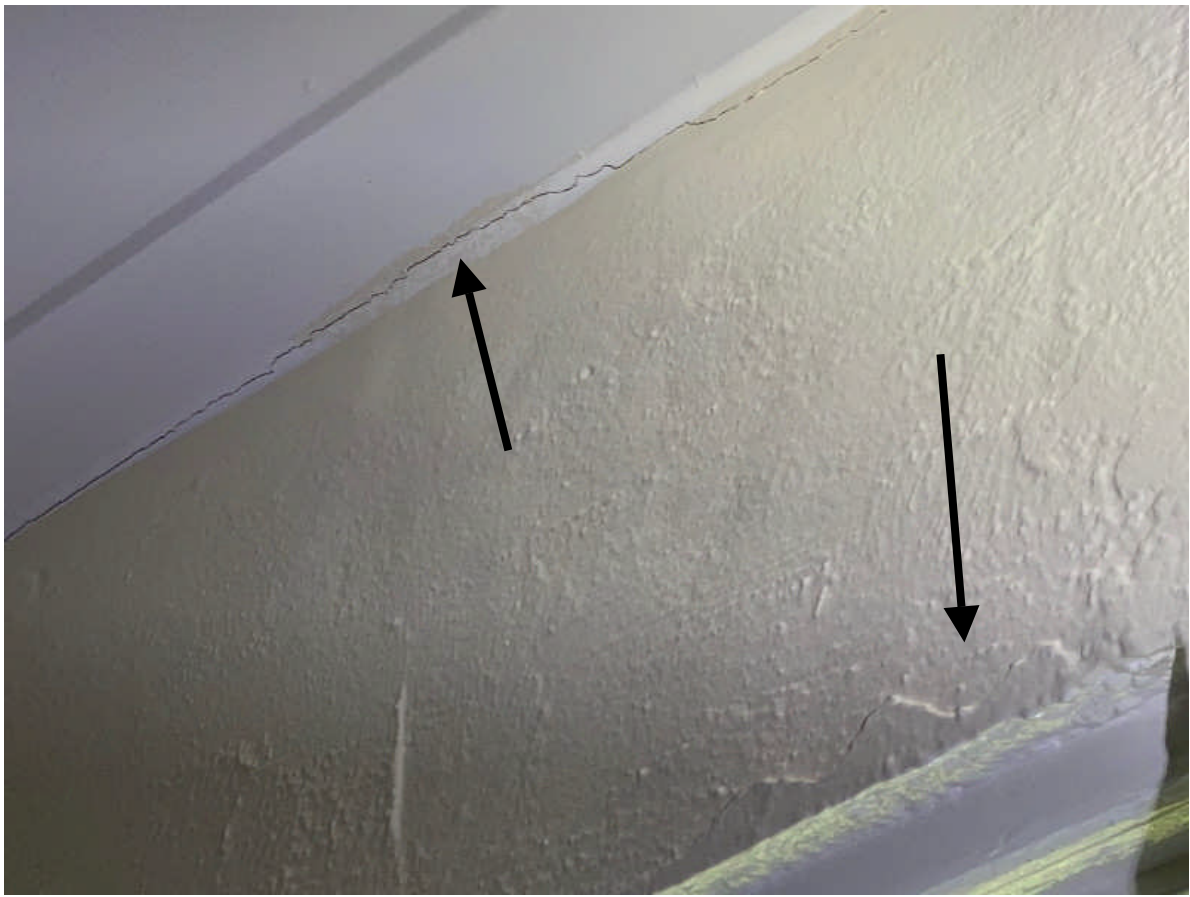
### **Photograph 22**

A view of minor new cracking and old patching.

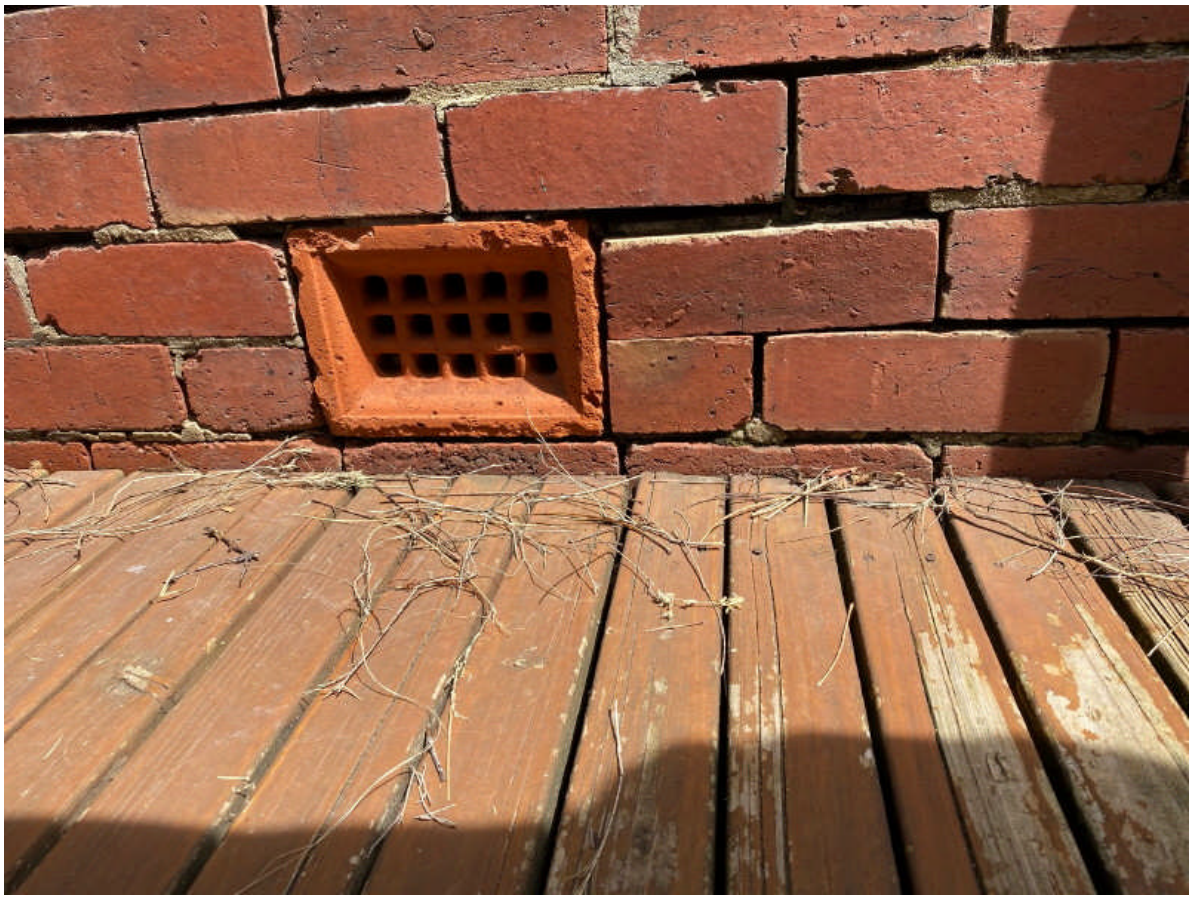
### **Photograph 23**

3.6 Our inspection of the exterior brickwork walls revealed a fretted terracotta floor vent and some missing mortar at the base of the northern wall most probably due to rising damp, some minor stepped brickwork cracking in the northern wall gable, render and concrete spalling from the concrete lintel located in the southern wall, and some brickwork movement at the eastern end of the southern wall. Refer to Photographs 23 to 26 Appendix C. Notwithstanding the brickwork was generally in very good condition.

A view of the fretted terracotta floor vent and missing mortar.

4.7 We would recommend that the efficacy of the damp proof course of the northern wall, at the fretted terracotta vent, be investigated.

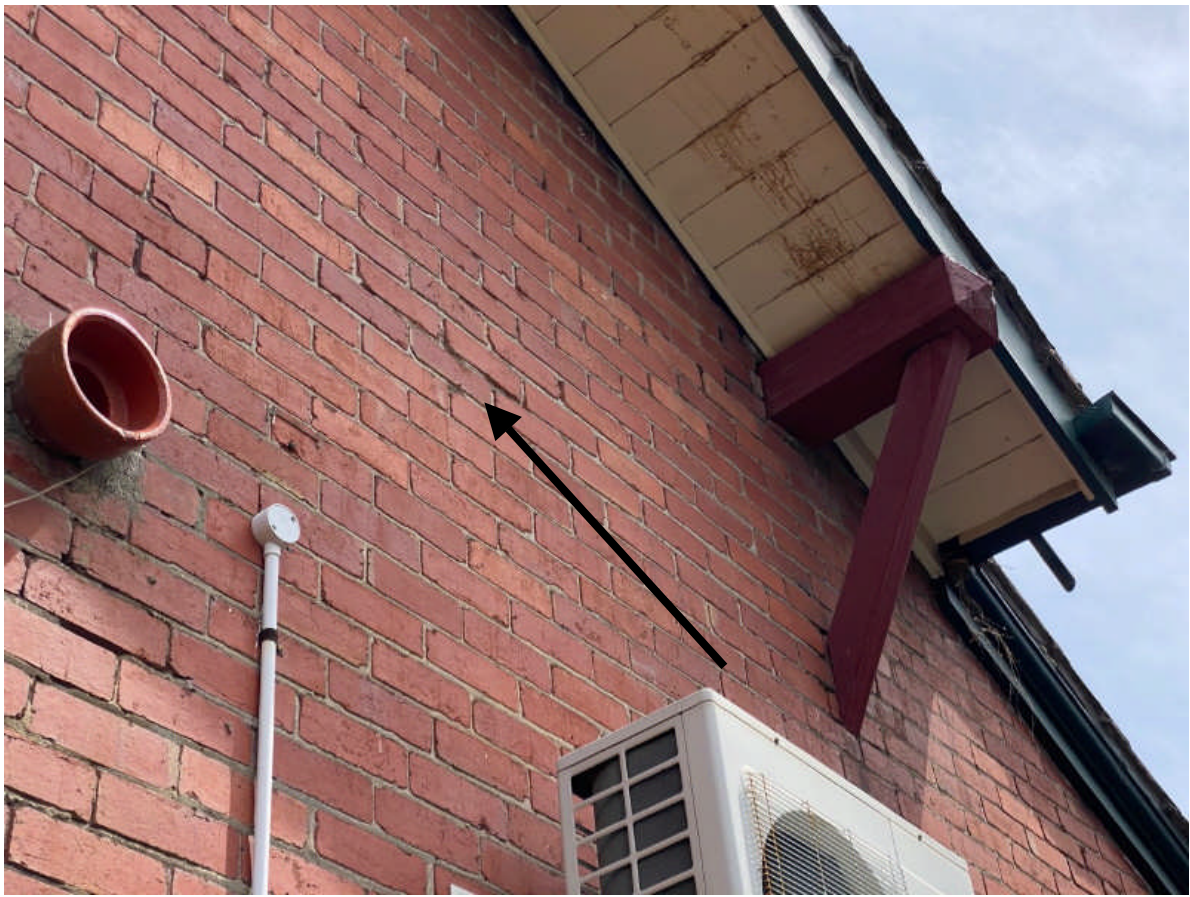
### **Photograph 24**

An oblique view of the stepped brickwork cracking in the northern gable.

4.4 We would recommend that the brickwork cracking and movement is re-pointed and then monitored for ongoing movement.

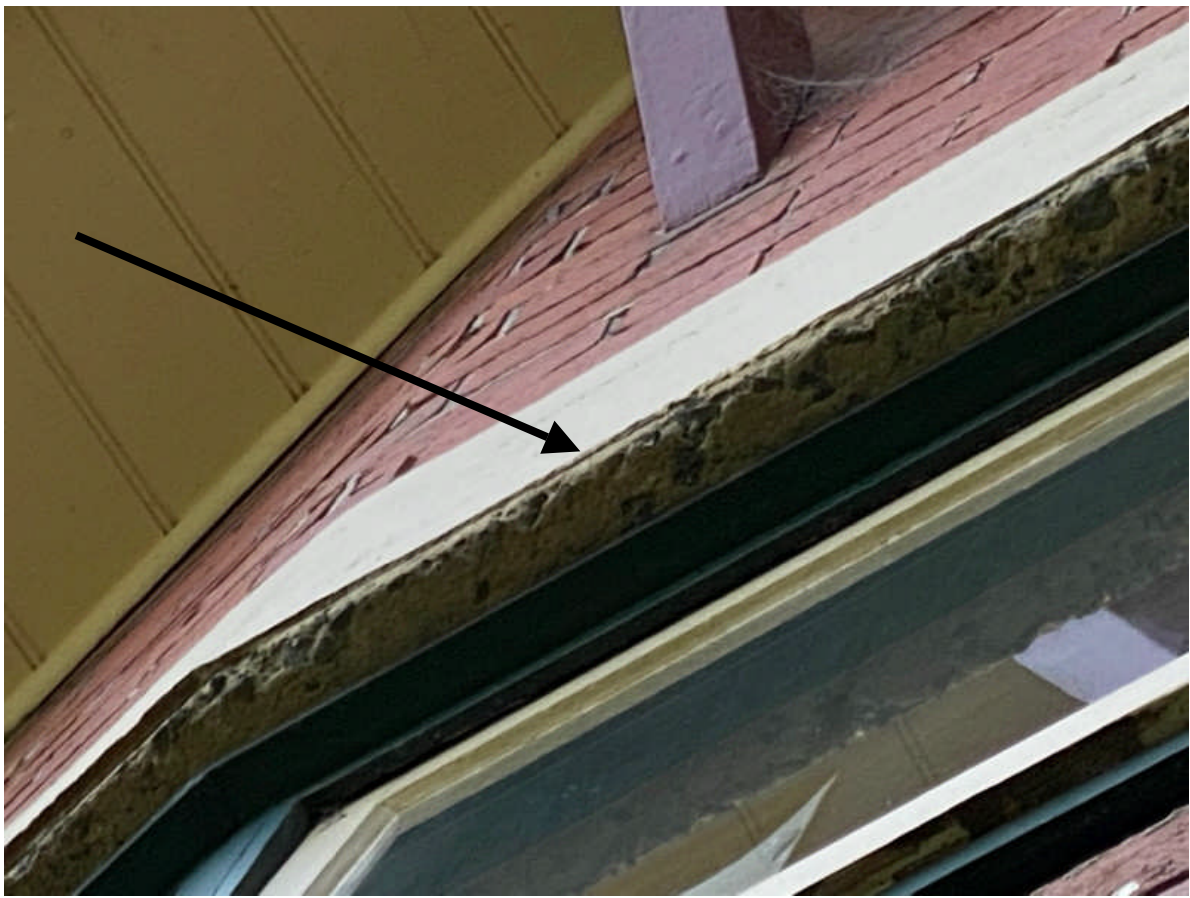
### **Photograph 25**

A view of the southern wall concrete lintel showing the render and concrete spalling.

4.5 We would recommend that the southern wall concrete lintel is inspected from an EWP, the loose concrete is removed and the concrete is then remediated.

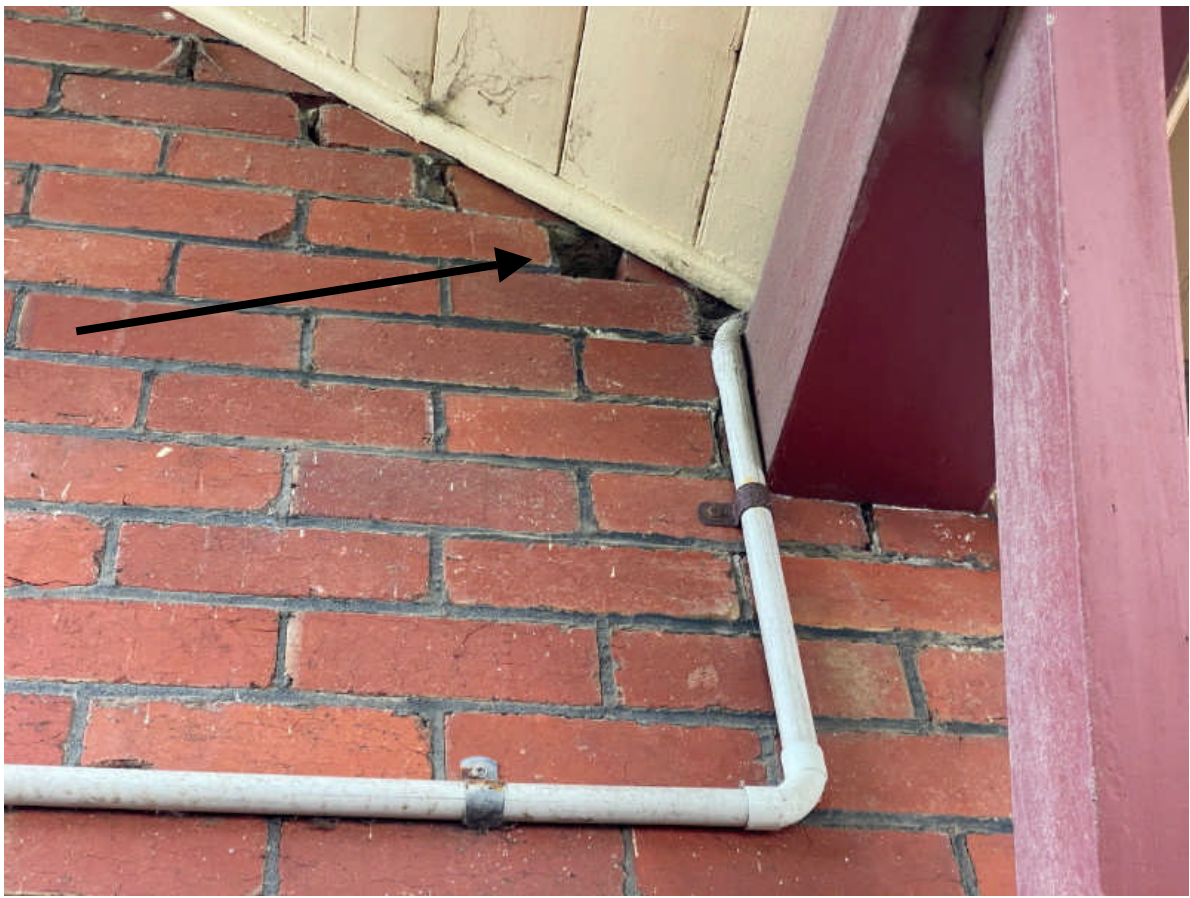
### **Photograph 26**

A view of the brickwork movement at the eastern end of the southern wall.

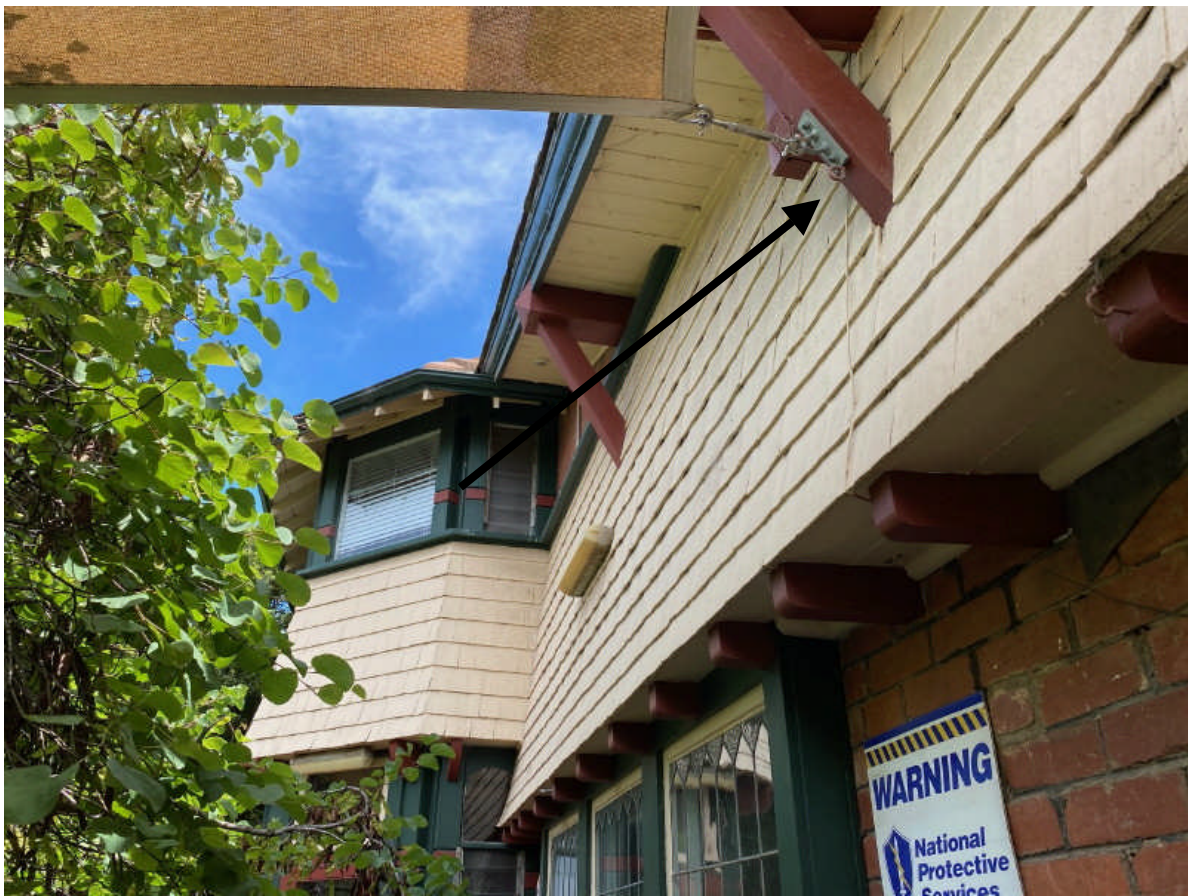
### **Photograph 27**

3.7 Our inspection of the exterior of the building also revealed that the sunshade that has been installed along the eastern side of the building has been connected to the exposed timber framing. Refer to Photographs 27 to 30 Appendix C.

A view of the eastern sunshade connection to the timber bracket.

4.11 We would recommend that Council engage a Structural Engineer to check the adequacy of the sunshade fixings, noting that they can be subjected to extremely high loadings during extremely windy conditions.

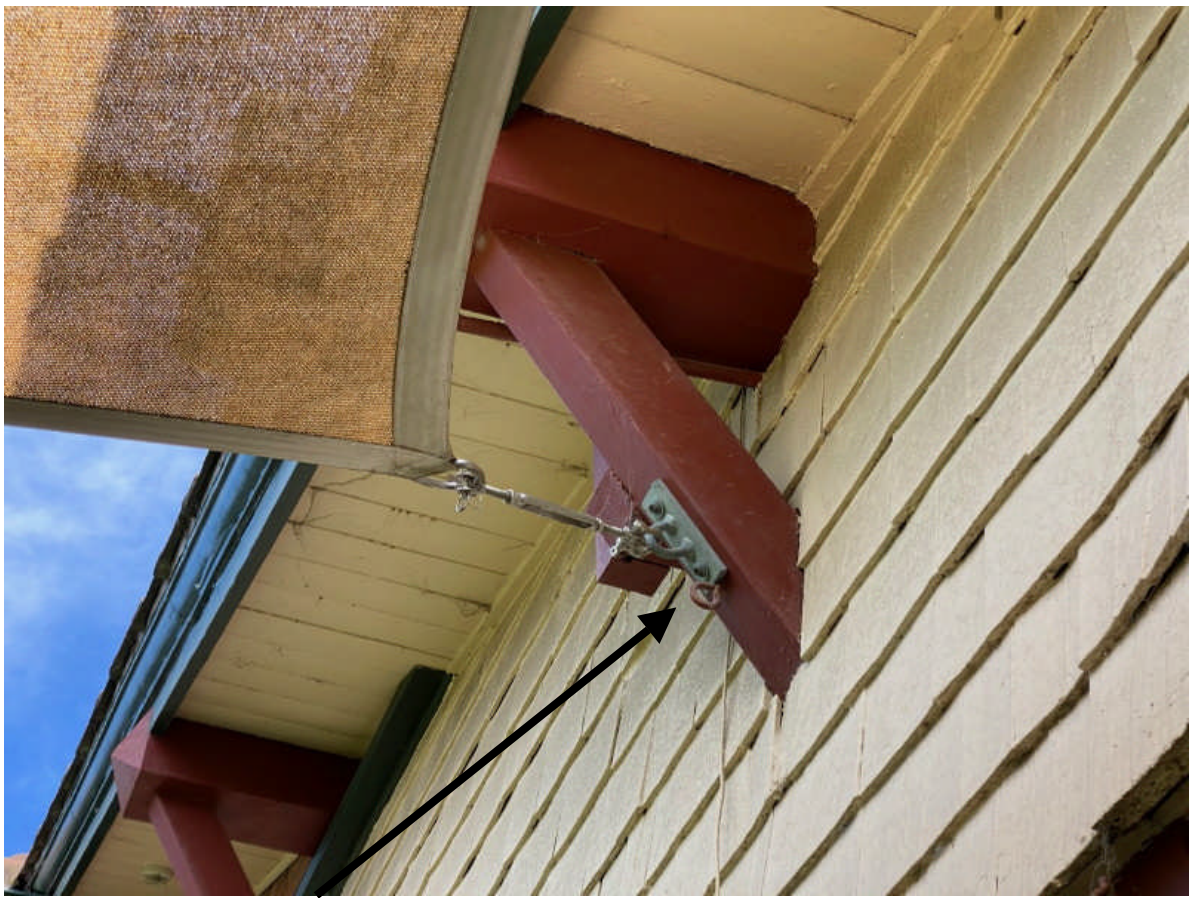
### **Photograph 28**

A close up view of the eastern sunshade connection to the timber bracket.

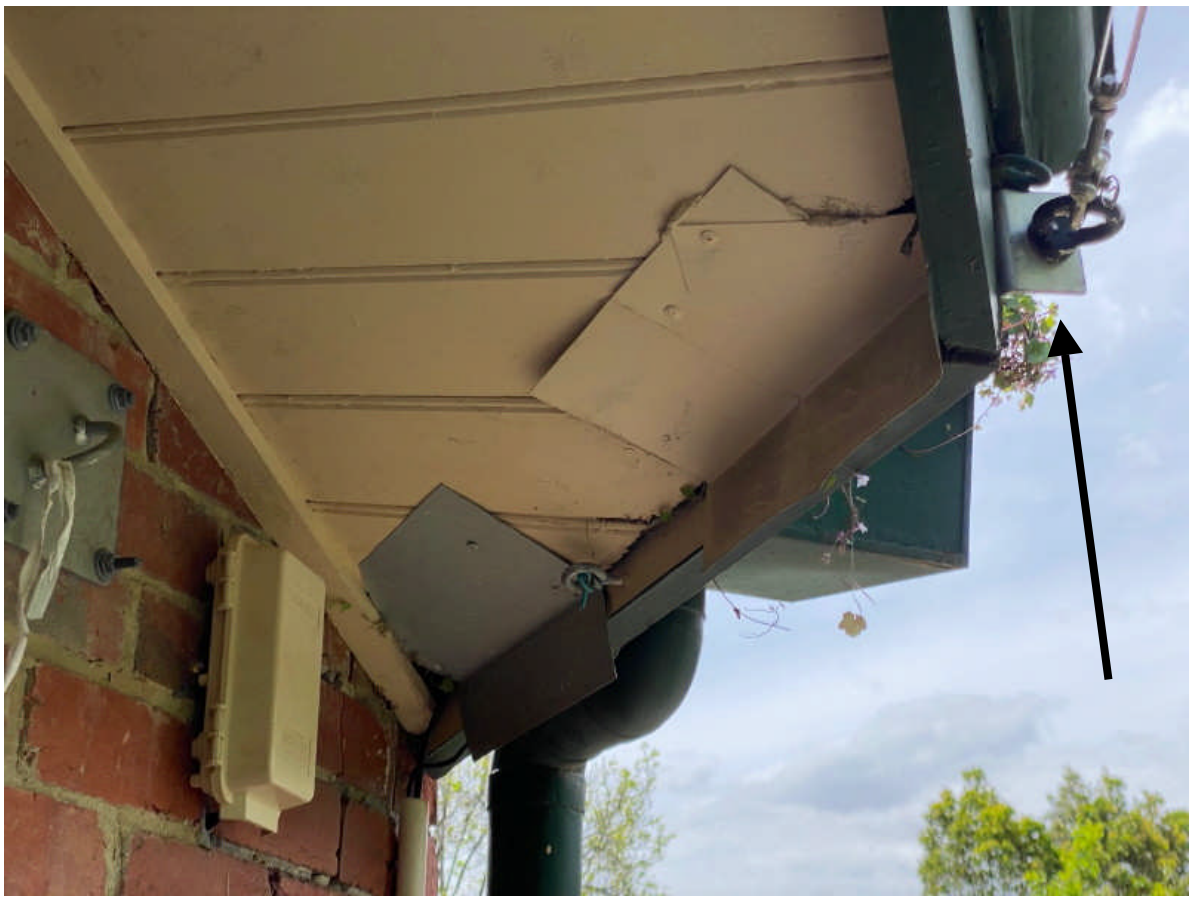
### **Photograph 29**

A view of the eastern sunshade connection to the timber fascia.

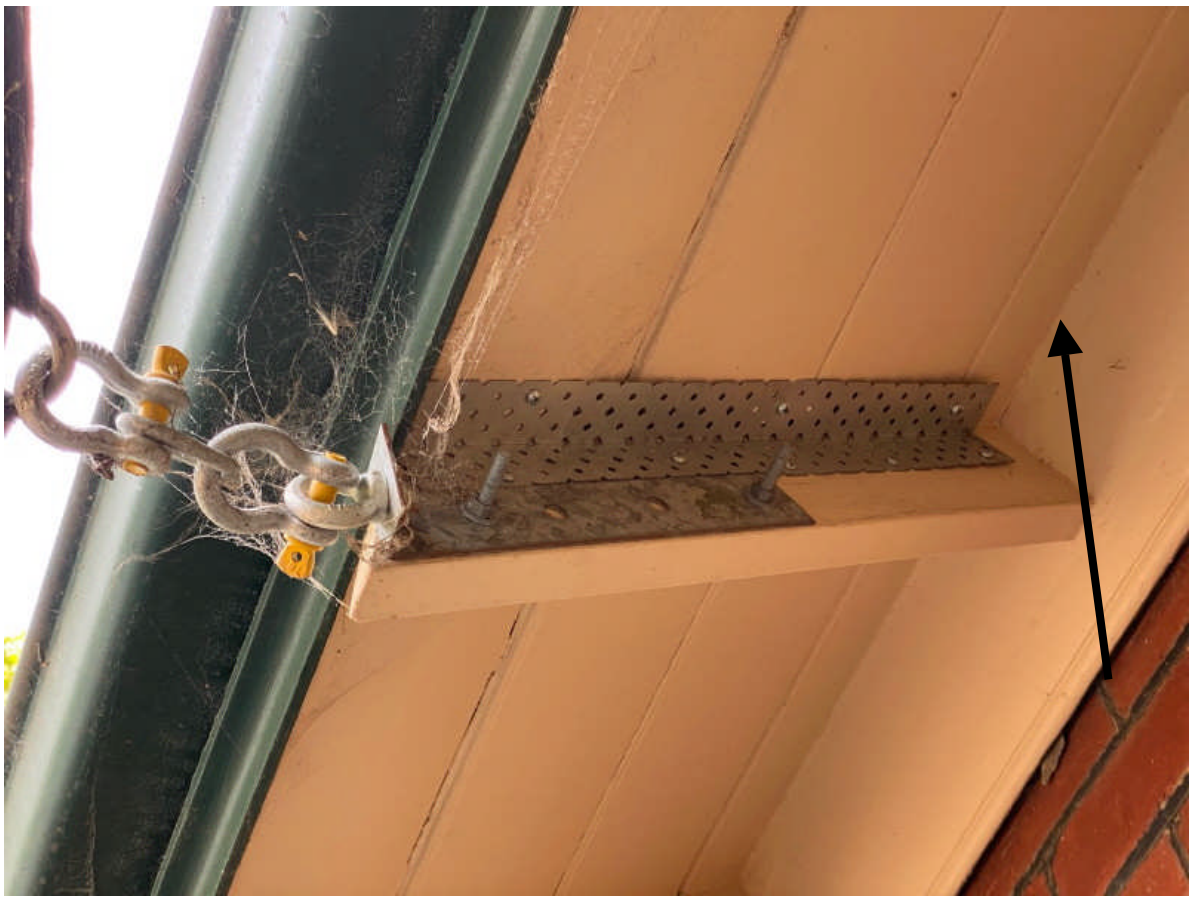
### **Photograph 30**

A view of the eastern sunshade connection to a timber rafter end.
