Architecture & Access (A&A) has been commissioned by City of Port Phillip to provide Occupational Health and Safety (OHS) risk assessment consulting services for Elwood Children's Centre. A site visit / appraisal was undertaken on 01/03/2022 with the aim of identifying OHS risks and highlighting areas of potential OHS issues. 73 items were assessed. Two risks were identified, which have been reduced so far as is reasonable practicable with suitable controls. The purpose of this report is to identify, assess and discuss existing controls for the above risks.

# Elwood Children's Centre OHS Site Appraisal 20220301

1 Mar 2022

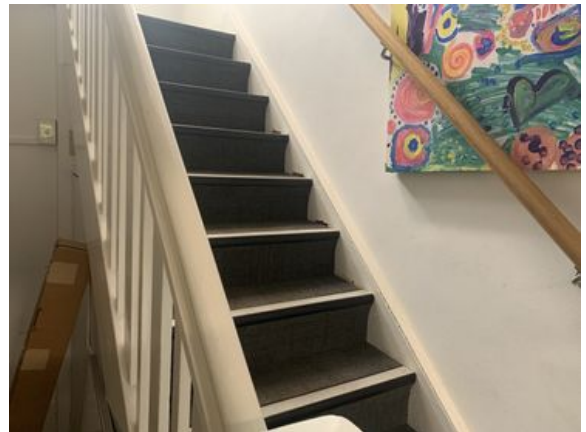
Photo 16

**Stair has bilateral handrails and slip resistant contrast nosings.**

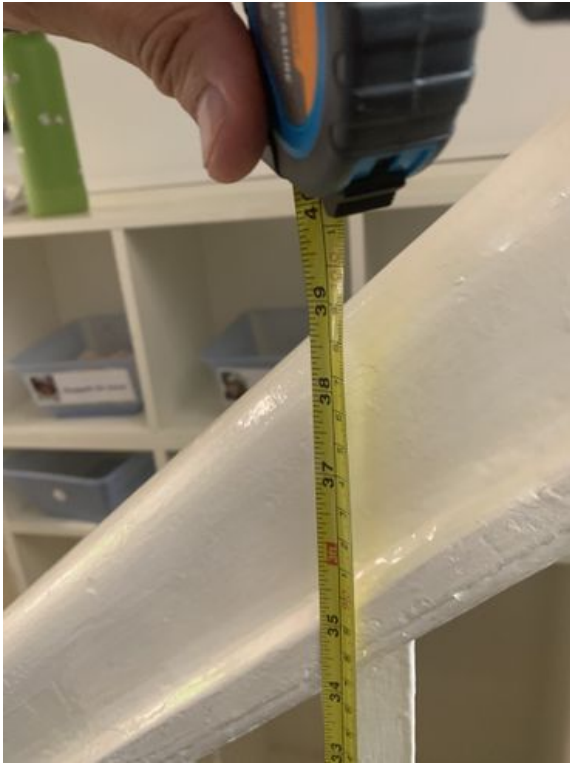
Photo 17

**Stair balustrade is >1000mm.**

No

Balustrade height is 900mm, which is 100mm less than the 1000mm minimum requirement specified in the current version (2019 Volume 1 Amendment 1) National Construction Code / Building Code of Australia (NCC/BCA). There is a likelihood of fall incident.

Architecture & Access acknowledges that the floors are non-slip (reducing the chance of falling over the balustrade as a result of slips); and the users going to the first floor are adults only (reducing the chance of risky behaviour, i.e., playing on the stairway or climbing on the balustrade). The risk likelihood is 'unlikely' (could occur at some time/once every 5-10 years); and consequence is 'major' (serious injury or hospital treatment).

Architecture & Access is of the opinion that the risk is reduced so far as is reasonably practicable. No further building modification action is required from an OHS perspective. However, building surveyor may require modification action from a building compliance perspective. Residual risk remains of fall injury. It will be managed by Elwood Children's Centre via administrative controls.

City of Port Phillip must also inform future building owner / employer about this risk. Future building owner / employer needs to accept.

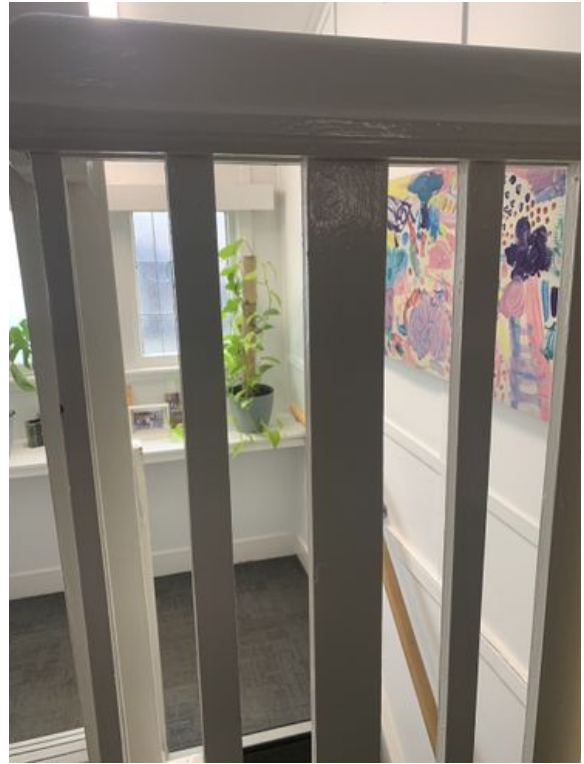
Photo 18

**Stair balustrade contains no climbable features.**

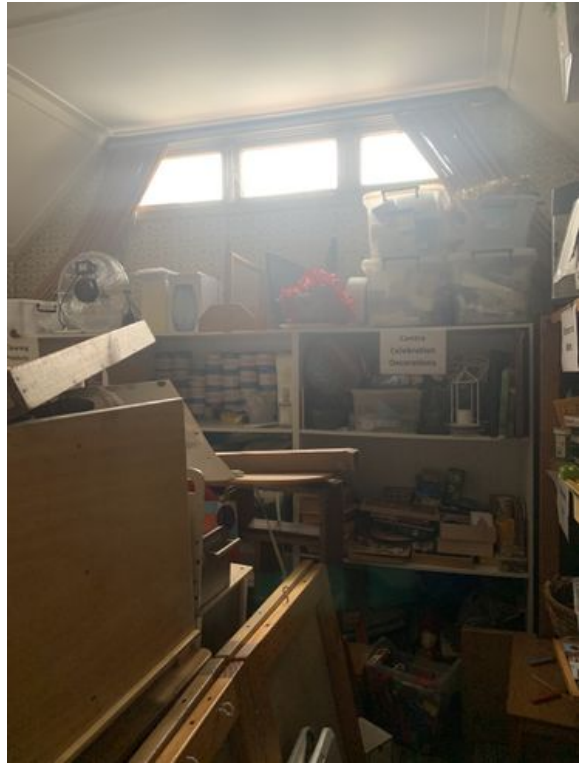
Photo 22

**Any internal hard-to-reach places can be cleaned using long-handled tools, without having to use a portable ladder.**

Highlight windows can be reached using long tools.

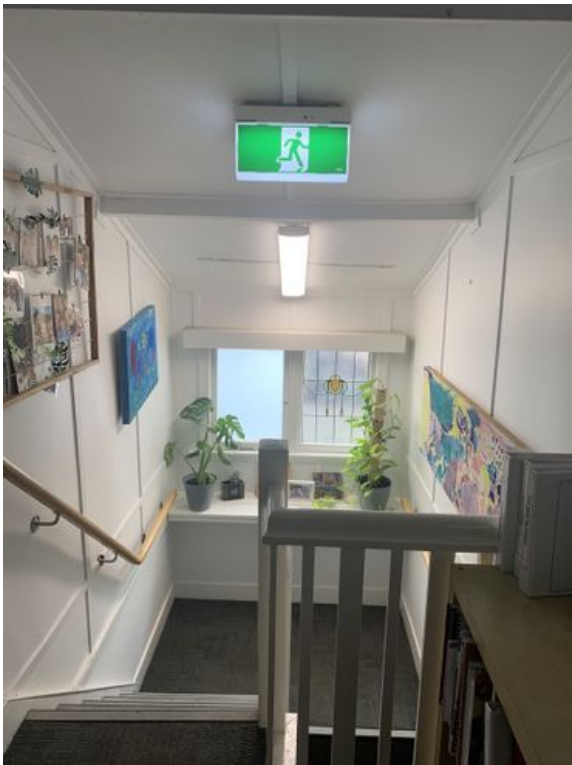
Photo 23

**No item or fixture installed directly above staircase that would require maintenance.**

Lightings can be reached from mid landing in a safe manner.

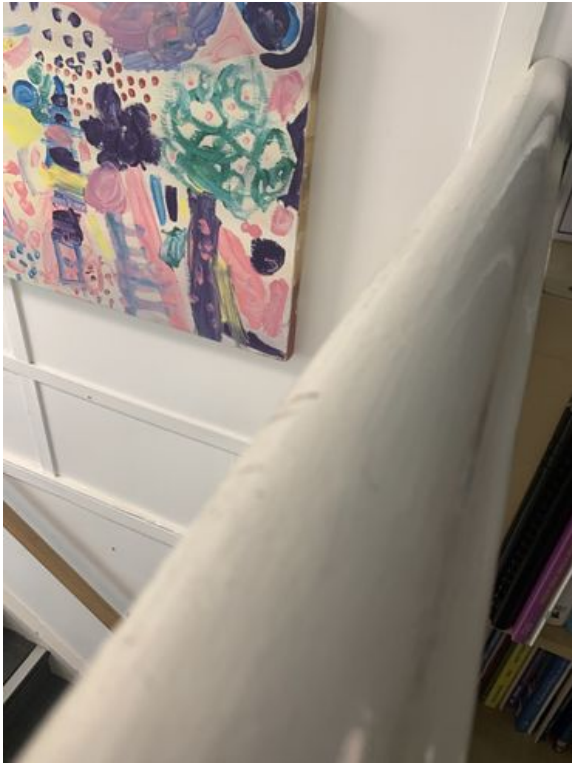
Photo 25

**Stair balustrade does not allow loose items to be placed on top.**

Round top.

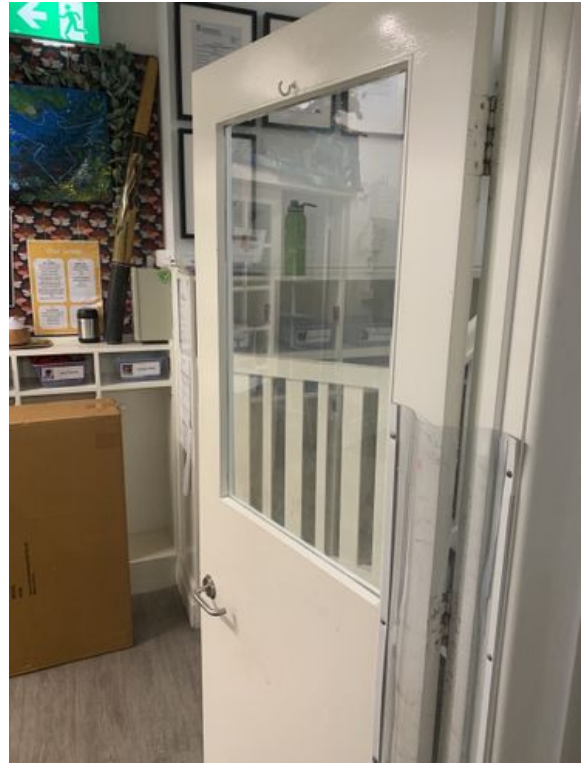
Photo 26

**Doors with anticipated frequent item movement have vision panels and door holding mechanisms.**

Most doors have a vision panel.
