ROOF CONDITION ASSESSMENT: 46 TENNYSON ST, ELWOOD, VIC 3184

3 May 2022

for
City of Port Phillip

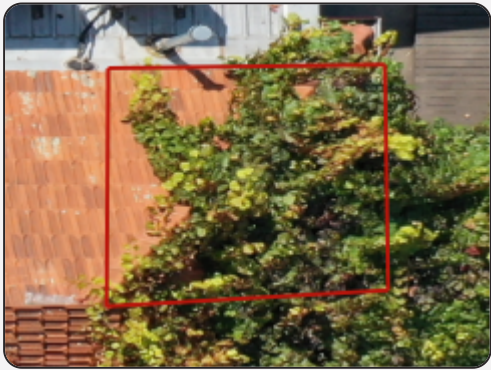
Issue #52

MEDIUM RISK Awaiting Action

Defect	Vegetation Surface Growth
Component	Tile - Concrete
Priority	8
Repair Estimate	\$0.00
Notes	-

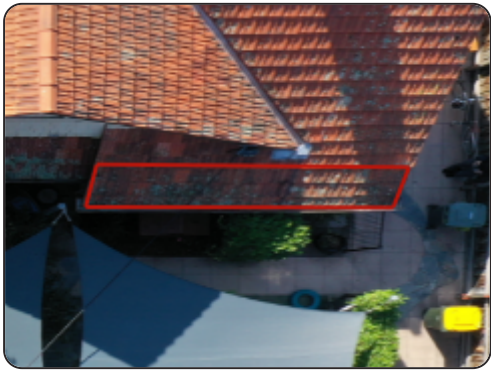
Issue #53

MEDIUM RISK Awaiting Action

Defect	Vegetation Surface Growth
Component	Tile - Concrete
Priority	8
Repair Estimate	\$0.00
Notes	-

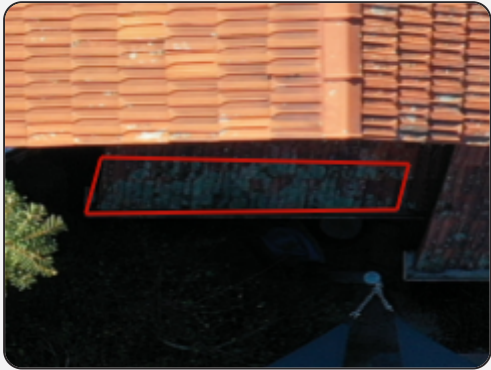
Issue #48

MEDIUM RISK Awaiting Action

Defect	Deterioration Moderate
Component	Tile - Concrete
Priority	7
Repair Estimate	\$0.00
Notes	-

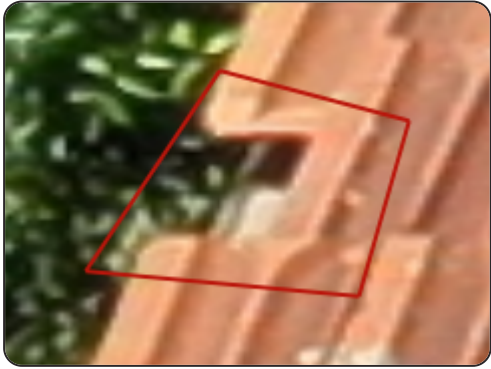
Issue #49

MEDIUM RISK Awaiting Action

Defect	Deterioration Moderate
Component	Tile - Concrete
Priority	7
Repair Estimate	\$0.00
Notes	-

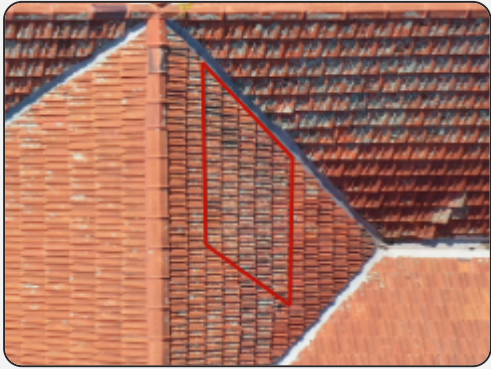
Issue #58

MEDIUM RISK Awaiting Action

Defect	Displaced Missing
Component	Tile - Concrete
Priority	7
Repair Estimate	\$0.00
Notes	-

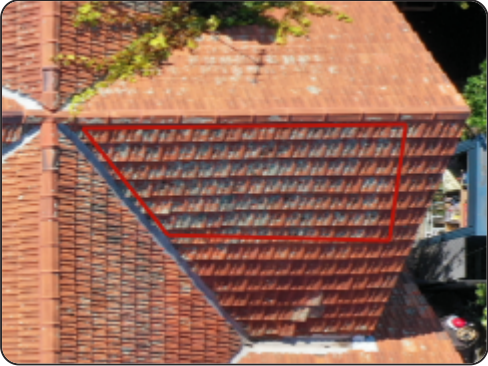
Issue #61

MEDIUM RISK Awaiting Action

Defect	Deterioration Moderate
Component	Tile - Concrete
Priority	6
Repair Estimate	\$0.00
Notes	-

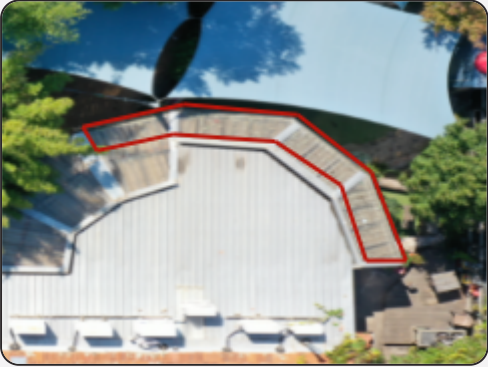
Issue #50

MEDIUM RISK Awaiting Action

Defect	Deterioration Moderate
Component	Tile - Concrete
Priority	6
Repair Estimate	\$0.00
Notes	-

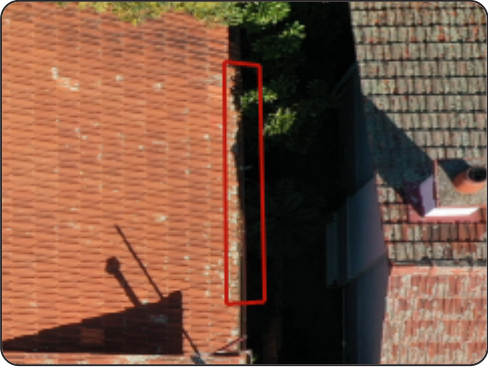
Issue #55

MEDIUM RISK Awaiting Action

Defect	Deterioration Moderate
Component	Sheeting - Polycarbonate
Priority	6
Repair Estimate	\$0.00
Notes	-

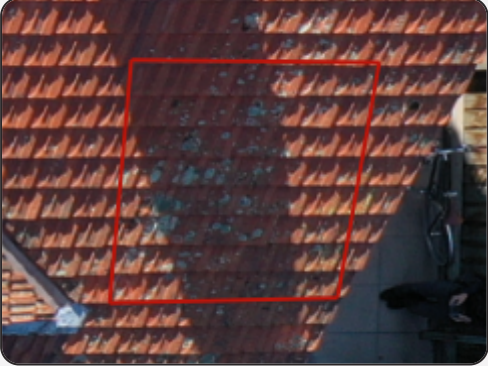
Issue #62

MEDIUM RISK Awaiting Action

Defect	Debris Leaf/Plant Litter
Component	Gutter - Fascia
Priority	5
Repair Estimate	\$0.00
Notes	-

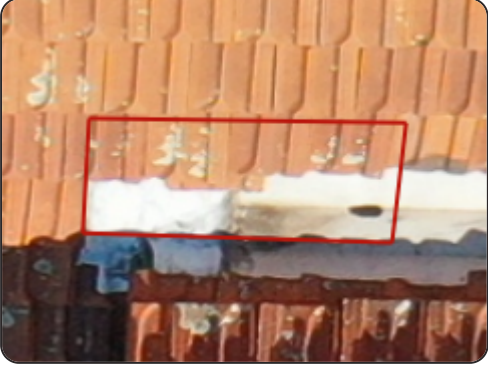
Issue #85

MEDIUM RISK Awaiting Action

Defect	Deterioration Moderate
Component	Tile - Concrete
Priority	5
Repair Estimate	\$0.00
Notes	-

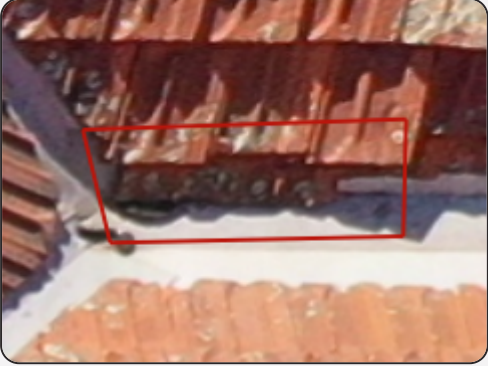
Issue #80

MEDIUM RISK Awaiting Action

Defect	Displaced Loose
Component	Tile - Concrete
Priority	5
Repair Estimate	\$0.00
Notes	-

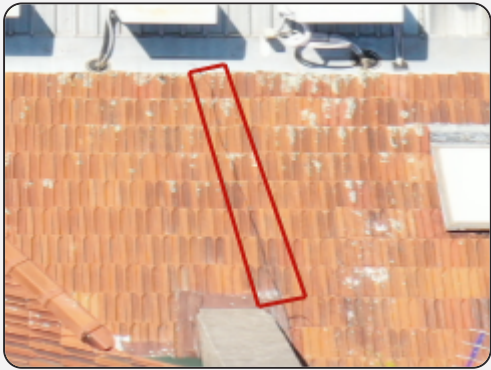
Issue #59

MEDIUM RISK Awaiting Action

Defect	Vegetation Surface Growth
Component	Sheeting - Steel
Priority	5
Repair Estimate	\$0.00
Notes	-

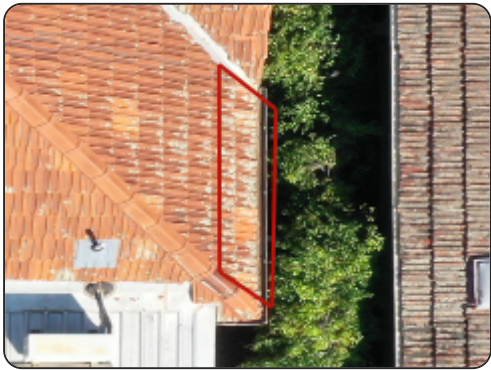
Issue #76

MEDIUM RISK Awaiting Action

Defect	Electrical Exposed Wire
Component	Roof
Priority	4
Repair Estimate	\$0.00
Notes	-

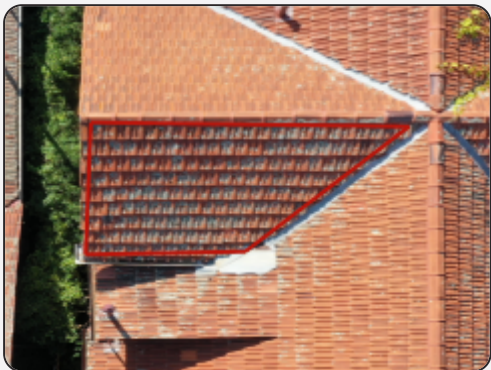
Issue #56

Low Risk Awaiting Action

Defect	Discolored Efflorescence
Component	Tile - Concrete
Priority	5
Repair Estimate	\$0.00
Notes	-

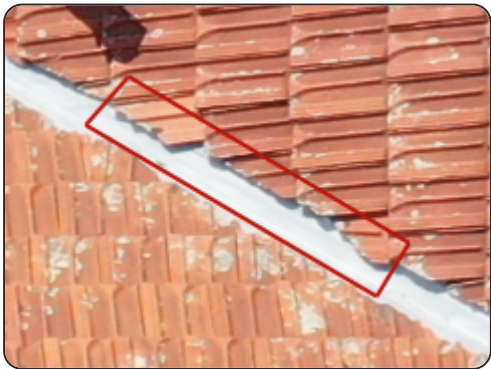
Issue #51

Low Risk Awaiting Action

Defect	Deterioration Moderate
Component	Tile - Concrete
Priority	5
Repair Estimate	\$0.00
Notes	-

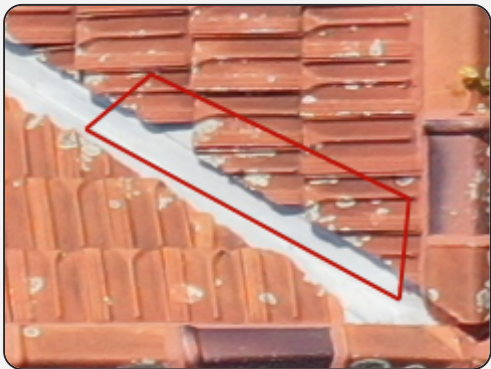
Issue #82

Low Risk Awaiting Action

Defect	Damaged Cracked
Component	Tile - Concrete
Priority	4
Repair Estimate	\$0.00
Notes	-

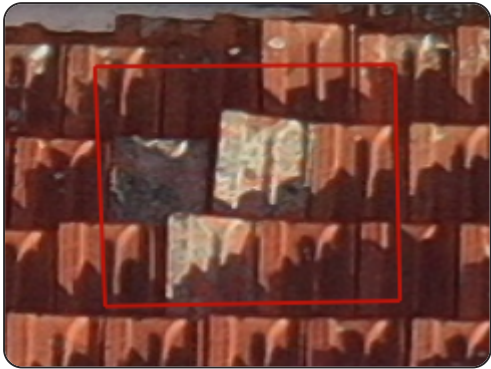
Issue #73

Low Risk Awaiting Action

Defect	Damaged Chipped
Component	Tile - Concrete
Priority	4
Repair Estimate	\$0.00
Notes	-

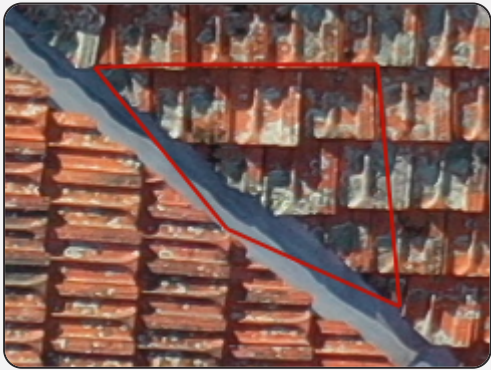
Issue #60

LOW RISK Awaiting Action

Defect	Displaced Alignment
Component	Tile - Concrete
Priority	4
Repair Estimate	\$0.00
Notes	-

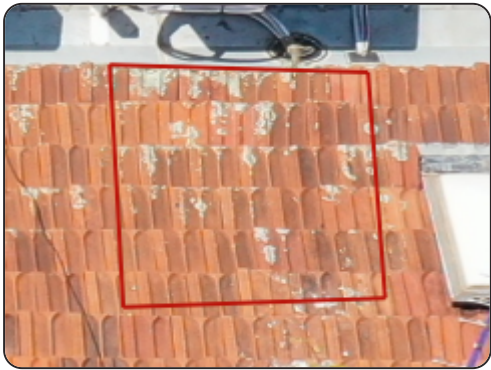
Issue #78

LOW RISK Awaiting Action

Defect	Displaced Alignment
Component	Tile - Concrete
Priority	3
Repair Estimate	\$0.00
Notes	-

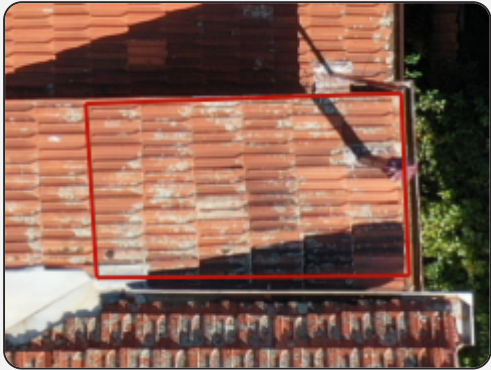
Issue #74

LOW RISK Awaiting Action

Defect	Deterioration Minor
Component	Tile - Concrete
Priority	3
Repair Estimate	\$0.00
Notes	-

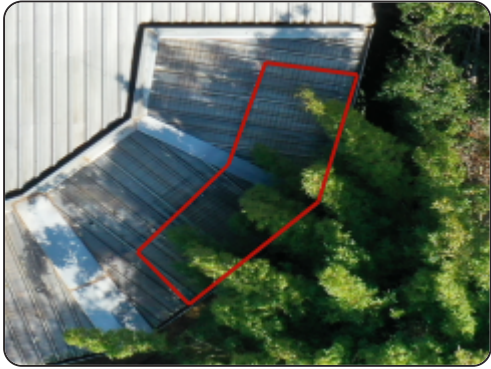
Issue #57

LOW RISK Awaiting Action

Defect	Discolored Efflorescence
Component	Sheeting - Steel
Priority	3
Repair Estimate	\$0.00
Notes	-

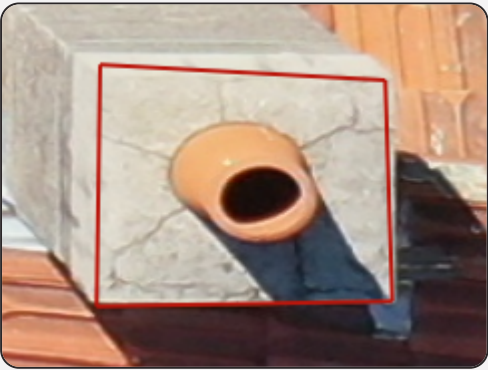
Issue #77

LOW RISK

Defect	Displaced Alignment
Component	Tile - Concrete
Priority	2
Repair Estimate	\$0.00
Notes	-

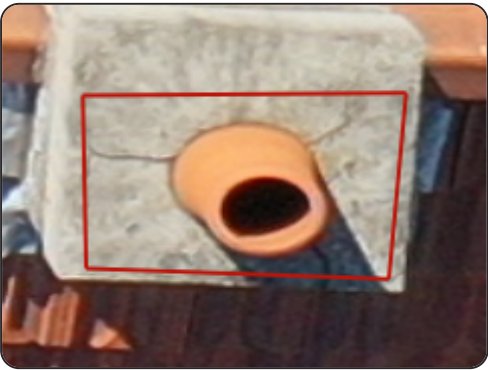
Issue #75

LOW RISK

Defect	Damaged Cracked
Component	Roof
Priority	2
Repair Estimate	\$0.00
Notes	-

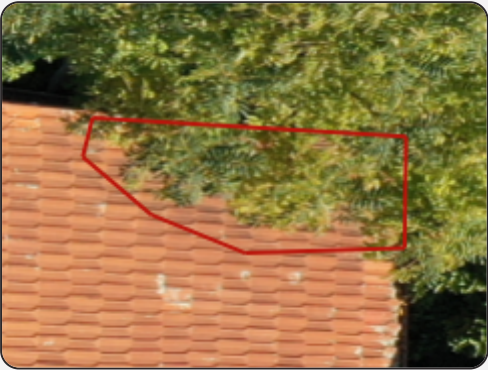
Issue #84

LOW RISK

Defect	Damaged Cracked
Component	Roof
Priority	1
Repair Estimate	\$0.00
Notes	-

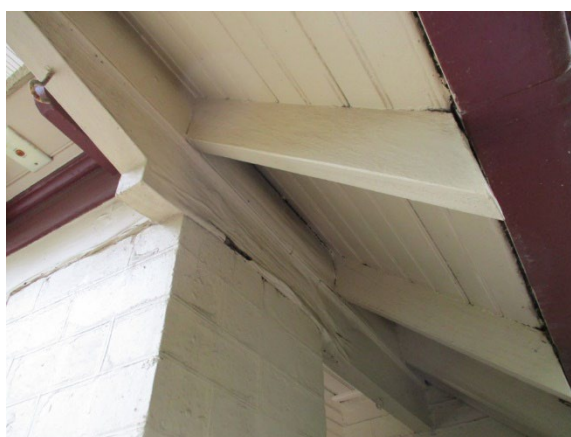
8: Exterior - Eaves (painted over wood rot)

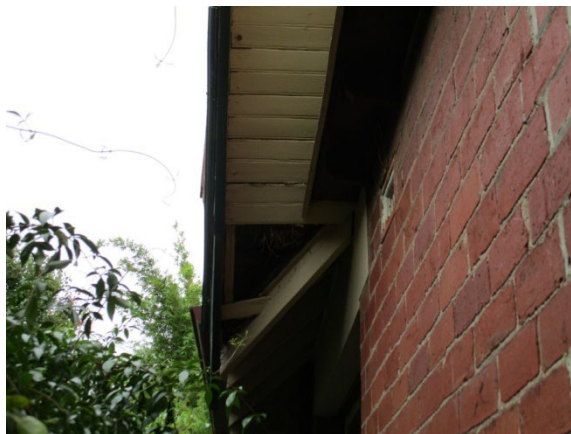
18: Exterior - Missing eaves (north elevation)

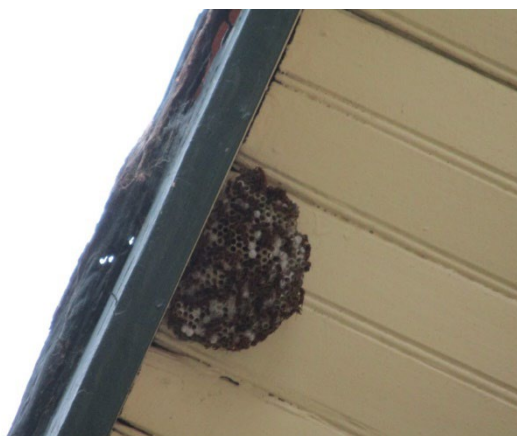
19: Exterior - Pest Infestation
