39 THE AVENUE, BALACLAVA

BUILDING CONDITION ASSESSMENT - UPDATE

39 THE AVENUE, BALACLAVA BUILDING CONDITION ASSESSMENT - UPDATE

3 May 2022

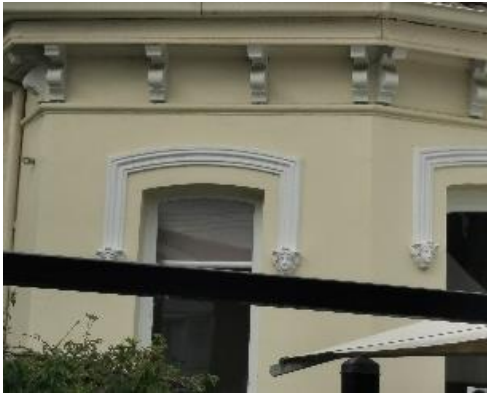
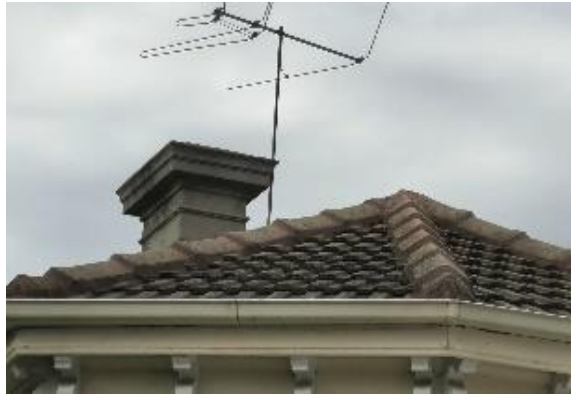
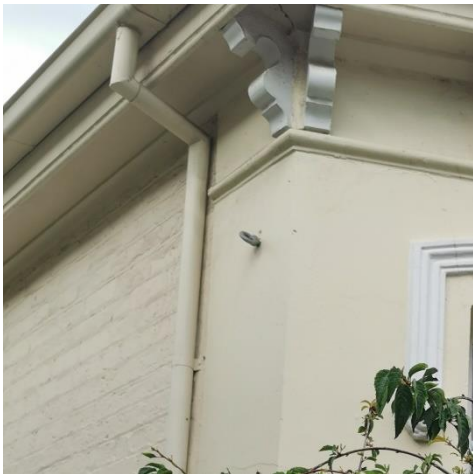
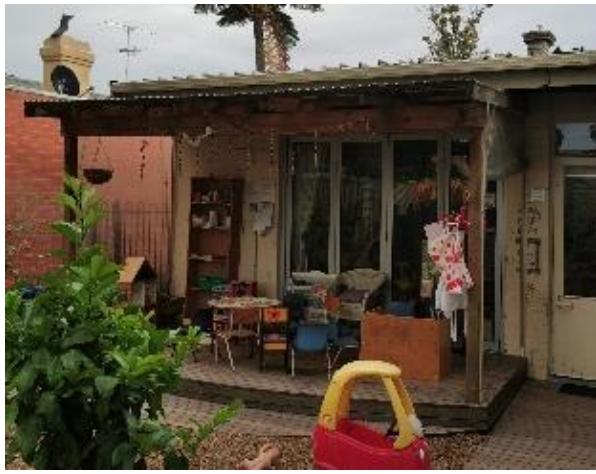
GENERAL BUILDING STRUCTURE

The general building structure and façade were all found to be in good condition. WT did not observe any visual structural defects to the exterior walls of the property.

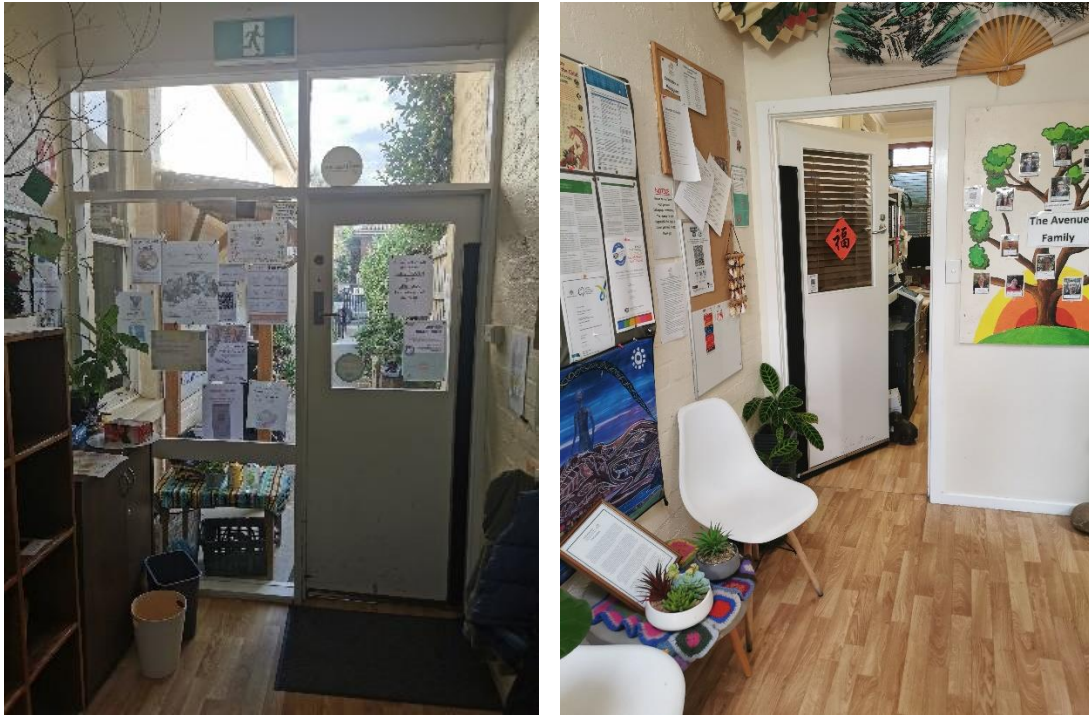
ENTRY HALL

Each of the interior finishes were all found to be in a good condition. There were no trip hazards or un-even finishes to the timber flooring. The building fixtures were a mixture of older and new furniture items, none of which appeared to have any major defective issues. The defibrillator and air purifying unit contained in this area were observed to be in a very good visual condition.

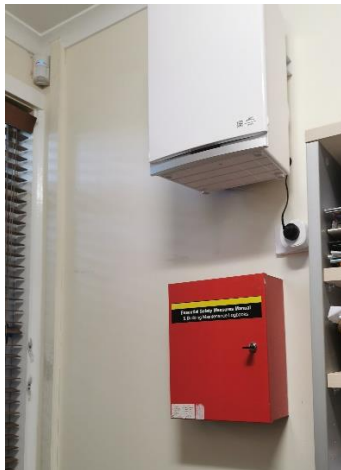
AIR PURIFYING UNIT AND SAFETY LOG BOOK

The air conditioning equipment, wall mounted air purifying unit and essential safety measure logbook all appeared to be in a good visual condition. There were no major visual defects evident to the large glass windows and external door. Whilst the furniture was of a variety of ages all furniture appeared to be structurally sound. There was no evidence of roof leaks to the ceilings of both the office rooms.

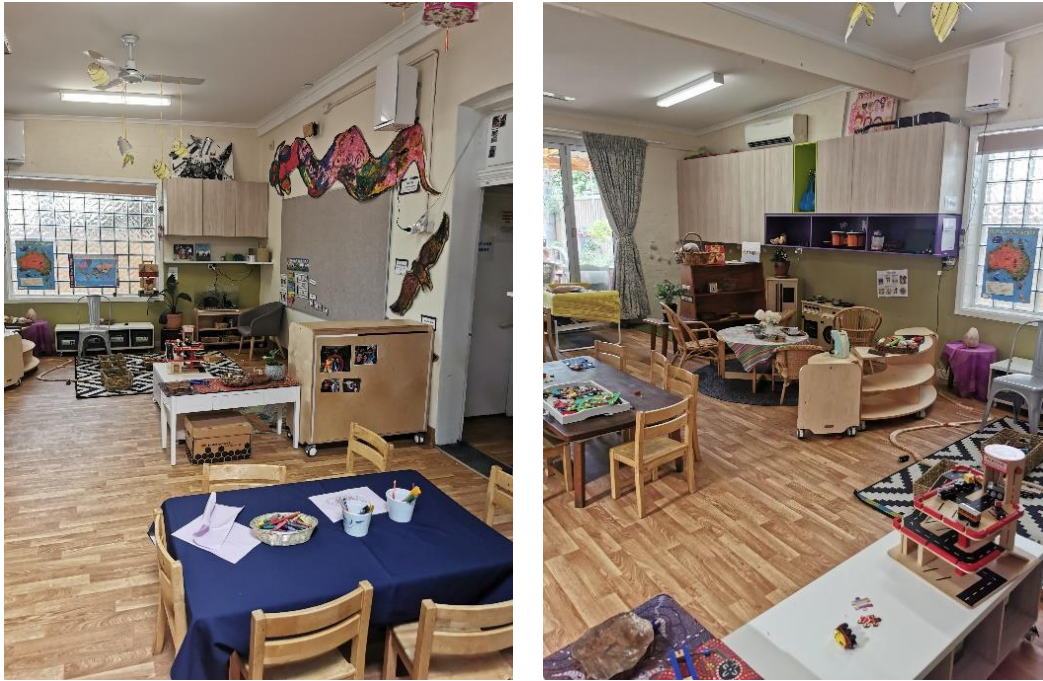
CHILDREN'S PLAY AREA

All mechanical and electrical equipment appeared to be in good condition. Furniture observed was of a range of ages, generally in good condition throughout with no major visual defects of note. All external doors were operating with no issues and had no observable visual defects.

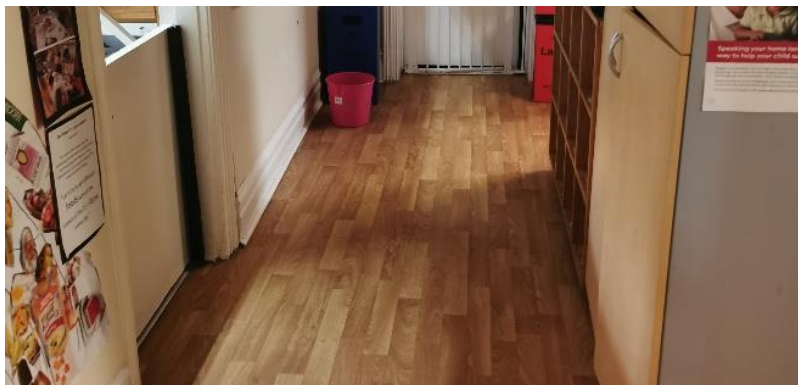
HALL FLOORING

The internal hall finishes were found in a good condition with no notable observable defects.

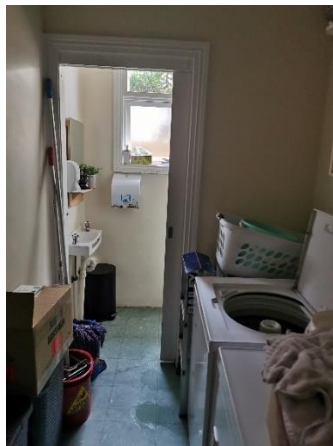
LAUNDRY ROOM

All floor, wall and ceiling finishes were in good condition with no notable observable defects. Minor corrosion was observed to the hand paper towel dispenser of the laundry room toilet which appeared to require replacement. A member of staff was present in the kitchen at the time of the inspection who confirmed all the equipment mentioned above was in working condition with no notable issues.

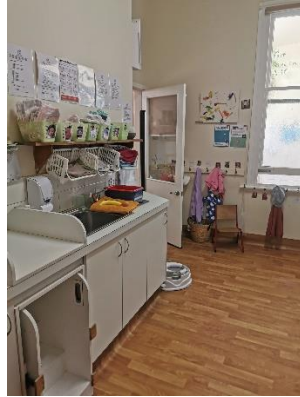
BATHROOM

Each of the interior finishes were found to be in a very good condition. No visual evidence of roof leak or trip hazard were found in the bathroom. All the sanitary equipment appeared to be in good visual condition.

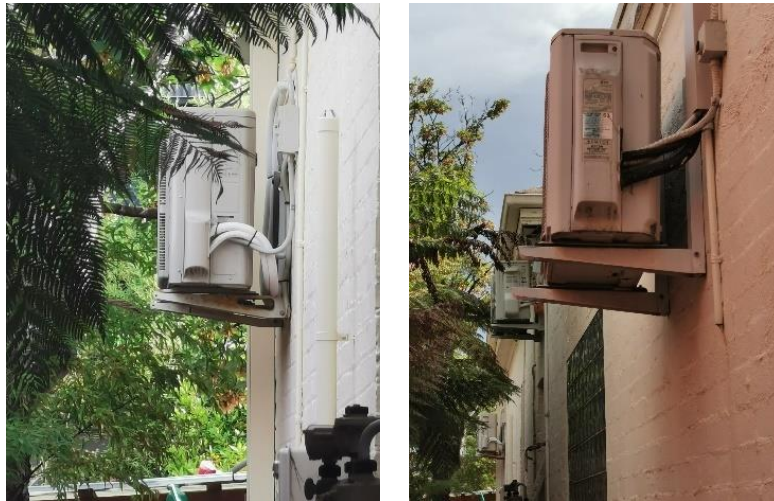
AIR CONDITIONING UNITS TO WEST EXTERIOR

The West external walls of the building featured three split air conditioning units. Each of the units appeared to be in good visual condition, as was the instantaneous hot water unit in the West pathway. Due to the height of the assets the nameplate of each unit was not visible to obtain the age of these assets. There was also an instantaneous hot water unit at ground level in the West pathway.

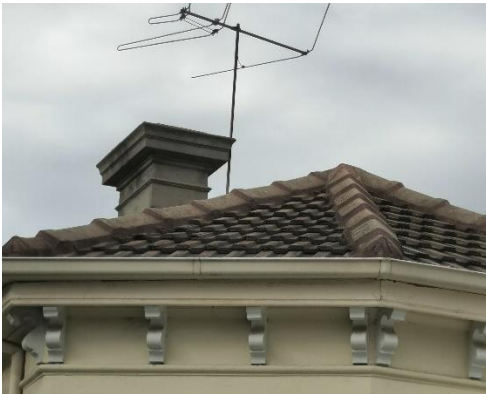
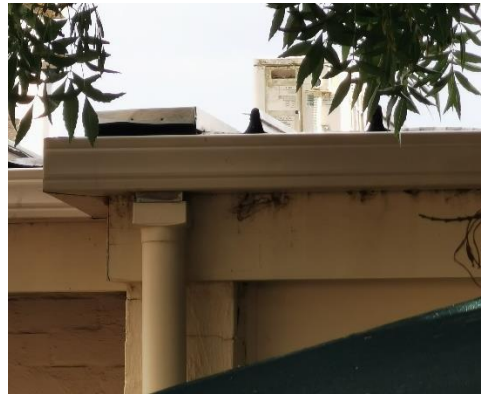
DRAINPIPES AND GUTTERING

All drainpipes and guttering appeared to be in good condition, as the weather had been dry at the time of inspection there was no means of identifying any defective issues relating to the assets performance in wet weather.

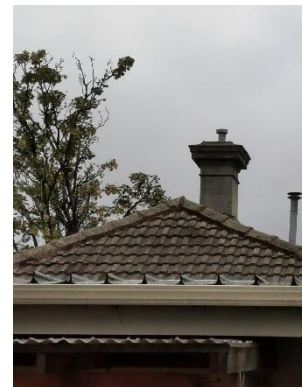
REFERENCE	ELEMENT	LOCATION	DESCRIPTION	COMMENT/CONDITION	RATING	PHOTO REF
33	Building Fabric - Doors	Children Playroom to Hall	Door	Timber	2 - Good	CHILDREN PLAYROOM 2
34	Building Structure	Chimney	Chimney	No visual signs of any issues	3 - Fair	CHIMNEY
35	Building Fabric	Entry Hall (Entrance)	Timber Sign-In Desk		2 - Good	ENTRY HALL 4
36	Building Fabric	Entry Hall (Entrance)	Wooden Box Shelf		2 - Good	ENTRY HALL 3
37	Building Fabric - Ceiling Finish	Entry Hall (Entrance)	Plasterboard		2 - Good	ENTRY HALL 4
38	Building Fabric - Doors	Entry Hall (Entrance)	Door	Main Entry - Timber Glazed	3 - Fair	ENTRY HALL 1
39	Building Fabric - Floor Finish	Entry Hall (Entrance)	Timber Look Vinyl		3 - Fair	ENTRY HALL 5
40	Building Fabric - Wall Finish	Entry Hall (Entrance)	Painted Blockwork		2 - Good	ENTRY HALL 2
41	Electrical	Entry Hall (Entrance)	Lighting	Recessed Spotlight	2 - Good	ENTRY HALL
42	Electrical	Entry Hall (Entrance)	Lighting	Exit Lighting	2 - Good	ENTRY HALL 1
