39 THE AVENUE, BALACLAVA

BUILDING CONDITION ASSESSMENT - UPDATE

39 THE AVENUE, BALACLAVA BUILDING CONDITION ASSESSMENT - UPDATE

3 May 2022

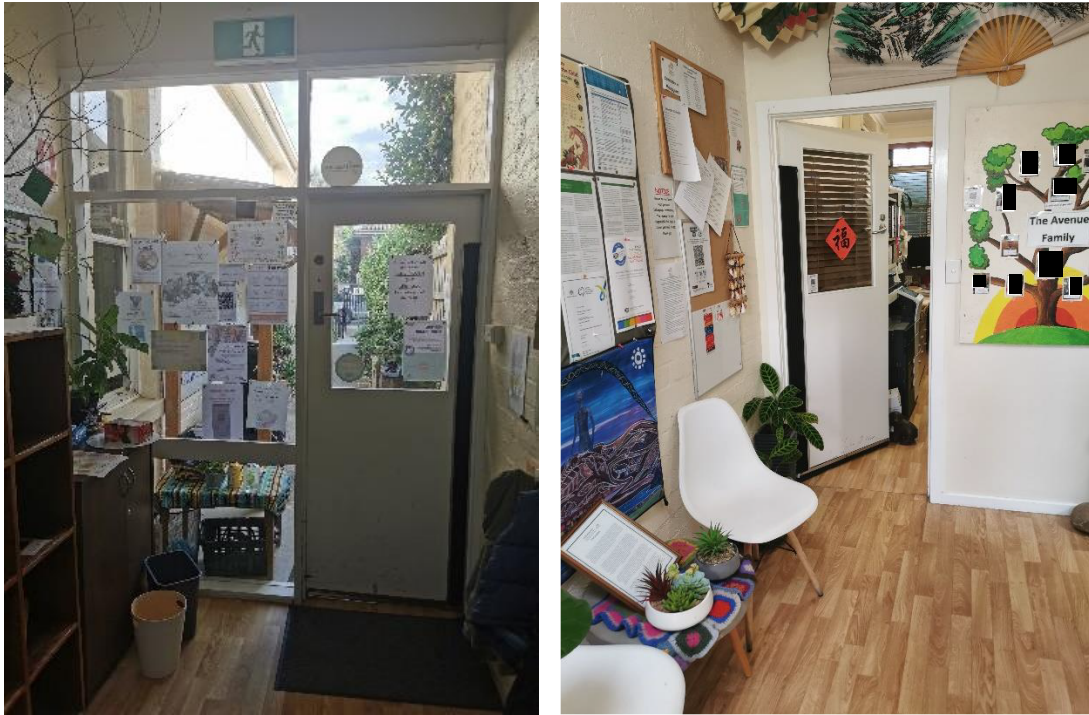
ENTRY HALL

Each of the interior finishes were all found to be in a good condition. There were no trip hazards or un-even finishes to the timber flooring. The building fixtures were a mixture of older and new furniture items, none of which appeared to have any major defective issues. The defibrillator and air purifying unit contained in this area were observed to be in a very good visual condition.

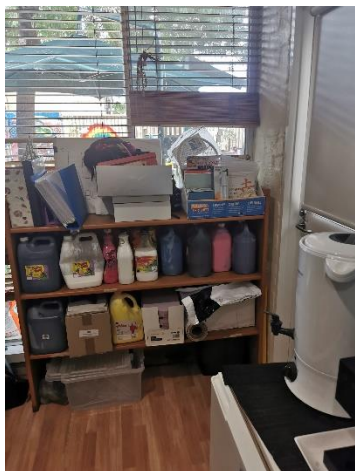
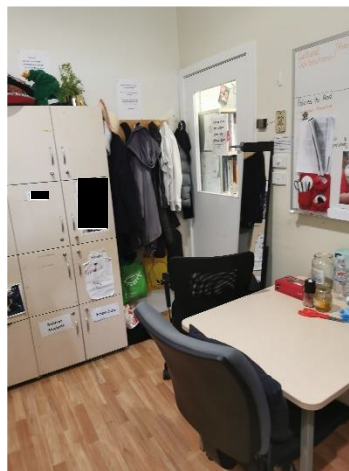
OFFICE ROOM 2

The air conditioning equipment, wall mounted air purifying unit and essential safety measure logbook all appeared to be in a good visual condition. There were no major visual defects evident to the large glass windows and external door. Whilst the furniture was of a variety of ages all furniture appeared to be structurally sound. There was no evidence of roof leaks to the ceilings of both the office rooms.

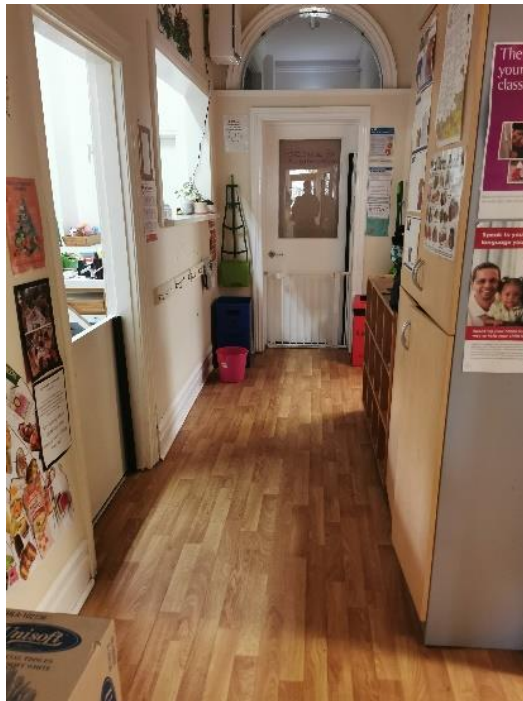
HALL

The internal hall finishes were found in a good condition with no notable observable defects.

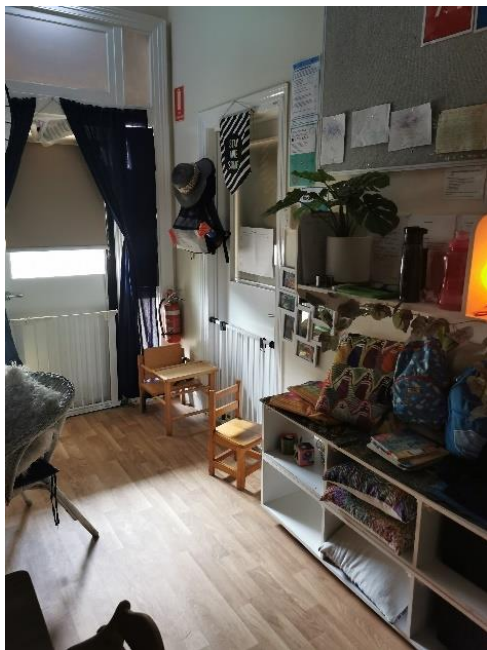
SLEEPING ROOM

All finishes were found to be in good condition with no trip hazards or un-even finishes to the timber flooring. There was no visual evidence of any roof leaks in children playroom or sleeping room's ceilings. The central fireplace to the children's playroom had been decommissioned. The air purifying units were both in a good visual condition in both rooms. Loose furniture was of a variety of aged but all in reasonable condition with no notable major defective items.
