REPORT

ROOF CONDITION ASSESSMENT: 39 THE AVENUE, BALACLAVA, VIC 3183

4 May 2022

for
City of Port Phillip

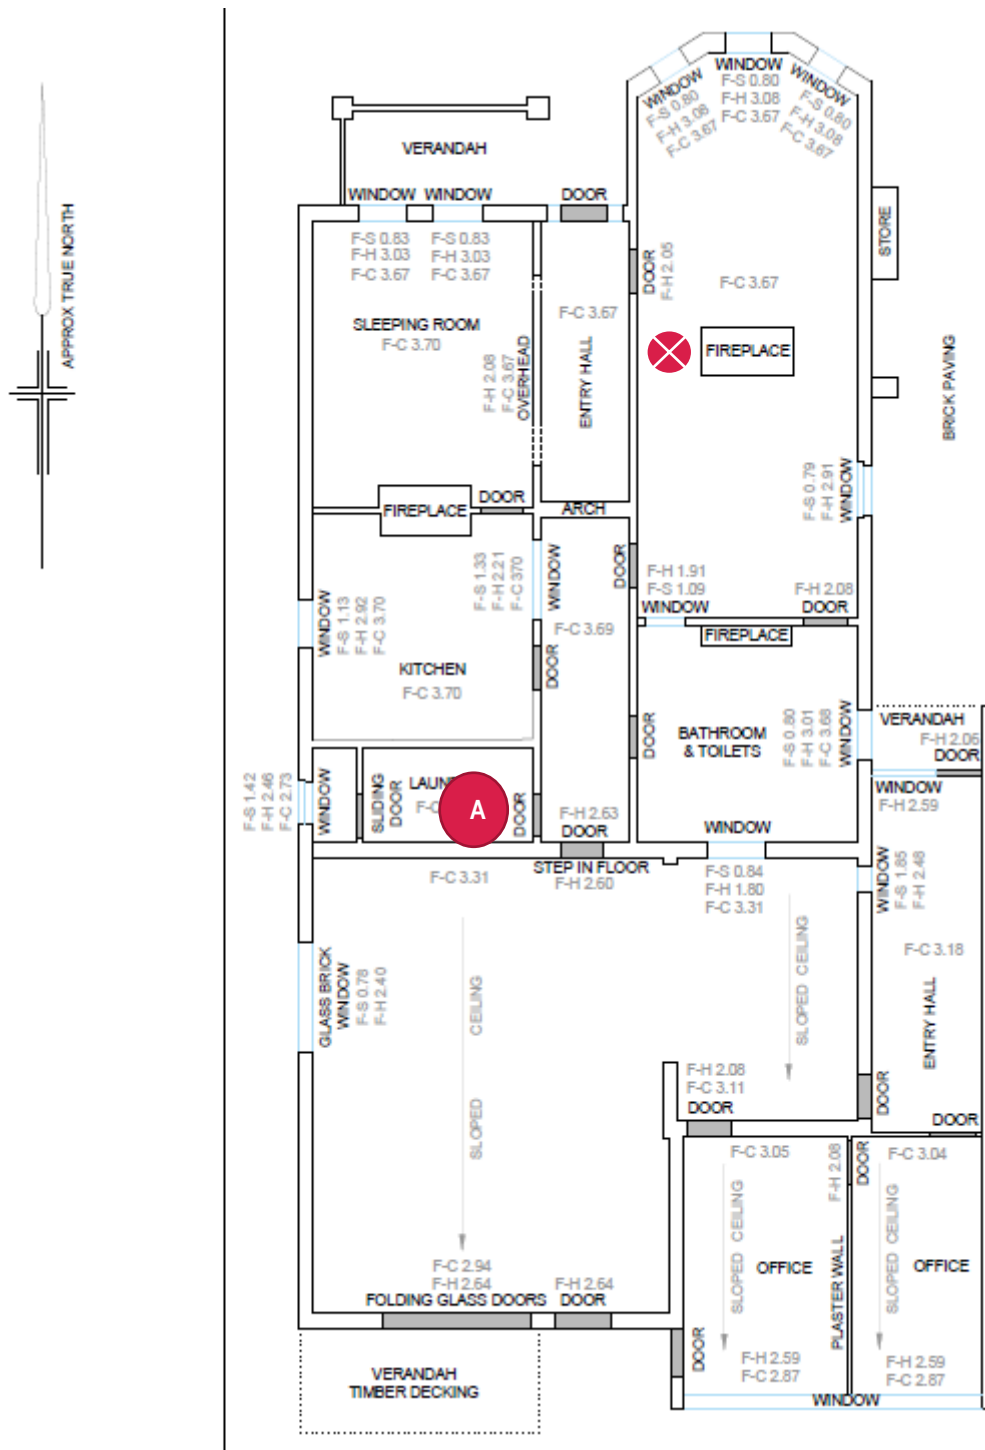
Location of 'previous' leak

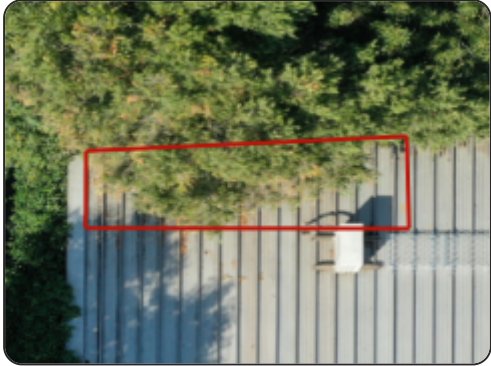
Issue #36

MEDIUM RISK Awaiting Action

Defect	Debris Leaf/Plant Litter
Component	Sheeting - Colorbond
Priority	5
Repair Estimate	\$0.00
Notes	-

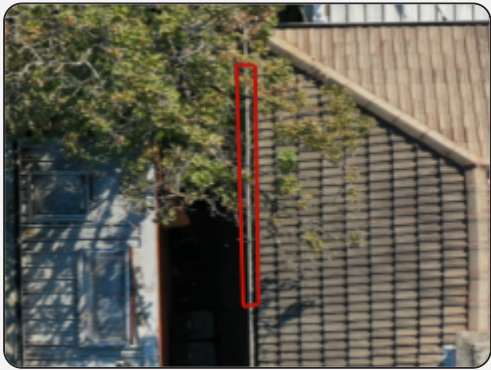
Issue #42

MEDIUM RISK Awaiting Action

Defect	Debris Leaf/Plant Litter
Component	Gutter - Fascia
Priority	5
Repair Estimate	\$0.00
Notes	-

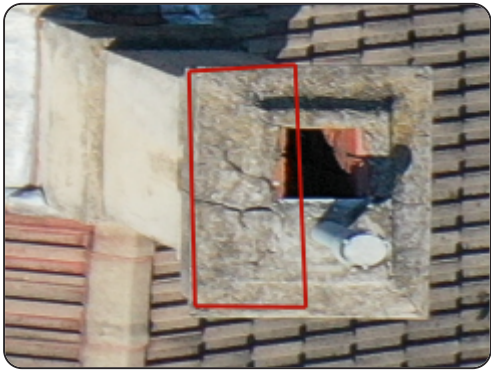
Issue #65

Low Risk Awaiting Action

Defect	Damaged Cracked
Component	Roof
Priority	4
Repair Estimate	\$0.00
Notes	-

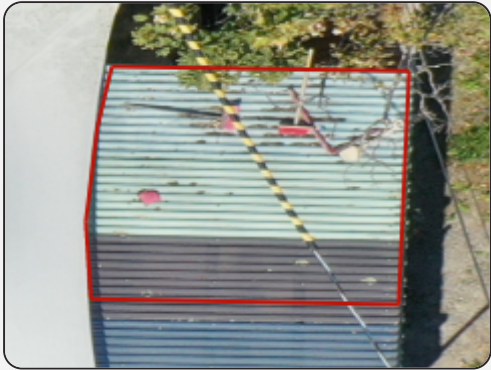
Issue #34

Low Risk Awaiting Action

Defect	Debris Medium
Component	Sheeting - Colorbond
Priority	3
Repair Estimate	\$0.00
Notes	-

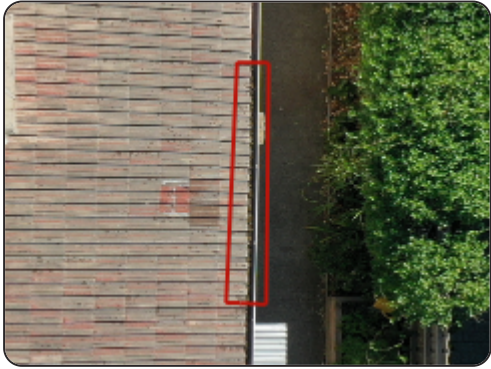
Issue #47

Low Risk Awaiting Action

Defect	Debris Leaf/Plant Litter
Component	Gutter - Fascia
Priority	3
Repair Estimate	\$0.00
Notes	-

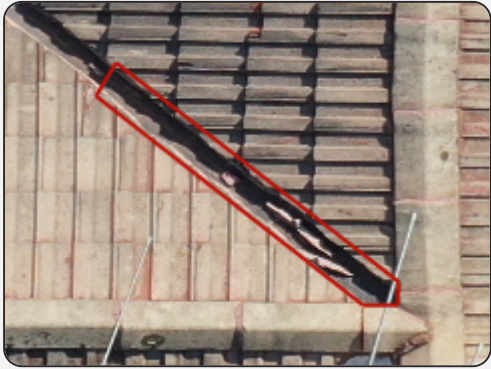
Issue #68

Low Risk Awaiting Action

Defect	Debris Small
Component	Roof
Priority	3
Repair Estimate	\$0.00
Notes	-

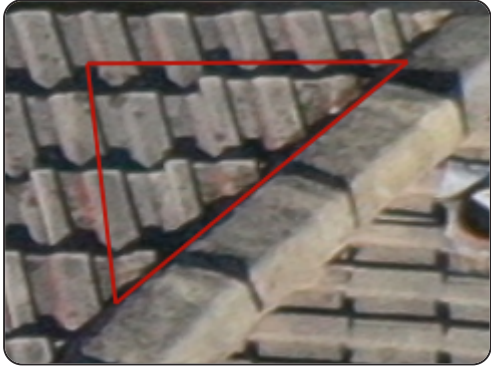
Issue #63

LOW RISK Awaiting Action

Defect	Displaced Alignment
Component	Tile - Concrete
Priority	3
Repair Estimate	\$0.00
Notes	-

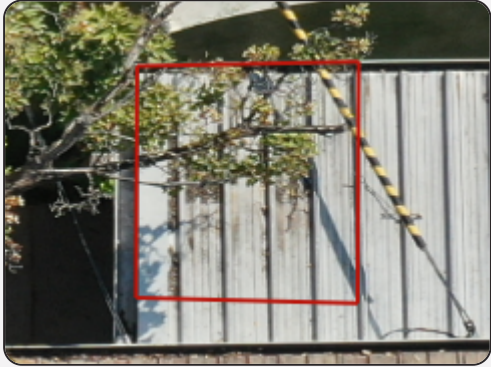
Issue #43

LOW RISK Awaiting Action

Defect	Debris Leaf/Plant Litter
Component	Sheeting - Colorbond
Priority	3
Repair Estimate	\$0.00
Notes	-

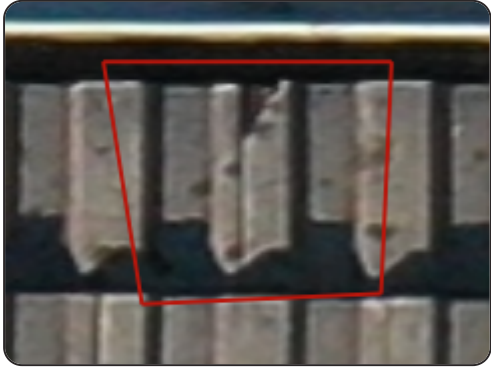
Issue #71

LOW RISK Awaiting Action

Defect	Damaged Cracked
Component	Tile - Concrete
Priority	2
Repair Estimate	\$0.00
Notes	-

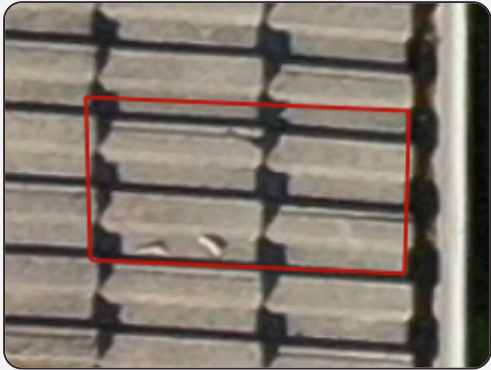
Issue #70

LOW RISK Awaiting Action

Defect	Damaged Cracked
Component	Tile - Concrete
Priority	2
Repair Estimate	\$0.00
Notes	-

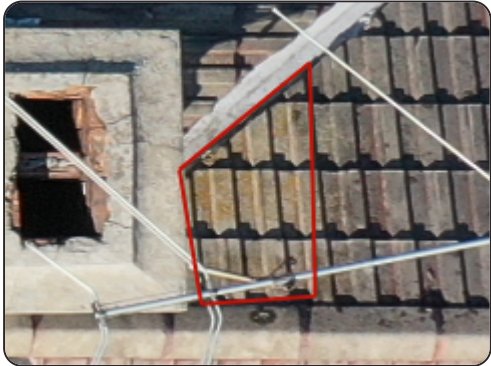
Issue #35

LOW RISK Awaiting Action

Defect	Discolored Staining
Component	Tile - Concrete
Priority	2
Repair Estimate	\$0.00
Notes	-

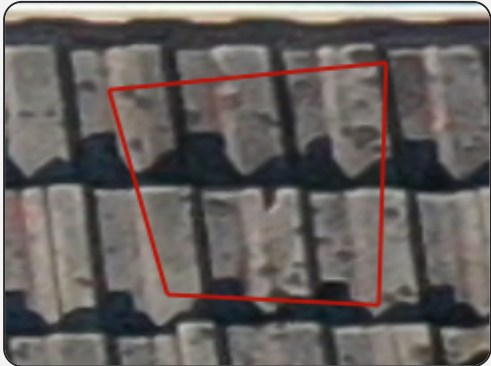
Issue #64

LOW RISK Awaiting Action

Defect	Damaged Cracked
Component	Tile - Concrete
Priority	1
Repair Estimate	\$0.00
Notes	-

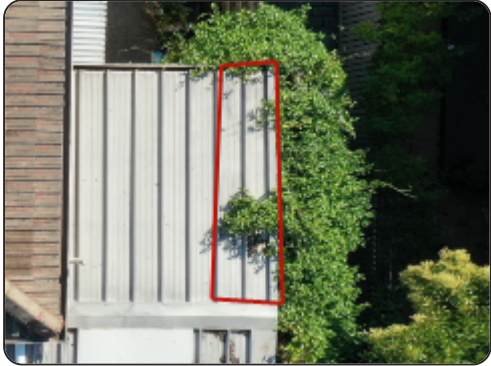
Issue #46

LOW RISK Awaiting Action

Defect	Vegetation Overhanging
Component	Sheeting - Colorbond
Priority	1
Repair Estimate	\$0.00
Notes	-

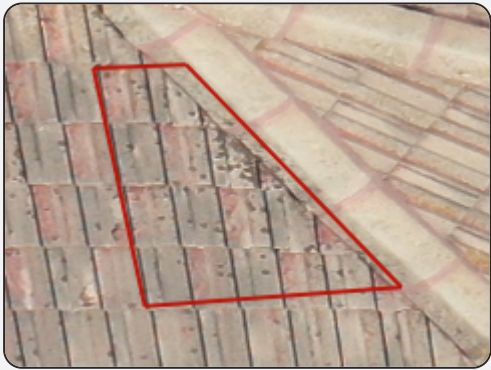
Issue #69

LOW RISK Awaiting Action

Defect	Debris Leaf/Plant Litter
Component	Tile - Concrete
Priority	1
Repair Estimate	\$0.00
Notes	-

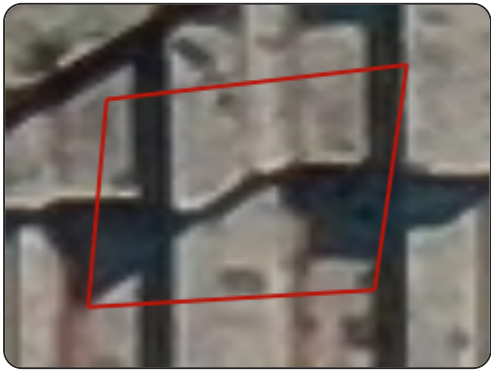
Issue #66

LOW RISK Awaiting Action

Defect	Damaged Cracked
Component	Tile - Concrete
Priority	1
Repair Estimate	\$0.00
Notes	-

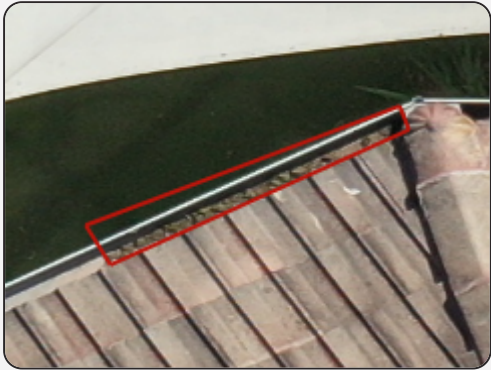
Issue #40

LOW RISK Awaiting Action

Defect	Debris Leaf/Plant Litter
Component	Gutter - Fascia
Priority	1
Repair Estimate	\$0.00
Notes	-

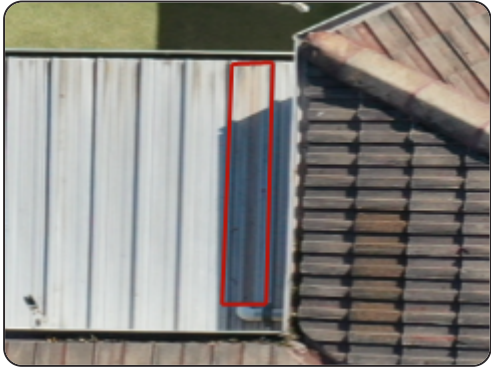
Issue #39

LOW RISK Awaiting Action

Defect	Discolored Water Staining
Component	Sheeting - Colorbond
Priority	1
Repair Estimate	\$0.00
Notes	-

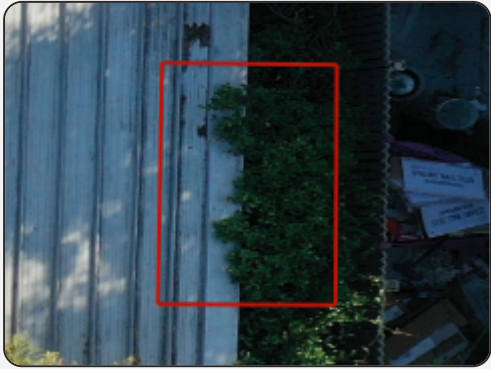
Issue #45

LOW RISK Awaiting Action

Defect	Vegetation Near Edge
Component	Sheeting - Colorbond
Priority	1
Repair Estimate	\$0.00
Notes	-

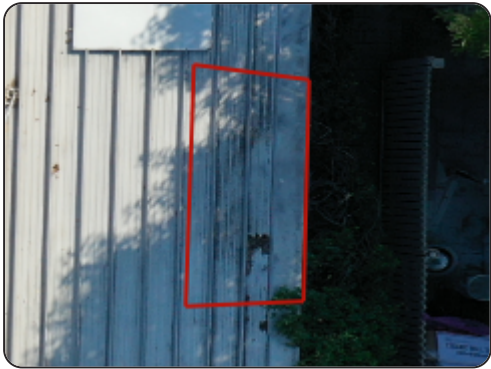
Issue #44

LOW RISK Awaiting Action

Defect	Discolored Dirty
Component	Sheeting - Colorbond
Priority	1
Repair Estimate	\$0.00
Notes	-

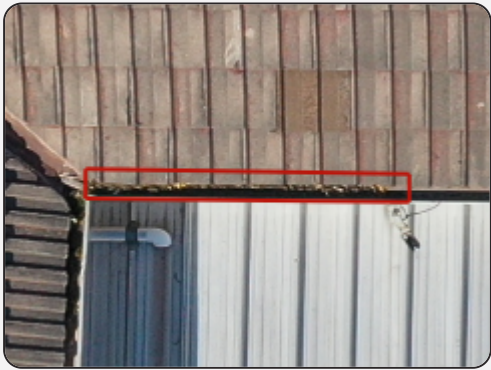
Issue #41

LOW RISK Awaiting Action

Defect	Debris Leaf/Plant Litter
Component	Gutter - Fascia
Priority	1
Repair Estimate	\$0.00
Notes	-

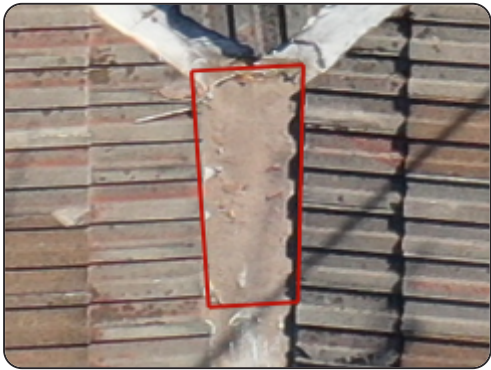
Issue #38

LOW RISK Awaiting Action

Defect	Discolored Dirty
Component	Gutter - Box
Priority	1
Repair Estimate	\$0.00
Notes	-

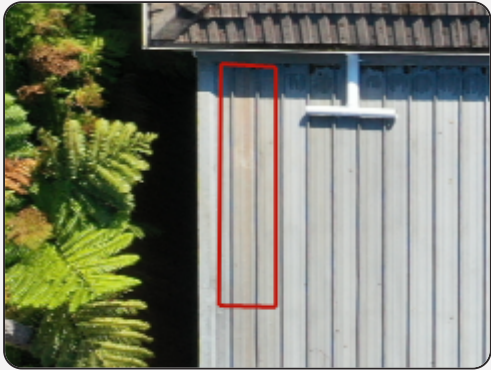
Issue #37

LOW RISK Awaiting Action

Defect	Discolored Water Staining
Component	Sheeting - Colorbond
Priority	1
Repair Estimate	\$0.00
Notes	-

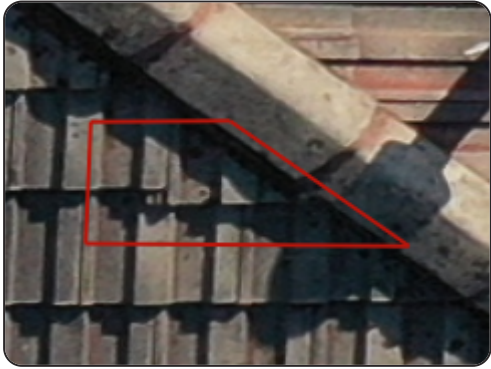
Issue #72

LOW RISK Awaiting Action

Defect	Displaced Alignment
Component	Tile - Concrete
Priority	1
Repair Estimate	\$0.00
Notes	-

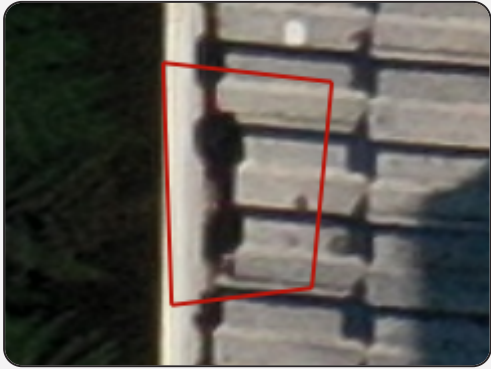
Issue #67

LOW RISK Awaiting Action

Defect	Displaced Alignment
Component	Tile - Concrete
Priority	1
Repair Estimate	\$0.00
Notes	-

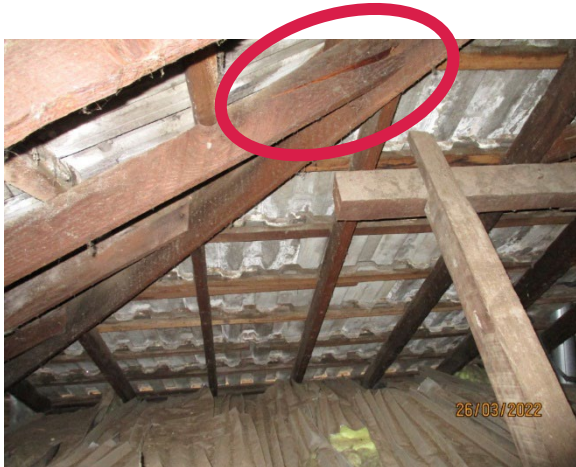
2.00	INTERNAL					
2.01	Roof	General	The main roof appears to be hardwood timber rafters, beams and purlins with concrete interlocking tiles. Limited access was afforded to the roof void via a manhole (Refer Section 8) in Laundry near the main kitchen. The 'new' manhole was installed underneath an eave and was not accessible. There is insulation batts installed between the ceiling joists with a profile aluminium foil and steel decking material over.	Internal roof void inspection was limited to access point A (refer Section 8). No sarking has been installed as a barrier against dust, storms and bushfires in per AS/NZS 4200.2 however foil sheeting has been installed which appears to be an attempt to reflect heat and possibility mitigate any roof leak issues. The space has a high volume of dust and debris. There is some evidence of some water penetration however the extent could not be fully determined. There is also evidence of some tiles being misaligned with evidence of light emitting into some areas from outside which is consistent with the aerial photographs. The insulation batts are not uniformly placed and therefore the thermal comfort would be compromised. There is a split in the rafter which would compromise the structural integrity of the roof in this area (see photo 25), further investigation is advised.	4.0	23 - 30

29: Roof Space (3) Cracked Rafter
