EXPERT REPORT - STRUCTURAL ENGINEERING

Site	17 Eildon Road, St Kilda
Brief	Inspect & Report re: Structural Issues
Our Reference	2211 R1
Client Reference	City of Port Phillip Purchase Order PO20019824
Inspection Date	26 April 2022
Report Date	29 April 2022
Client	City of Port Phillip
Instructor	[REDACTED] Head of Real Estate Portfolio (Development & Transactions)
Author	Patrick Irwin, forensic structural engineer

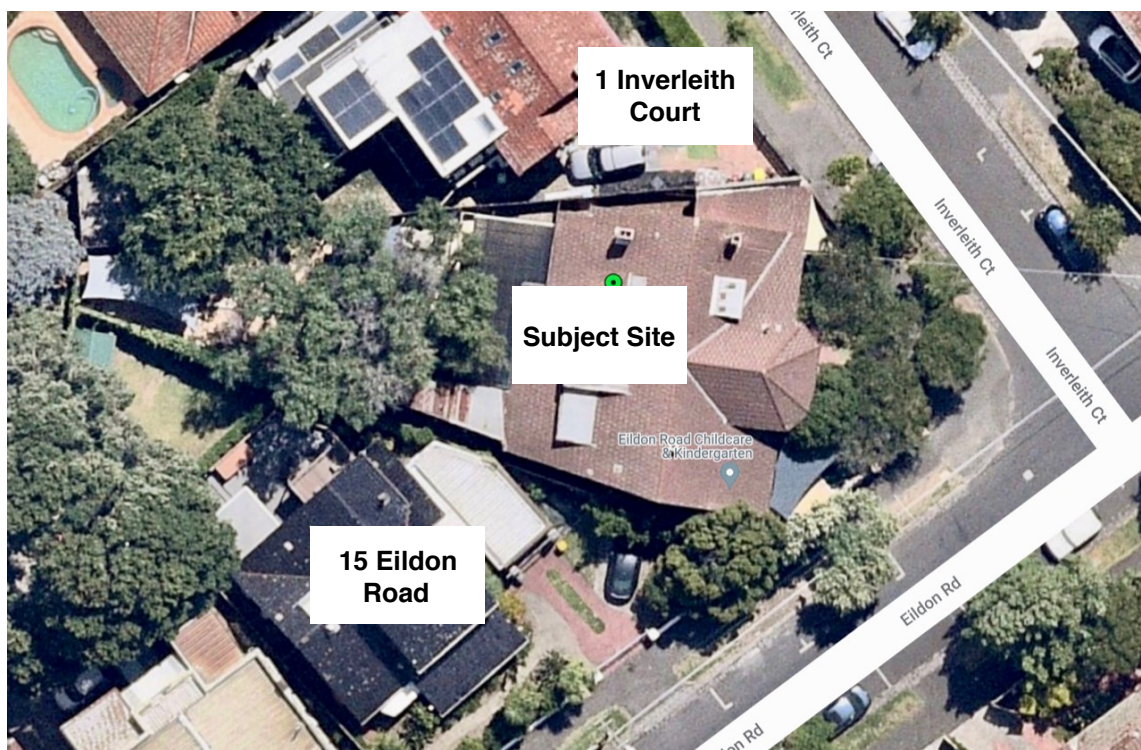
- 4.1. The site and immediate surrounds grade to the north east so there is probably adequate natural surface drainage.
- 4.2. The east end of the site contains a number of trees close to the building. Based on scale, type and size, these are likely foundation drying influences so may cause or exacerbate building movement.

- 4.4. 15 Eildon Road contains a clump of substantial evergreen trees immediately adjacent the south east corner of the building. Based on scale, type and size, these are likely foundation drying influences so may cause or exacerbate building movement..

February 2022 Nearmap image showing trees described above.

- 10.12. The differential movement and footing rotation issues will gradually deteriorate if no action is taken.
- 10.13. The foundation is being influenced by drying from trees within and adjacent the site. If the building is to be preserved, improved or renovated this issue will ultimately require attention. Removal of some trees or isolation via root barriers are likely required.

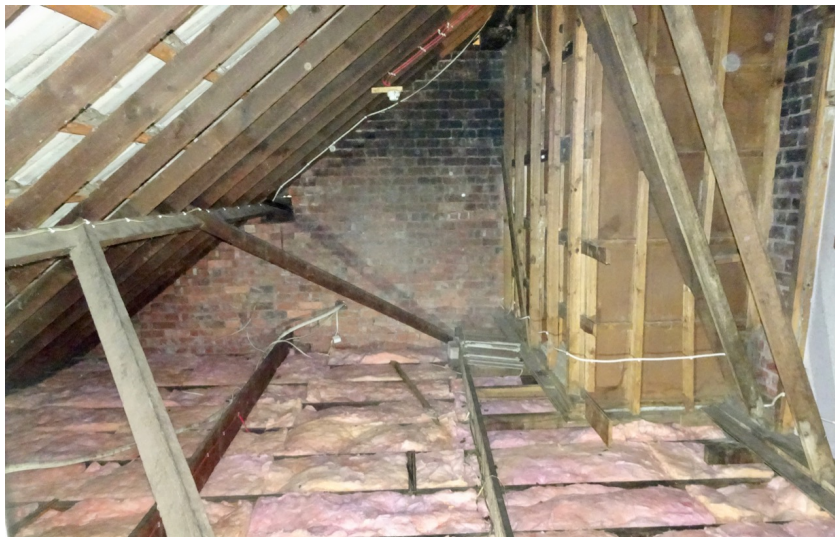
5.2. The view at right looks south to the south gable wall within the roof space.

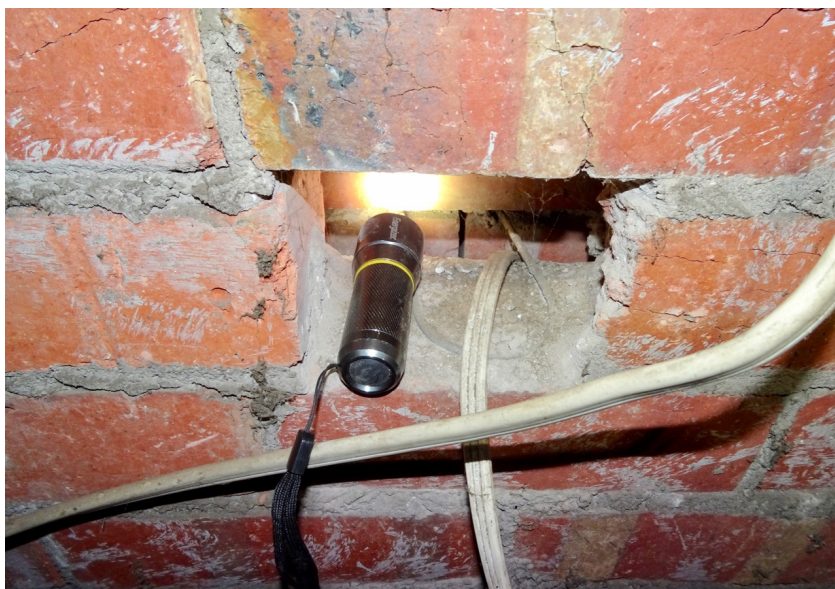
5.3. This view of a pre-existing penetration clearly shows a brick tie on the mortar bed under the electrical cable.

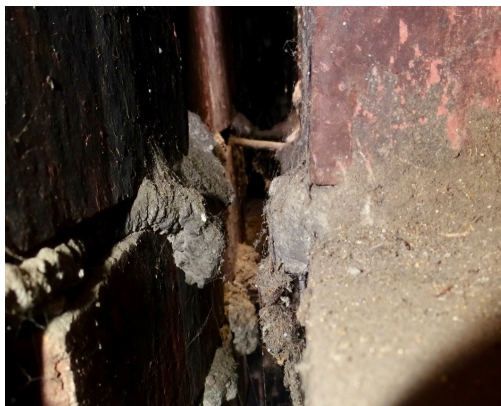
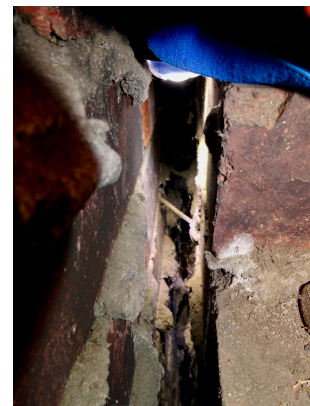
5.4. These detail views within the cavity show un-corroded galvanised wire brick ties. Image quality was compromised by lighting and the constraints of photographing within the cavity but the findings are clear.

10.1.1. All ties observed are sound. There are no signs of corrosion or related deterioration and the general environment does not suggest this is likely in the upper parts of the walls. Lower parts were not examined but are much less critical. The surveyed profiles of the walls confirm some outward rotation but this is not sufficient to load brick ties.

10.1.2. Remedial works are not required.

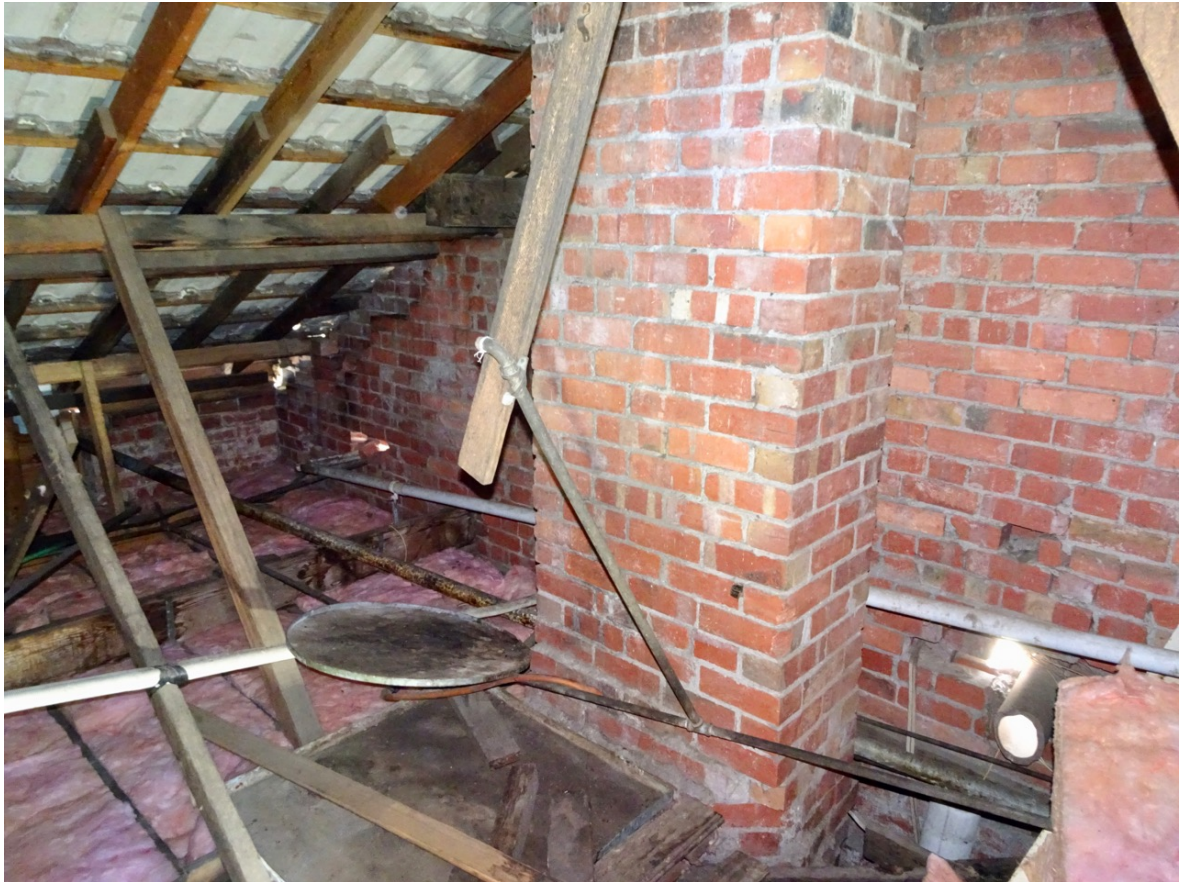
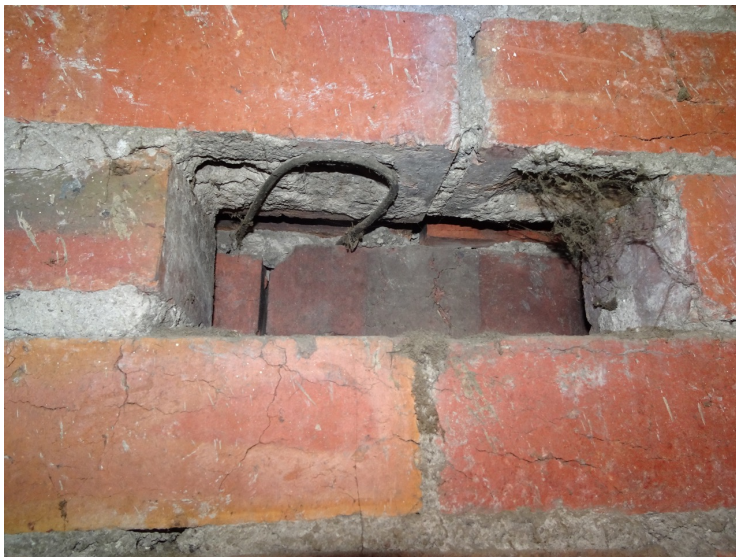
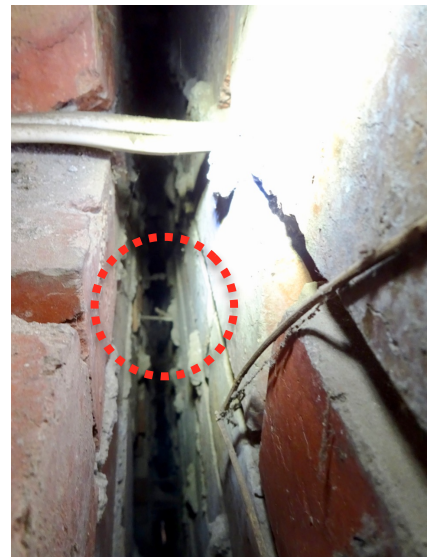
- 5.5. The view immediately below looks north west towards the north gable from within the roof space. The view at left far below shows an un-corroded wire tie exposed with the pre-existing penetration and the view at right far below looks down the cavity showing an un-corroded tie (ringed).

- 5.6. Both gable cavities are open at the top within the roof space. This give them ventilation and will have assisted the provision of an un-corrosive environment.
- 5.7. Since the gable walls are much the most sensitive to the need for brick ties we did not investigate further.

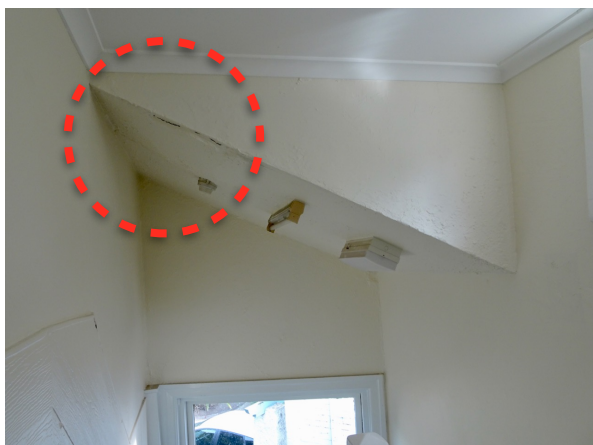
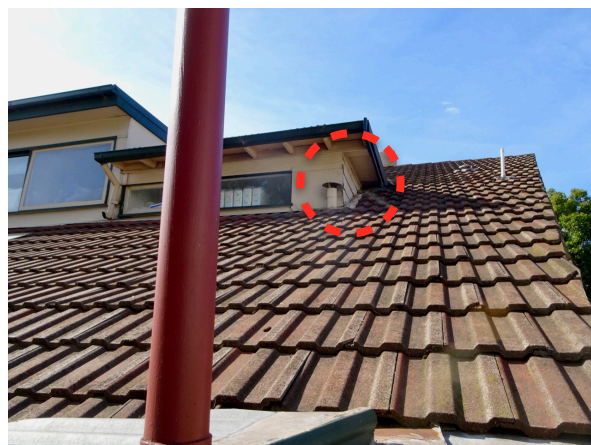
- 6.1. The concern is that this crack to the bulkhead plasterwork over the rear (south west) stair. The view at left below faces south and that right below faces east. The area of concern is ringed.

- 6.2. There is no reason to suppose this is a structural mechanism. The bulkhead will be framed off a rafter which only spans the width of the stairwell so is very lightly stressed.

This is not structural and no remedial works are required for structural reasons. Finishes may be repaired as and if required.

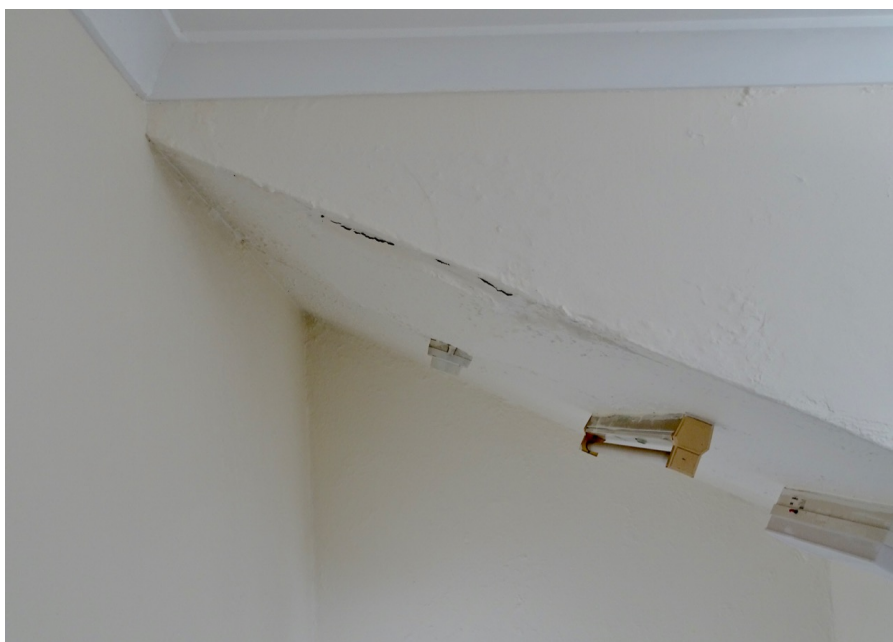
- 6.3. Close examination shows a high level of irregularity in the plasterwork, which has a stucco surface profile, and previous repair works. It looks likely that there has been a leak here at some stage and repairs have not soundly re-established the edge joint.

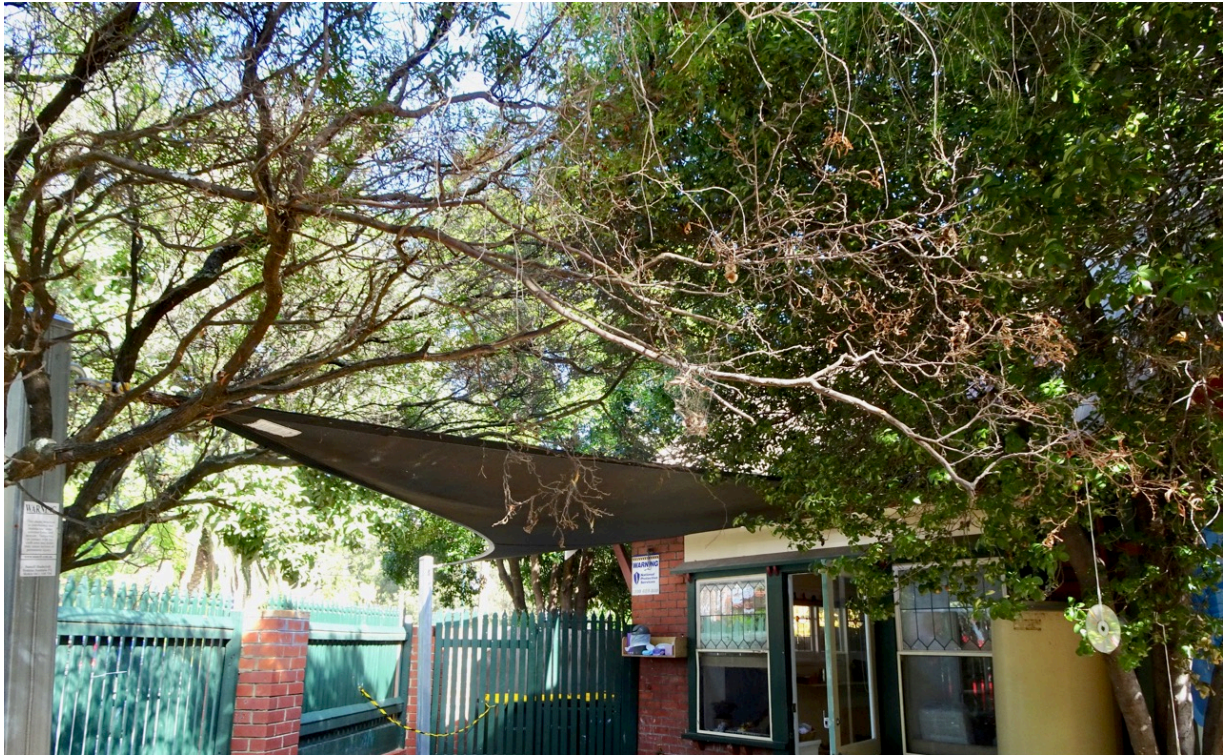
7.2. **The southern sail is shown below.**

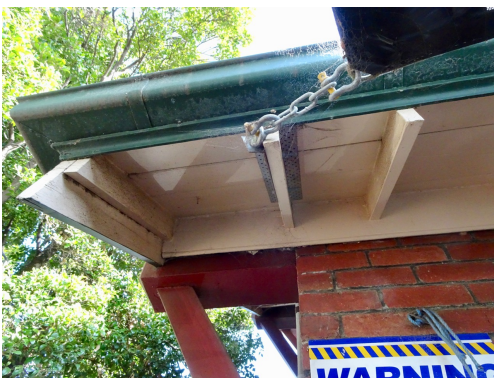
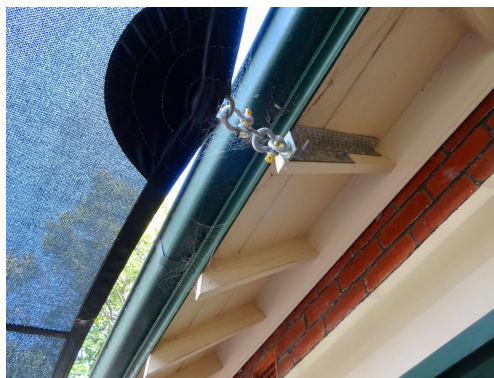
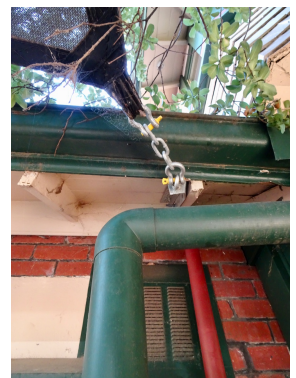
7.3. It is fixed to rafter ends with bolted brackets at three points. These are shown from south to north (left to right) below. In each case the direction of load is not parallel to the rafter so a lateral load is being imparted to the raft tip. In the northern case (rhs below), the bracket can be seen bending away from the rafter.

7.4. The fixings will not fail but they are poorly configured and do not present as having been engineered. Damage to rafters and further deformation of fixings may occur.

7.5. The other issue with this is that there is very little opportunity for fixings to yield and absorb wind loads. Longer fixings of flexible lines are more appropriate for this reason.

10.3.1. The manner in which rafter ends are loaded is inappropriate and is leading to some deformation of fixings. The fixing at the extreme south east corner is into a timber that may not be sufficiently sound. Fixing types, being high stiffness metals, are not ideal.

10.3.3. All fixings should be replaced with an appropriately engineered system in three to five years.

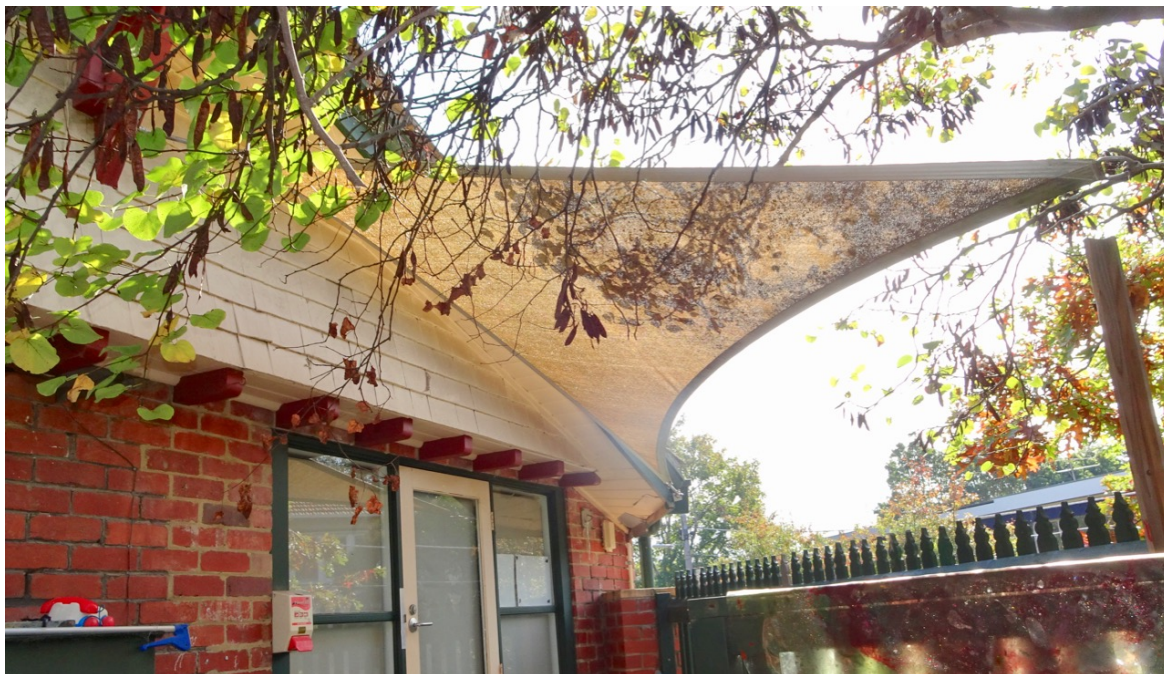
7.6. The northern sail is shown below.

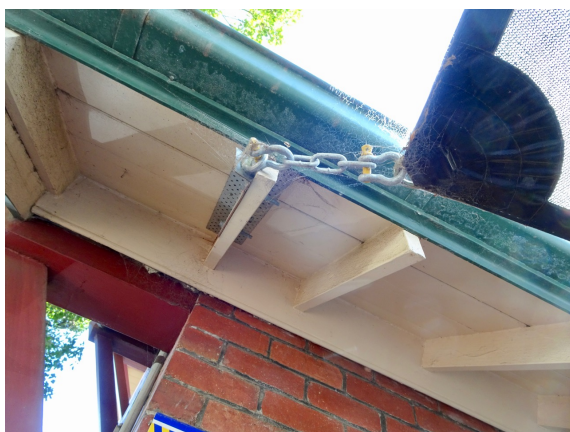
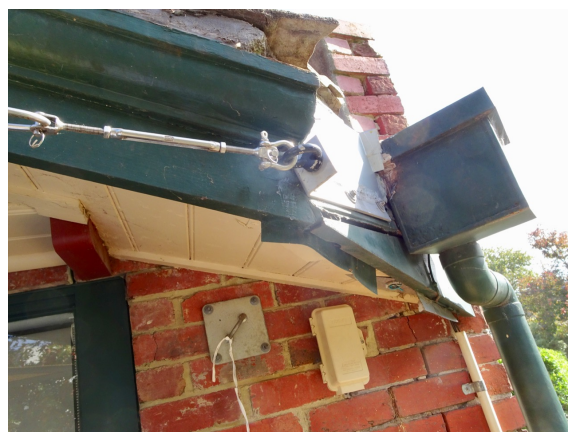
7.7. The southern fixing is shown below left and similar comments to above apply regarding integrity of fixing.

7.8. The northern fixing is shown below right. It is fixed through what appears to be a fascia board and, without destructive investigation, we cannot be sure that it is fixed soundly to rafters. Note also, immediately below the eaves soffit what appears to be a previous fixing. This is fixed to the outer skin of the brickwork which will not have been adequate.

7.9. The fixings may not fail but they are poorly arranged and do not present as having been engineered. Damage to rafters and further deformation of fixings may occur.

7.10. As for the southern case, the other issue with this is that there is very little opportunity for fixings to yield and absorb wind loads. Longer fixings of flexible lines are more appropriate for this reason.

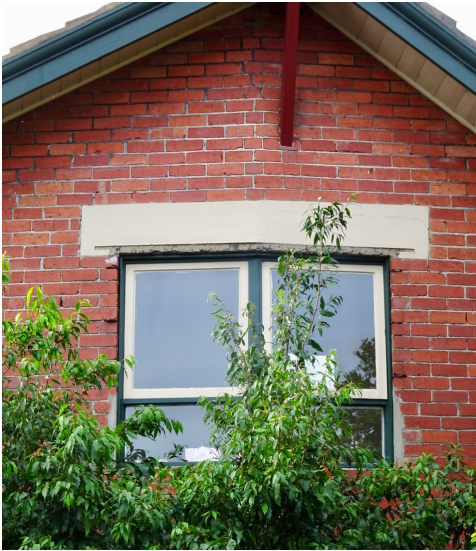
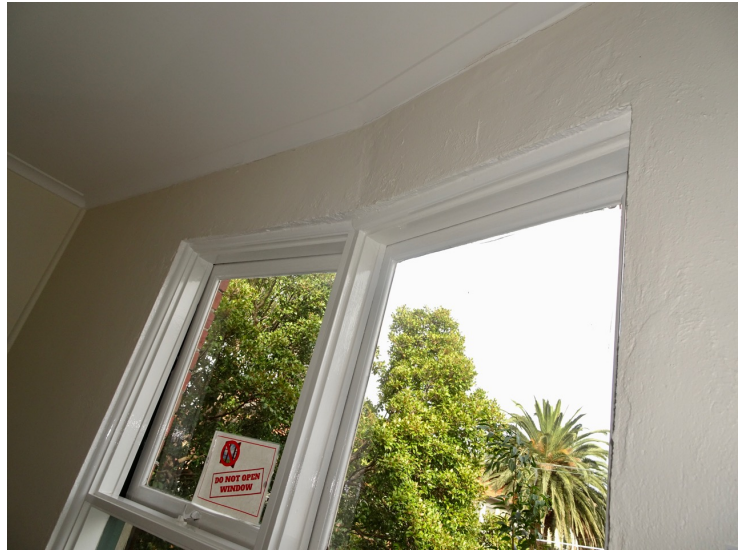
- 8.1. The concern is the structural condition of this first floor south elevation reinforced concrete window head lintel. It has the unusual characteristic of being cranked horizontally and is seen from outside and from within below.

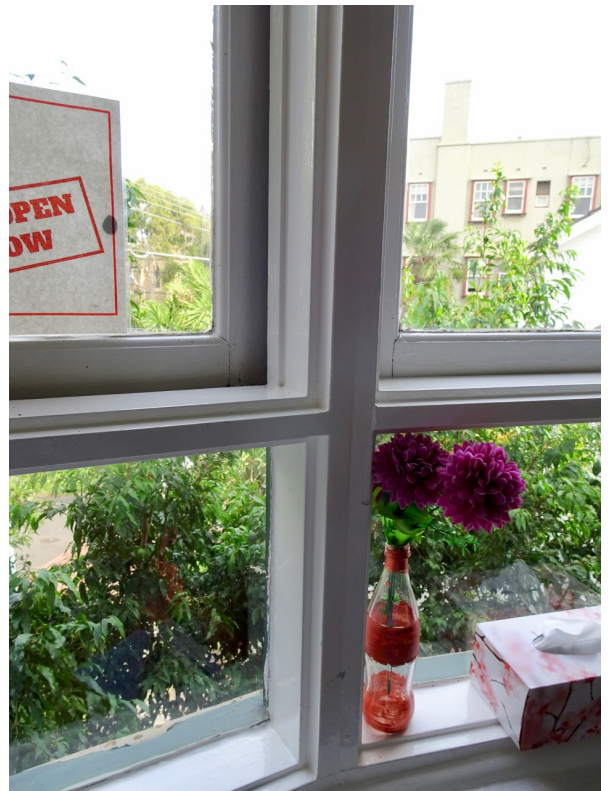
- 8.2. We first investigated whether the lintel was effectively supported mid span, at its most eccentric position. The surrounding window frames and linings are timber. There is just room for a very small section steel column between the window frames. We drilled a small investigation hole through from with the window frame and did not strike steel. Timber is never used to support reinforced concrete in such cases and would be ineffective due to shrinkage. Thus we are satisfied that the lintel is both spanning and resisting the eccentric loads from the brickwork. This means it is acting in torsion. The torsional moment is very low but is likely to be well beyond the capacity of the brickwork to arch. Many such conventional small brickwork openings can persist with deficient lintels due to brickwork arching. This is not such a case.

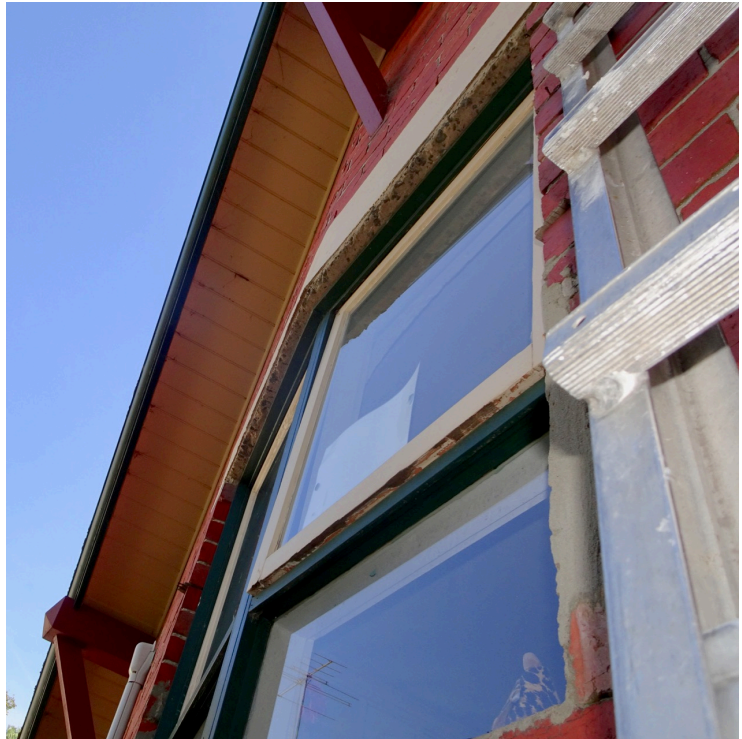
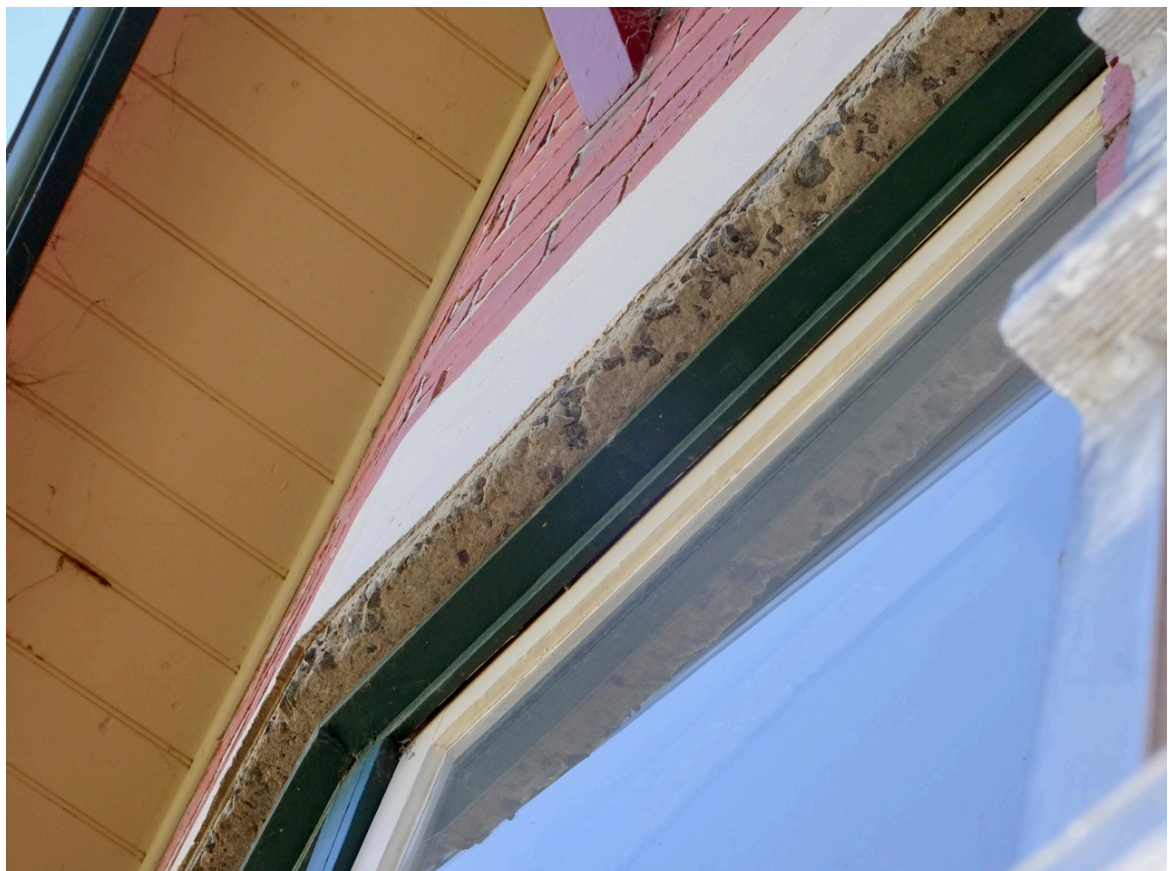
8.3. We viewed the lintel externally off a ladder and obtained the views below. Minor spalling has occurred at the lower outside edge which appears to have been scabbled. There is no sign of reinforcement and no sign of corrosion of reinforcement, usually evidenced by iron oxide stains.

8.4. The loss of a small amount of concrete below the reinforcement in this manner will not effect the structural capacity of the lintel measurable. It will compromise cover and thus corrosion protection of the reinforcement but, if this has occurred, it has not caused a significant issue yet as evidenced by the lack of corrosion product.

8.5. The issue requires attention to better protect the lintel but it is not structurally compromised in its current condition.

10.5. This is structurally sound having only suffered minor spalling of the outer lower edge of the lintel. Cover to reinforcement may be compromised.

10.6. Remedial works are recommended in the medium term to maintain integrity and appearance. These should consist of breaking away all loose material and repairing with an appropriate cementitious repair mortar.

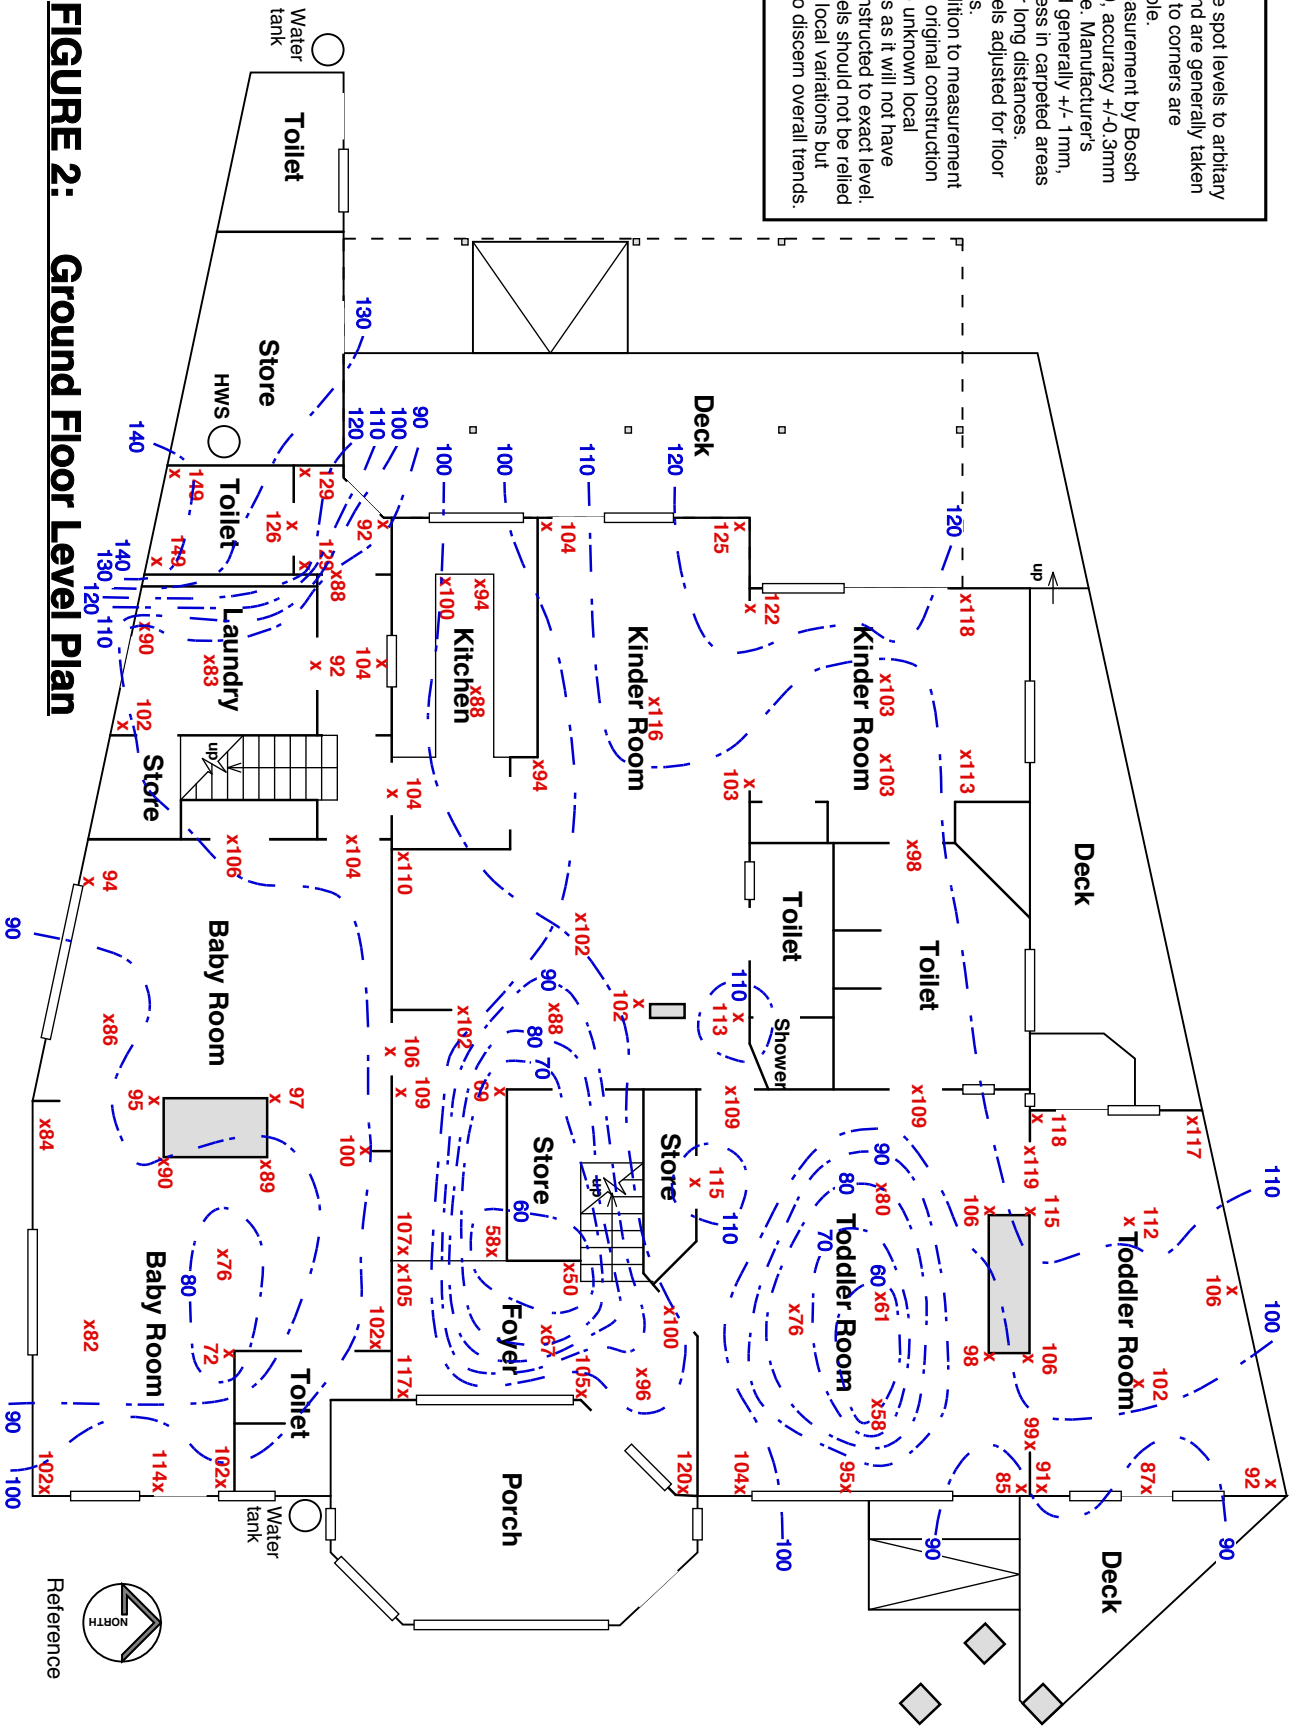
FIGURE 2: Ground Floor Level Plan

- 9.2. On the ground floor the pattern is dominated by two locally low areas, in the toddler room and around the main stairwell and stores. These will be due to stump settlement.

- 9.3. There is also a general trend of the central areas being low. This is usual for timber floored houses on reactive sites as the foundation dries out more beneath the building than around the perimeter.

- 9.4. The high region at the south side of the toilet may be a deliberate grade to drain. Ignoring this, the difference from highest to lowest levels around the perimeter is about 45mm which is not severe.

10.8. Internal floors have suffered significant movement and are noticeably irregular. Although stumps have not been examined there is evidence of a prior damp issue and, given the age of the building, stumps and/or soleplates will be deteriorated. In the medium term it should be assumed that the building requires re-stumping. This will likely require access through the floor and replacement of most flooring and some works to the frame so the scope will be significant. Considering the findings of Mark Hodgkinson Pty Ltd [2.3], it is likely that the frame will require replacement.

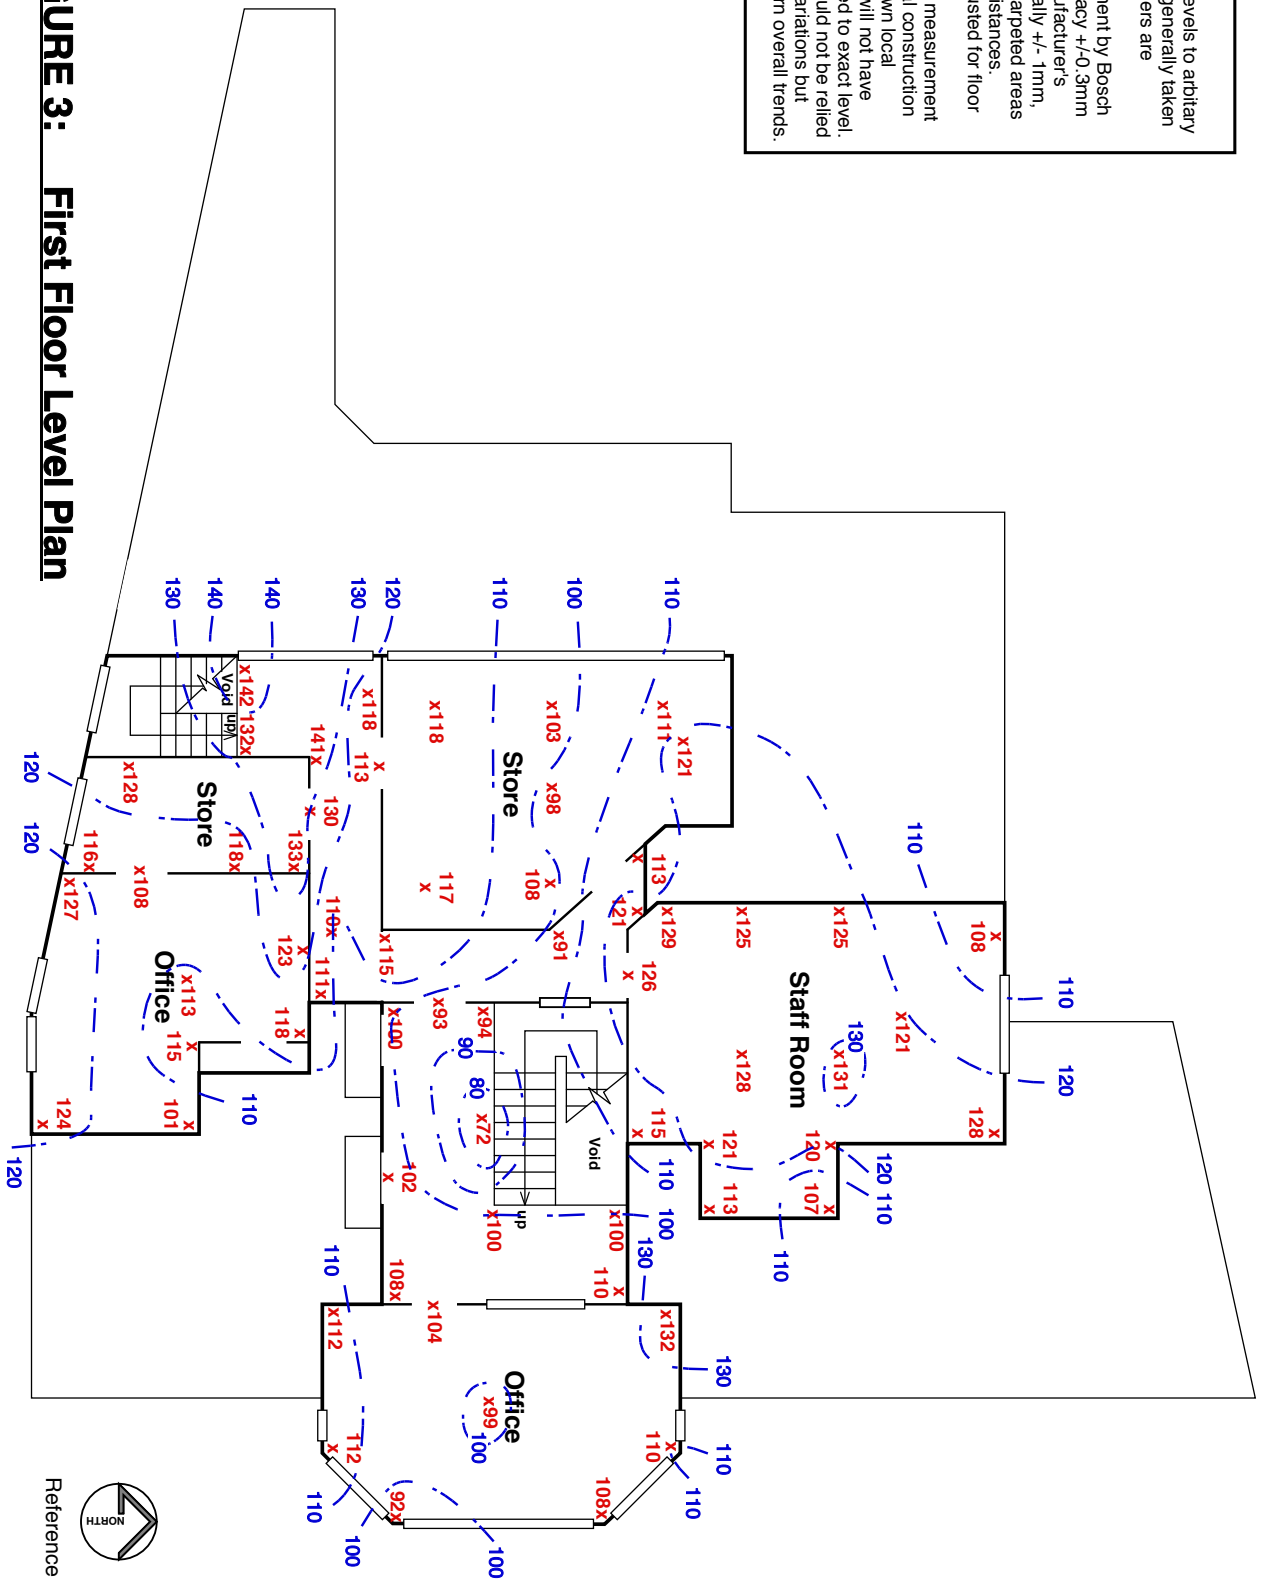
FIGURE 3: First Floor Level Plan

- 9.5. The first floor levels do not tell us much about perimeter levels and were recorded mainly to check for first floor frame settlement as the performance of long span timbers in buildings of this age and type is commonly an issue. The low region about the stair is reflected from downstairs. Otherwise there are other internal low points that one would expect from a timber frame of this age and type. For example, centres of the office and the larger store room being low.
