SITE INSPECTION REPORT

Attention:	██████████	Date:	9/05/2022
Company:	City of Port Phillip		
Phone Number:		Inspection Date:	27/04/2022
Email Address:	██████████@portphillip.vic.gov.au		
Site Address:	39 The Avenue, Balaclava		
Job Number:	187501 PRJ725471	Client Reference:	
Instruction Description:	Structural Remediation of Roof Rafter

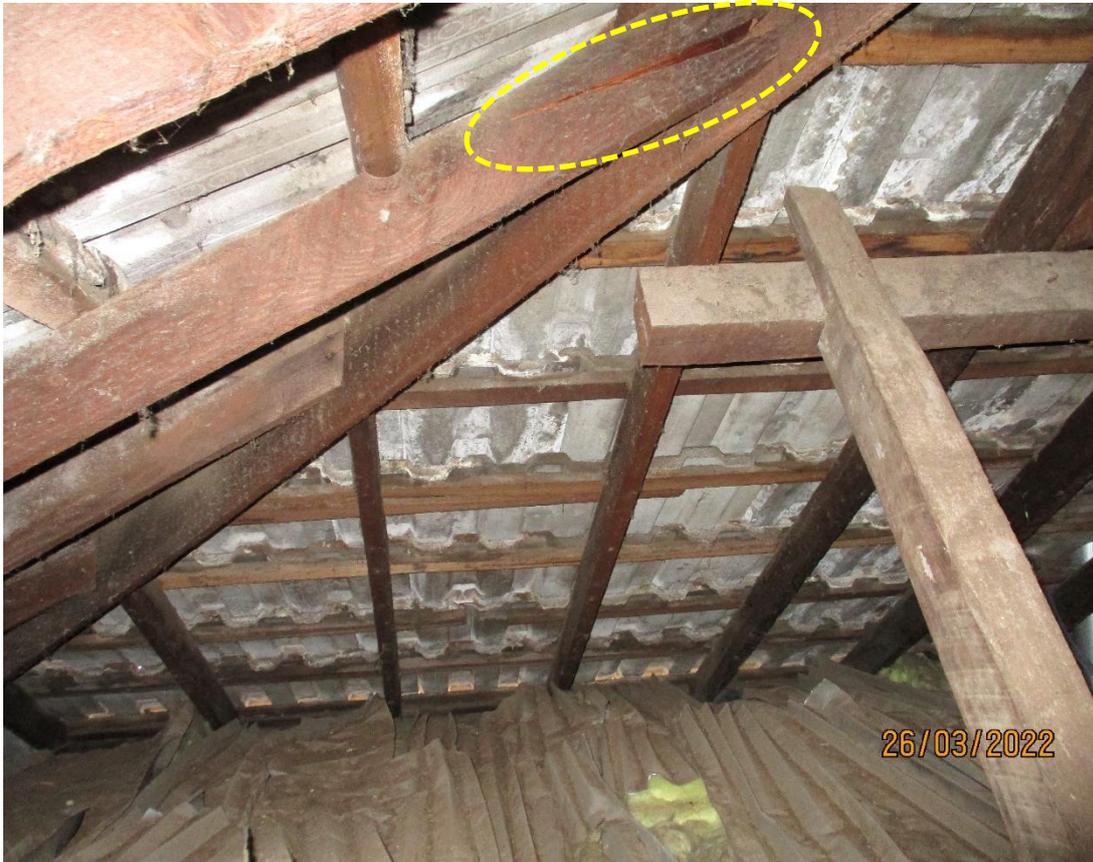
A structural matter of concern was identified in the RZ Report, which involves a damaged roof rafter, which has split (refer to Figure 1). Item 2.01 of the Schedule of Condition on page 12 of the RZ Reports states, *“There is a split in the rafter which would compromise the structural integrity of the roof in this area (see photo 25), further investigation is required”*. [Note that the photograph referenced in the RZ Report should be photograph 29 and not photograph 25]. There is also another split rafter visible in Photograph 30 (refer to Figure 2). The precise locations of the two split rafters are unknown, however it is understood to be at the south end of the roof space, based on subsequent information received from Redd Zebra.

Figure 1. Photograph 29 excerpted from the RZ Report, indicates a split in a timber rafter no.1.

Notwithstanding that the split rafters was not observed, review of photograph 29 and 30 in the RZ Report is deemed sufficient for the purposes of this report. Photographs 29 and 30 indicate that remediation of the split rafters is required and that a practical method of remediation would comprise augmentation of the split rafter. The split rafter shall remain in place and additional rafters at either side of the split rafter shall be installed.

The span of the existing rafters is estimated to be a maximum of 2.5m with a maximum load width of 750mm. Based on these dimensions, it is recommended that both split rafters are augmented with 2 / 140 x 35 MGP10 rafters, one each side of the existing split rafter. The new rafters shall provide support to the roof battens, therefore packing and shaping of the new rafters may be required. The new rafters shall be connected to the hip rafter with suitable angle brackets at the higher ends and shall be supported upon the external wall at the lower ends. The new rafters and the existing split rafters shall be bolted together using M12-4.6/s bolts at 300mm min to 450mm max centres (refer to Figure 2).

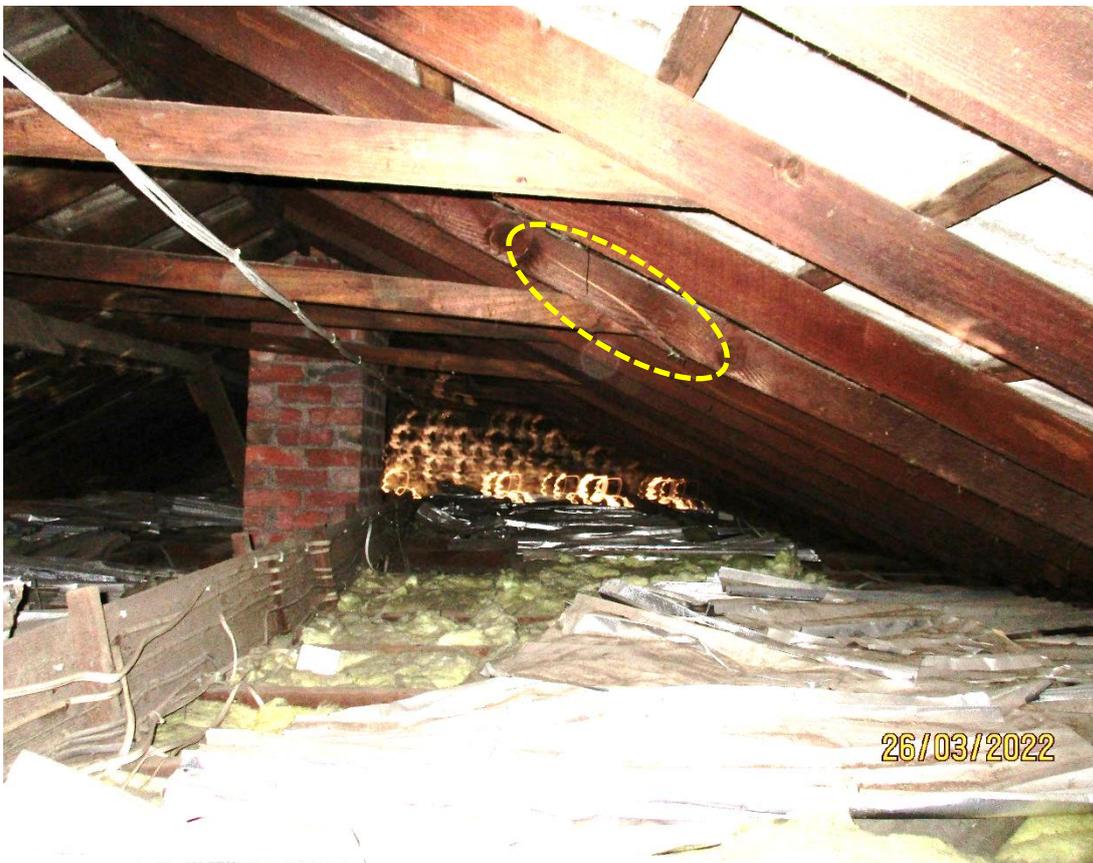
Figure 2. Photograph 30 excerpted from the RZ Report, indicates a split in a timber rafter no.2.

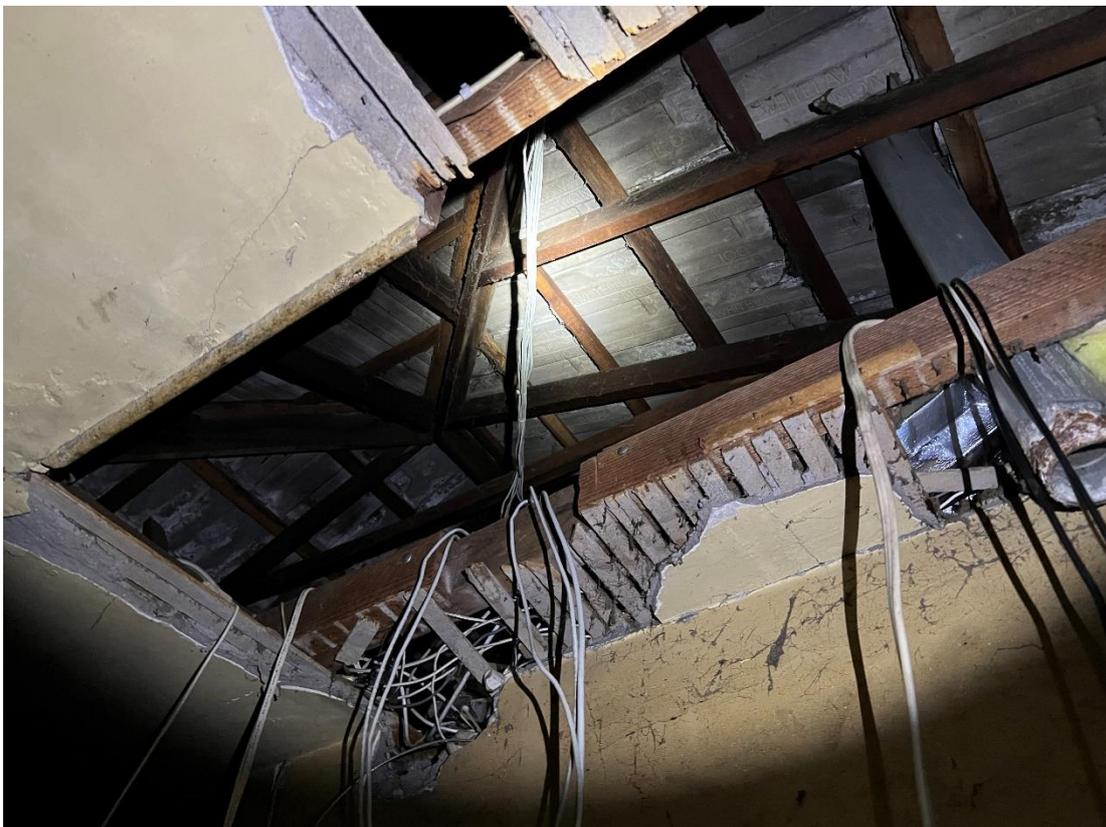
Figure 4. View of roof space from access hatch A.

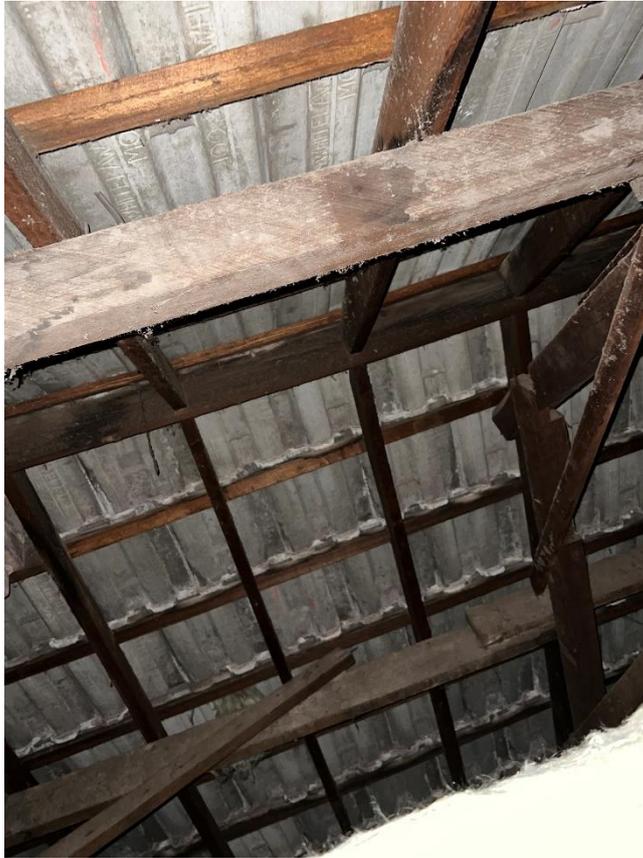
Figure 5. View of roof space from access hatch B.

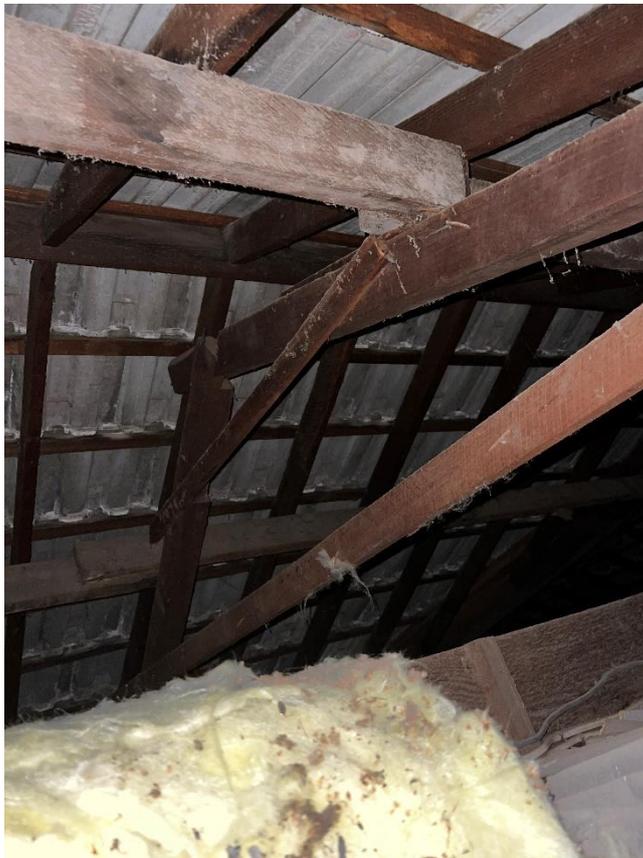
Figure 6. View of roof space from access hatch B.
