46 TENNYSON STREET, ELWOOD

BUILDING CONDITION ASSESSMENT - UPDATE

46 TENNYSON STREET, ELWOOD BUILDING CONDITION ASSESSMENT - UPDATE

2 May 2022

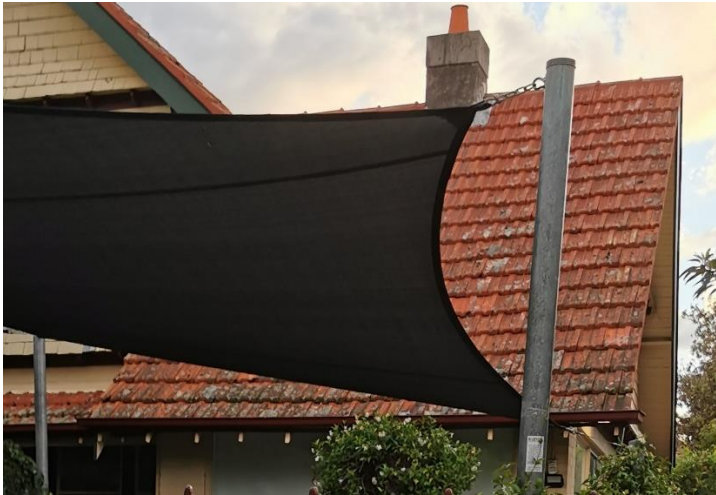
ROOF TILING

The general building structure and façade were all found to be in good condition. WT did not observe any major visual structural defects to the exterior walls and roof of the property. All roof tiles appeared to be in good visual condition with no evidence of any missing or loose tiles. There was minor cracking to the external brickwork around pipework which appeared to be in need of patch repair work.

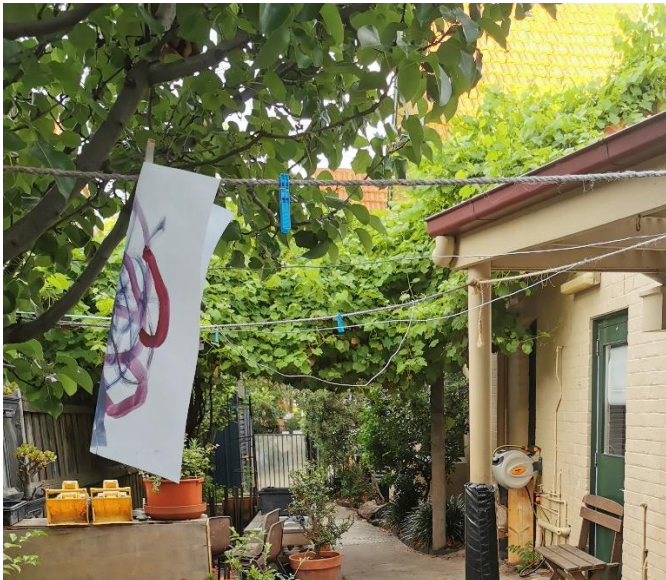
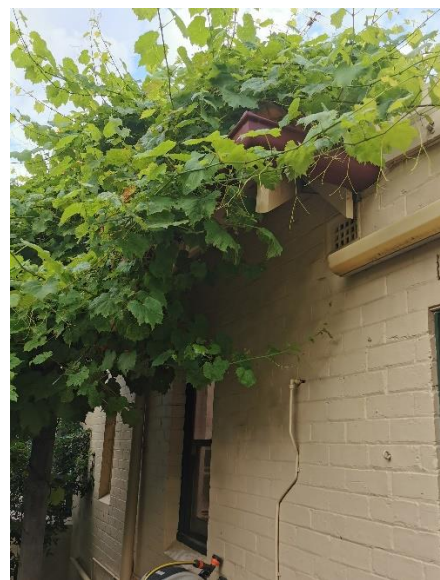
TIMBER VERANDA

The timber veranda roof in the South Yard was notably heavily covered by plant growth.

WT did note that the timber veranda in the South Yard of the building was bearing significant weight from plant growth on the veranda roof. Whilst there were no signs of any structural issues WT recommend that the plant growth and structural integrity of the veranda should be monitored in future going forward.

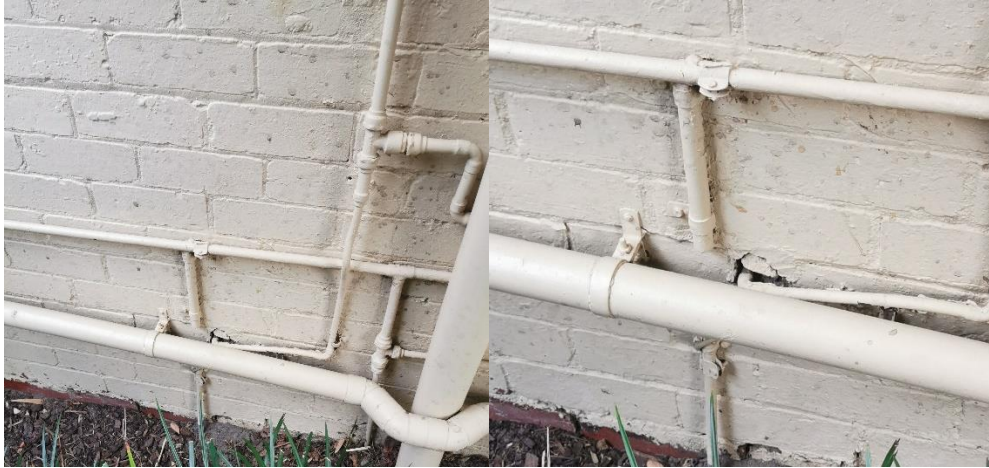
MINOR CRACKING BRICKWORK

Minor cracking to the brickwork in the South Yard was also evident.

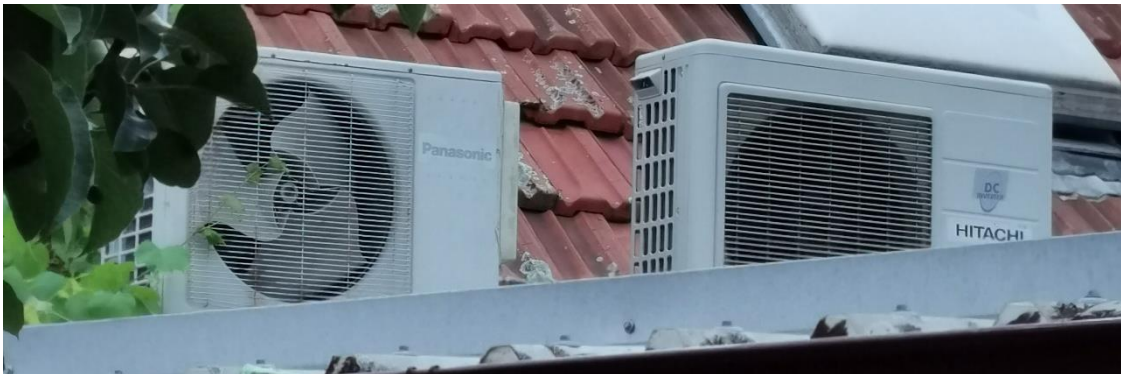
ROOFTOP AC/UNITS

There were two rooftop split air conditioning units which WT were unable to access to assess condition from close range.

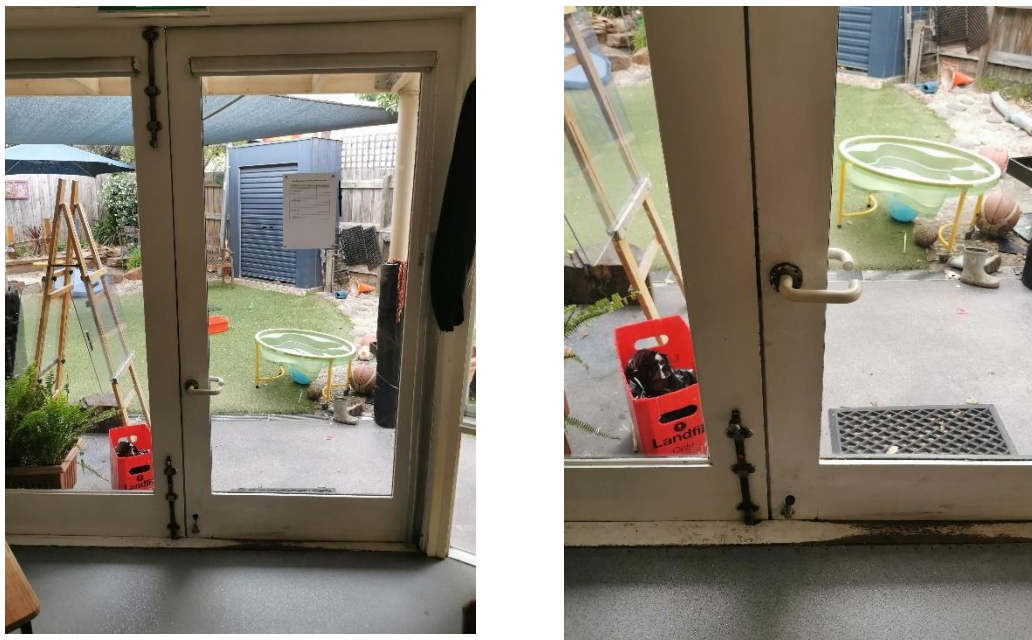
EXTERNAL TIMBER DOUBLE DOORS

The timber double doors providing access to the rear playground were jarred shut and unable to be opened at the time of the site visit by the member of staff on site.

The major defective item of note was the timber double doors providing access to the rear playground. The member of staff on site noted that this issue had been reported for repair. As a key route of egress this issue poses a health and safety risk should the door be inoperable, and it is recommended that further investigation takes place to ensure this issue has been resolved.

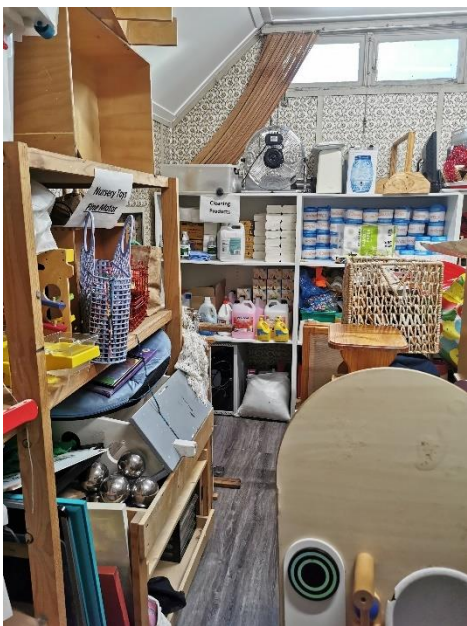
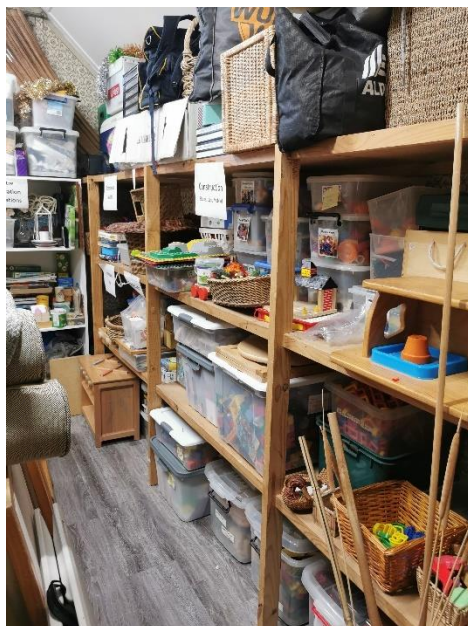
STORE ROOM

Each of the interior finishes in the office space and staff room were found to be in a very good condition. The store room wall finishes were in poor condition but as a back of house area did not pose as a major issue. No visual evidence of roof leak or trip hazard were found in the first-floor areas. All the equipment observed appeared to be in good visual condition.

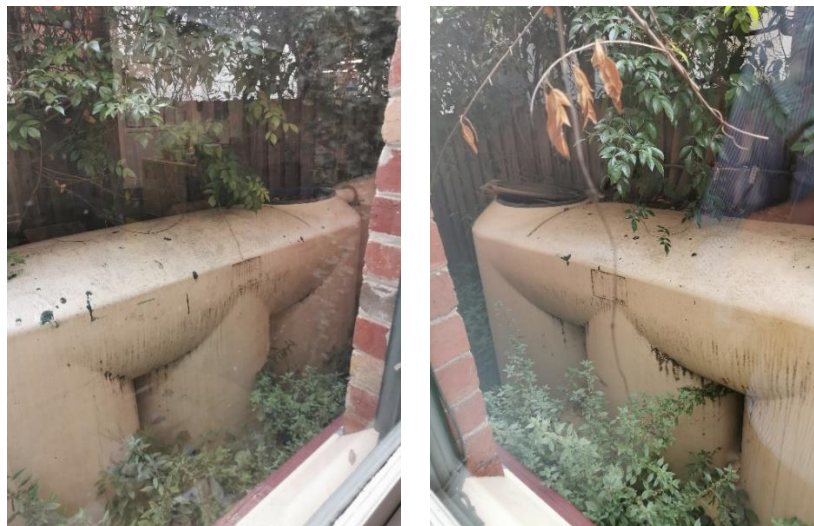
NORTH YARD

The North yard was closed off from access and plants were overgrown in this area. Whilst not accessible from the windows of the kinder playroom two old water tanks that appeared to be out of use were still stored in this area.

The air conditioning units were in good condition, the age of these assets was unable to be determined as the asset name plates were worn. The North yard was inaccessible as a route of access or egress as this area was blocked by two old water tanks. Site entry gates were all in good condition with working intercom. All drainpipes and guttering appeared to be in good condition, as the weather had been dry at the time of inspection there was no means of identifying any defective issues relating to the assets performance in wet weather.
