PROJECT: EILDON ROAD
CHILDCARE
ADDRESS: 17 EILDON RD, ST KILDA

TITLE: DDA UPGRADES -
EXISTING

FEASIBILITY REPORT

project **CoPP Eildon Road Childcare**
site 17 Eildon Road StKilda
client City of Port Phillip
date 7 Jan 2022
Job No: 202134
Site Area n/a

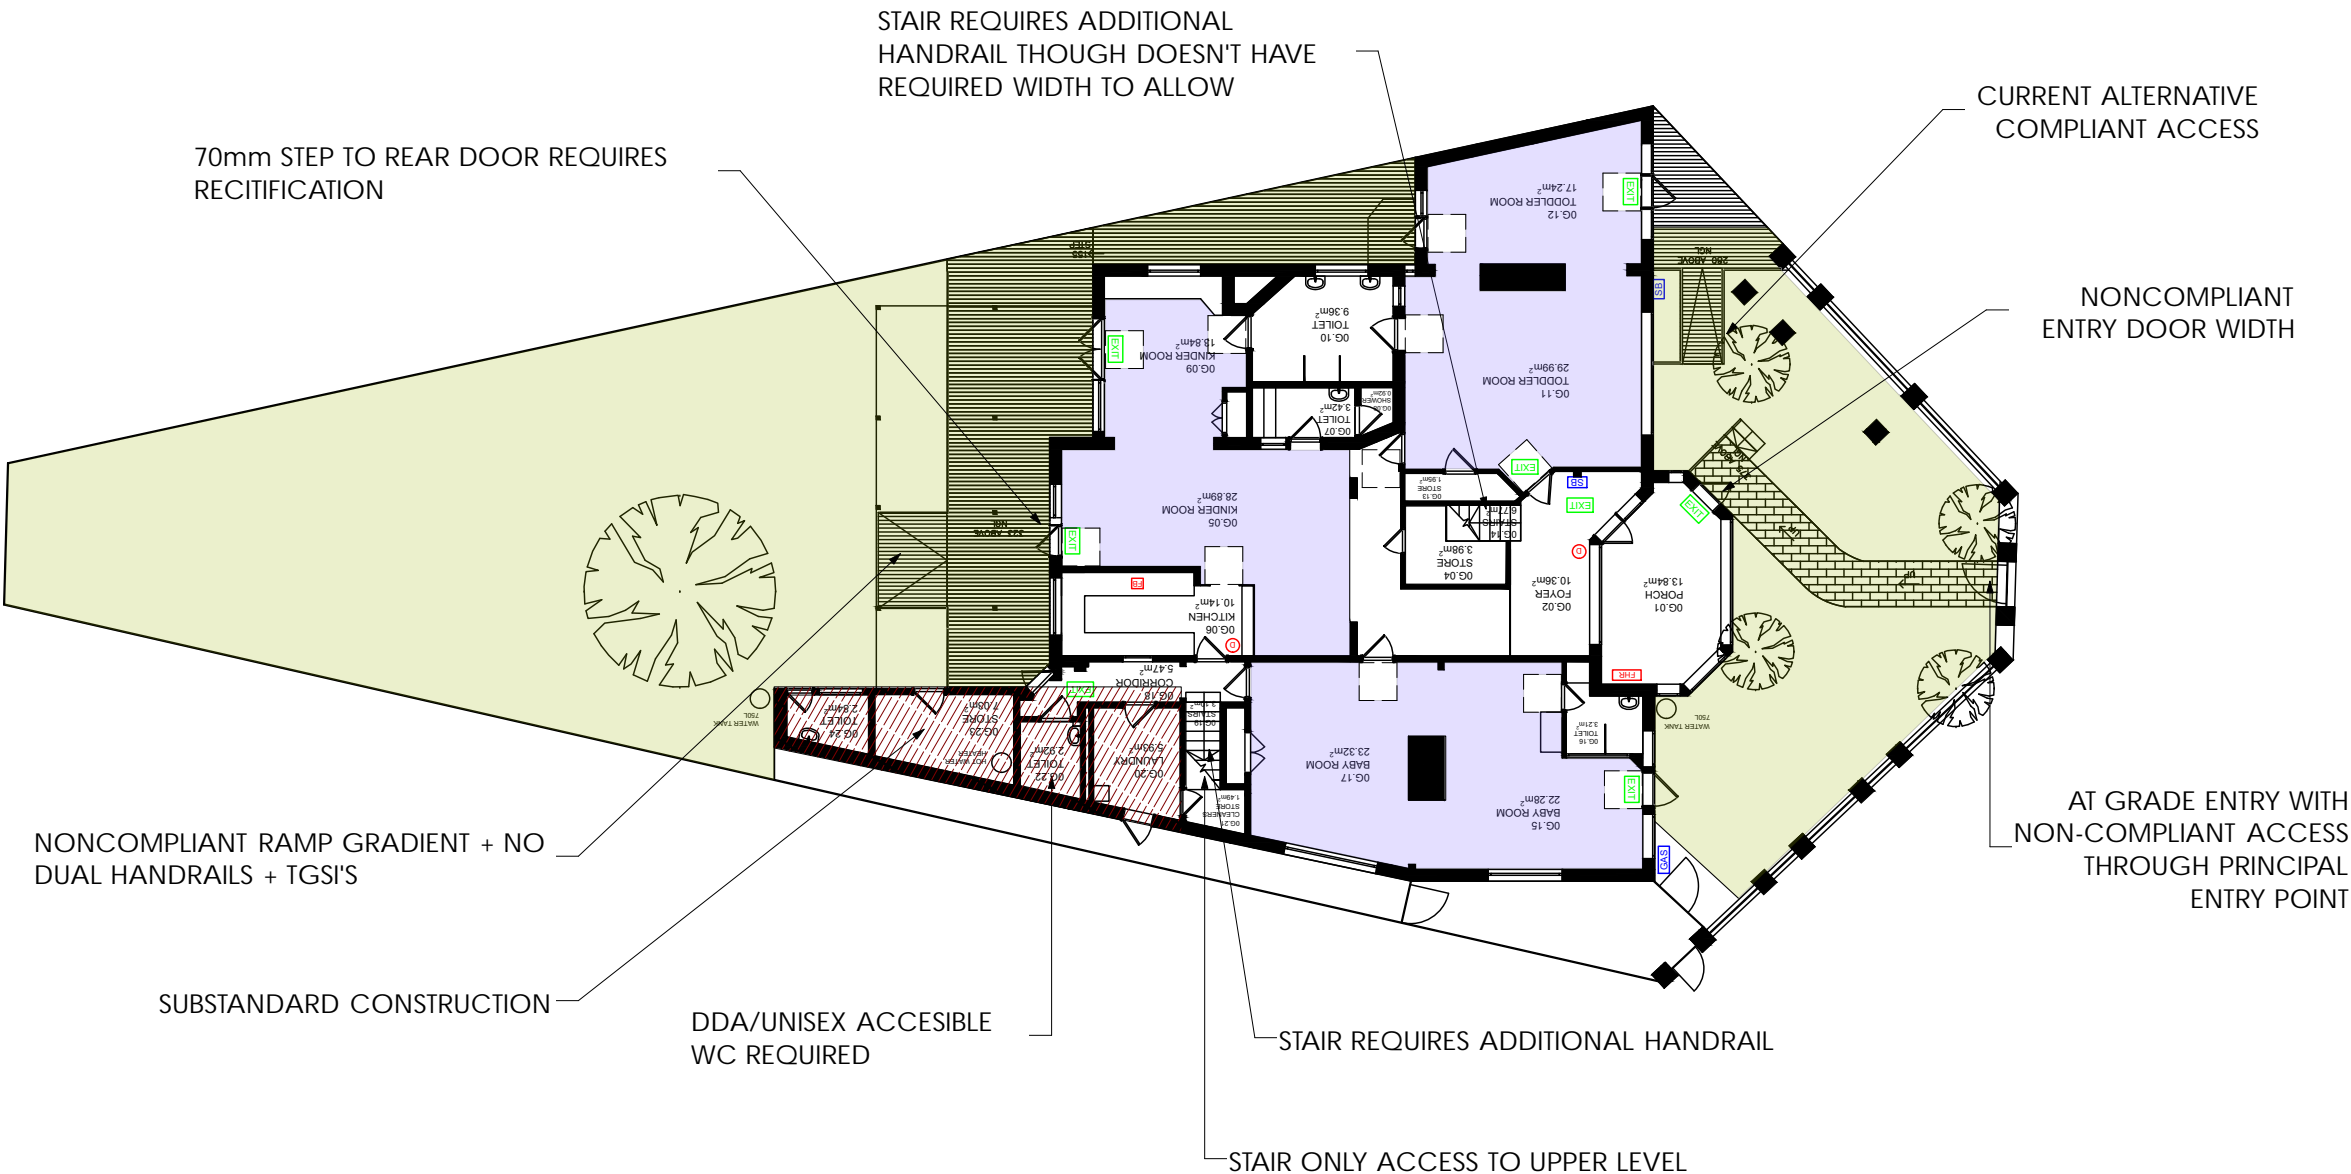
SD.01

- ALL INTERNAL DOORS WITH NON-COMPLIANT OPENING WIDTHS OF 750-770mm
- NON-COMPLIANT DOOR HARDWARE HEIGHT TO UPPER LEVEL (1150 AFL)
- GATE INTERCOM + DOORBELL TO BE LOWERED BETWEEN 900-1100 AFL.
- LIFT ACCESS TO UPPER LEVEL TECHNICALLY REQUIRED FOR CLASS 9B BUILDING.

A EXISTING CONDITIONS - DDA UPGRADE REQUIREMENTS
SCALE: NTS

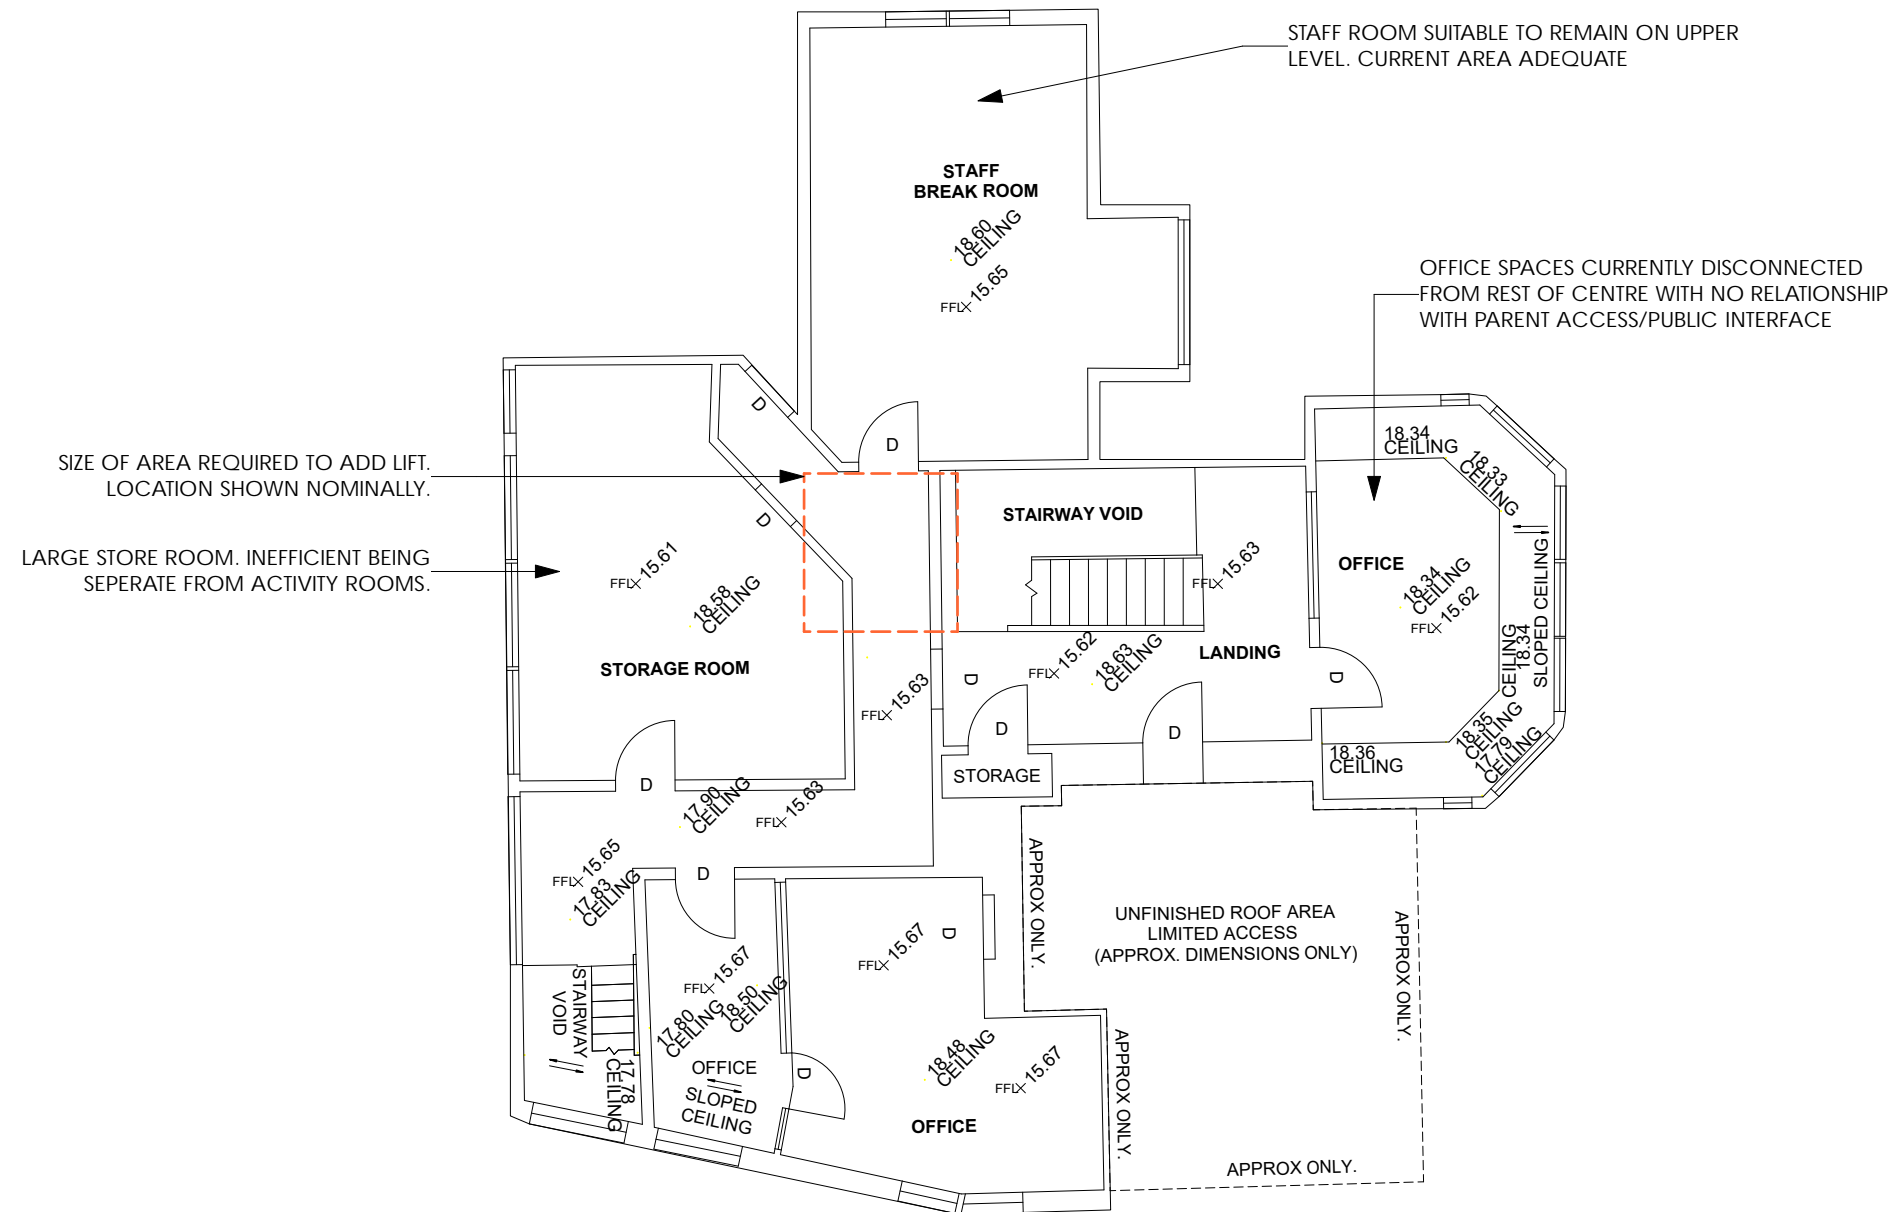
SD.03

- INEFFICIENT AND EXCESS SPACE FOR NON CHILD ACTIVITIES.
- IF CHILDREN SPACE UPSTAIRS, LIFT REQUIRED.
- CHILD ACTIVITY SPACE WILL REQUIRE ASSOCIATED OUTDOOR SPACE.

A INTERNAL AREA ANALYSIS - FIRST FLOOR
SCALE: 100
