Elwood Child Care Centre – CHS 222

ASBESTOS MANAGEMENT PLAN

46 Tennyson St, Elwood VIC 3184

City of Port Phillip

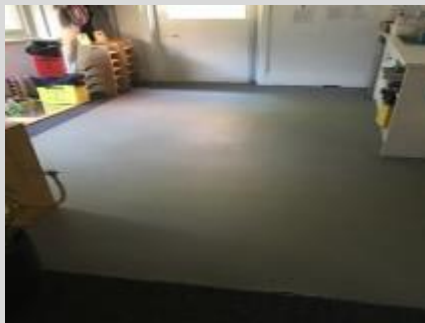
Location Details		Material Details		Results / Management Details		Photographs	
Sample #:	No sample required	Material Type:	Non-asbestos vinyl sheet	Status of ACM:

Accessed:	Yes						
Elevation:	Ground Floor	Quantity:		Disturbance Potential:			
Area:	Baby Playroom 1	Condition:		Sample Result:			
Position Installed:	Floor covering	Friability:		Risk Level:			
Internal/External:	Internal	Recommendation:					
Comments:						Urgent Action Required?

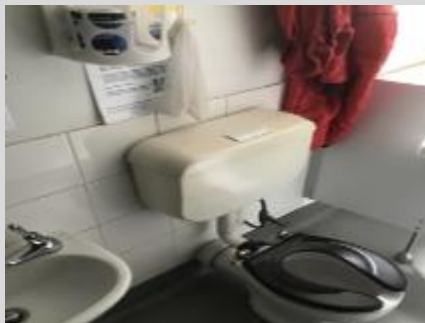
Location Details		Material Details		Results / Management Details		Photographs
Sample #:	No sample required	Material Type:	Possible Cement Sheet	Status of ACM:

Accessed:	No					
Elevation:	Ground Floor	Quantity:	5 - m2	Disturbance Potential:		
Area:	Children's W/C	Condition:		Sample Result:		
Position Installed:	Wall under ceramic tiles	Friability:		Risk Level:		
Internal/External:	Internal	Recommendation:	Inspect for asbestos prior to disturbance			
Comments:	No access without damage					Urgent Action Required?

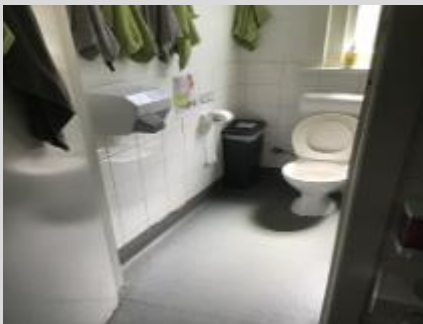
Location Details		Material Details		Results / Management Details		Photographs
Sample #:	No sample required	Material Type:	Possible Cement sheet	Status of ACM:

Accessed:	No					
Elevation:	Ground Floor	Quantity:	10 - m2	Disturbance Potential:		
Area:	Bathroom W/C	Condition:		Sample Result:		
Position Installed:	Wall under ceramic tiles	Friability:		Risk Level:		
Internal/External:	Internal	Recommendation:	Inspect for asbestos prior to disturbance			
Comments:	No access without damage					Urgent Action Required?

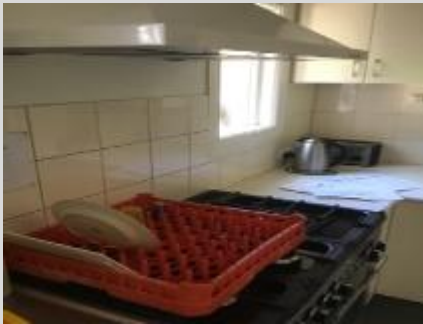
Location Details		Material Details		Results / Management Details		Photographs
Sample #:	No sample required	Material Type:	Possible Cement sheet	Status of ACM:

Accessed:	No					
Elevation:	Ground Floor	Quantity:	8 - m2	Disturbance Potential:		
Area:	Kitchen	Condition:		Sample Result:		
Position Installed:	Wall under ceramic tiles	Friability:		Risk Level:		
Internal/External:	Internal	Recommendation:	Inspect for asbestos prior to disturbance			
Comments:	No access without damage					Urgent Action Required?

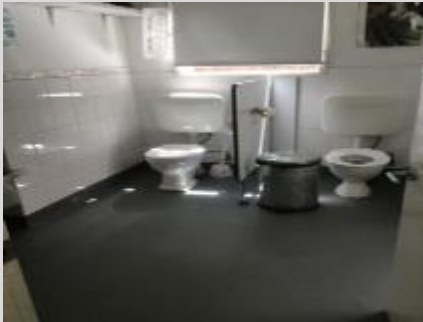
Location Details		Material Details		Results / Management Details		Photographs
Sample #:	No sample required	Material Type:	Cement sheet	Status of ACM:

Accessed:	No					
Elevation:	Ground Floor	Quantity:	8 - m2	Disturbance Potential:		
Area:	Toilet	Condition:		Sample Result:		
Position Installed:	Wall under ceramic tiles	Friability:		Risk Level:		
Internal/External:	Internal	Recommendation:	Inspect for asbestos prior to disturbance			
Comments:	No access without damage					Urgent Action Required?
