# St Kilda Marina

## Environmental & Coastal Hazard Assessment

City of Port Phillip

07 February 2018

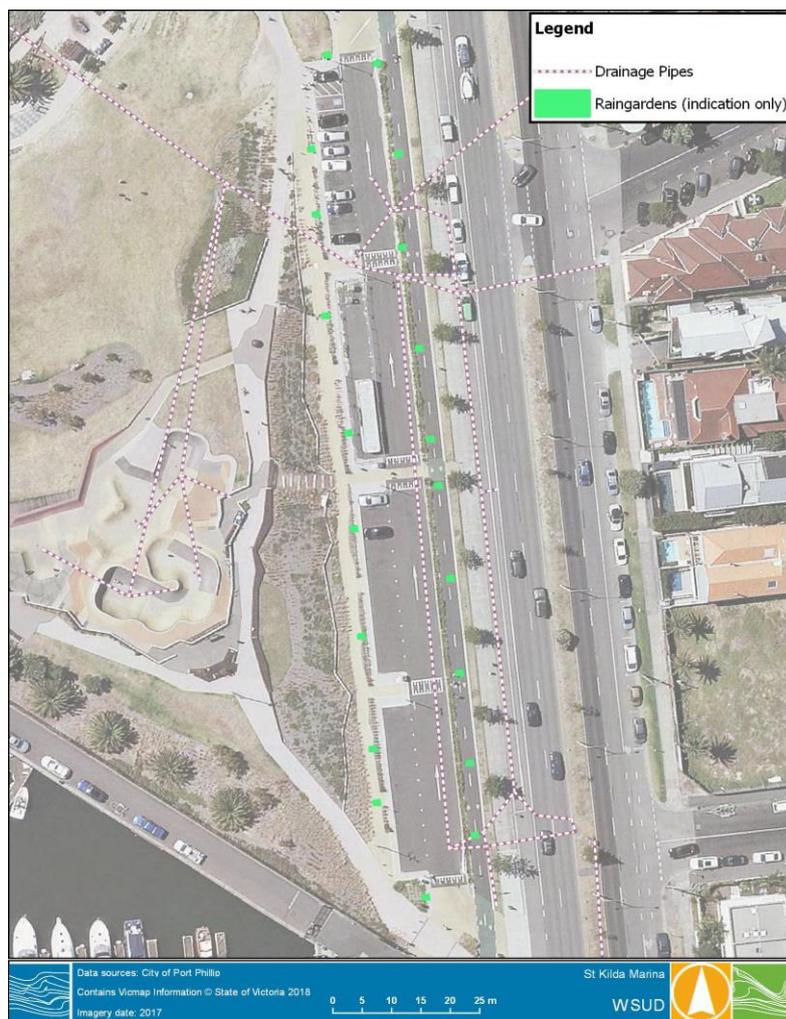
FIGURE 5-1 INDICATIVE LOCATION OF RAINGARDENS IN THE VICINITY OF THE MARINA

Stormwater from the local marina catchment is further investigated in Table 5-1 and Figure 5-1 below. The analysis for the full study area is presented in Table D-7 in Appendix D. Of key importance is the recommendation of the generation of a site-specific Stormwater Management Strategy and water quality monitoring program.

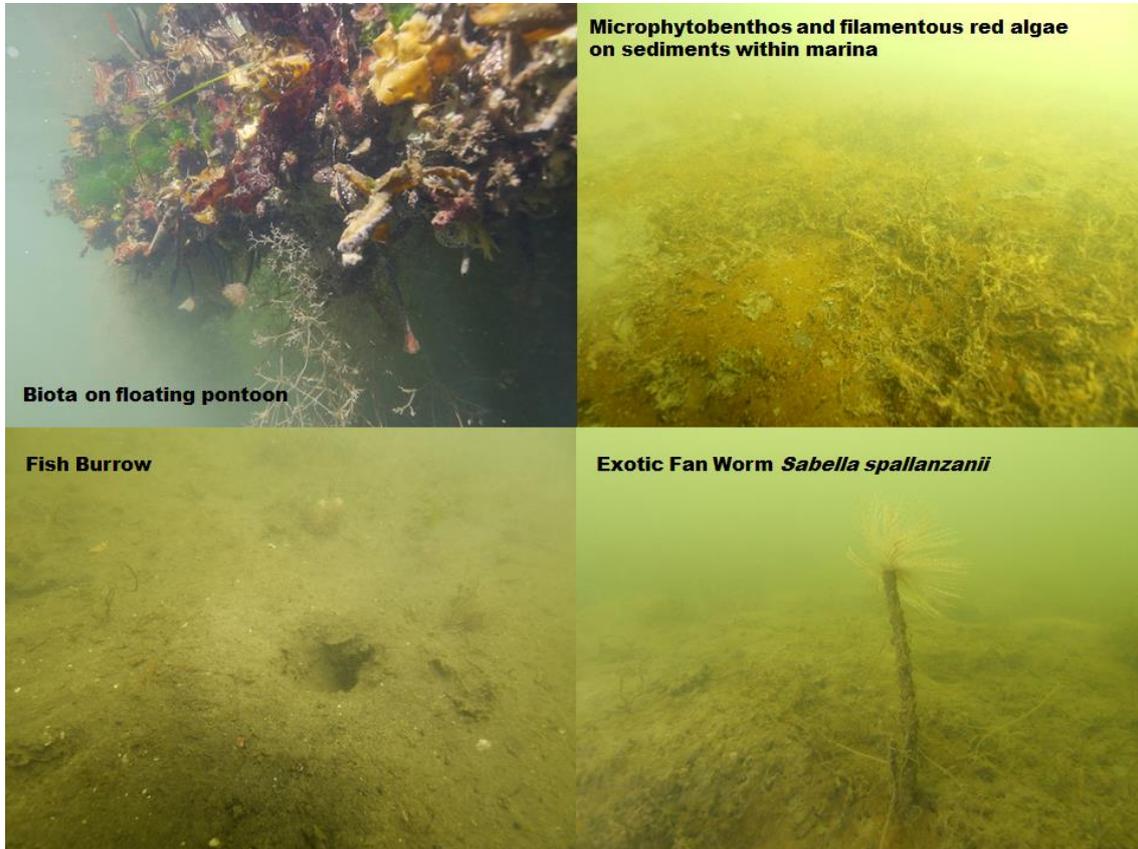
The species found within St Kilda Marina are typical of quiescent, artificial environments in northern Port Phillip Bay. Some of the most common biota are introduced species – most introduced marine species originate from ports and harbours in other parts of the world and are best adapted to these environments.

FIGURE C-2 IMAGES COLLECTED BY DIVER WITHIN ST KILDA MARINA

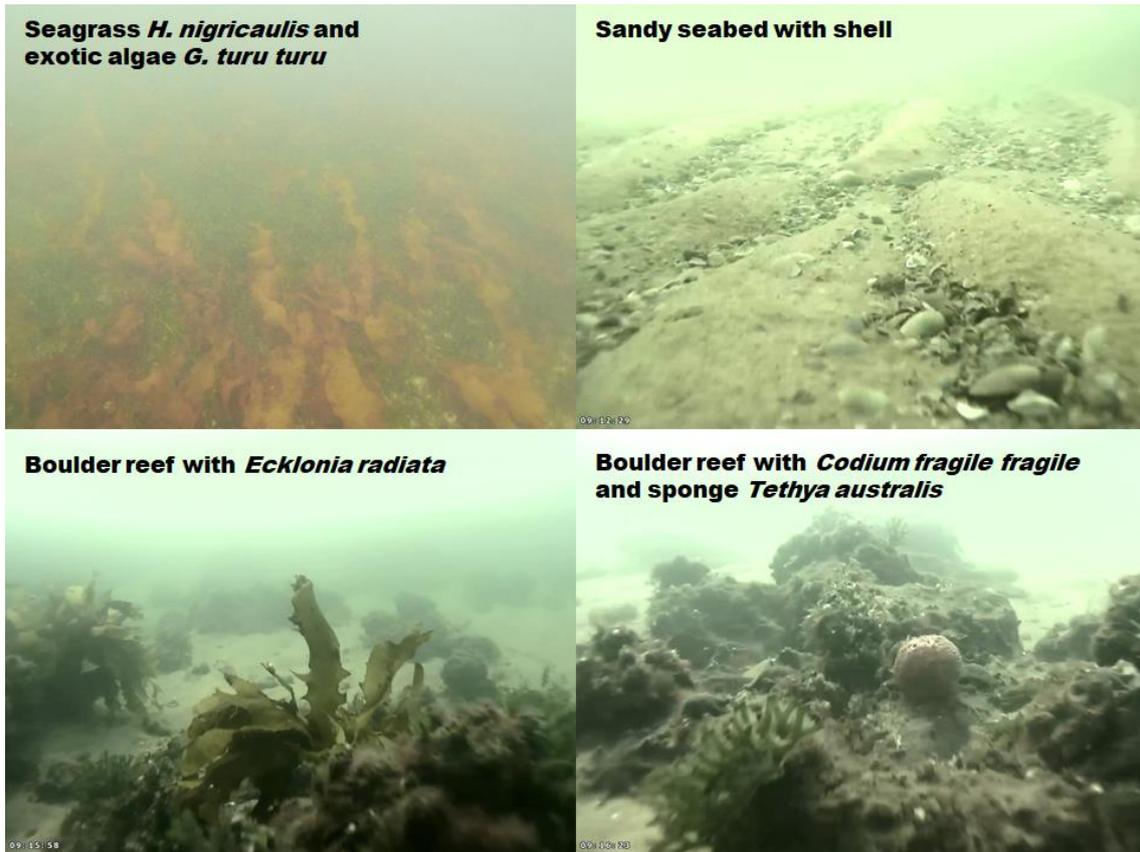
The species present in the area adjacent to (outside) the St Kilda Marina were typical of such habitats in northern Port Phillip Bay, comprising mostly native and endemic species, with a proportion of introduced species widely distributed in Port Phillip Bay.

FIGURE C-3 IMAGES FROM TOWED VIDEO OUTSIDE ST KILDA MARINA

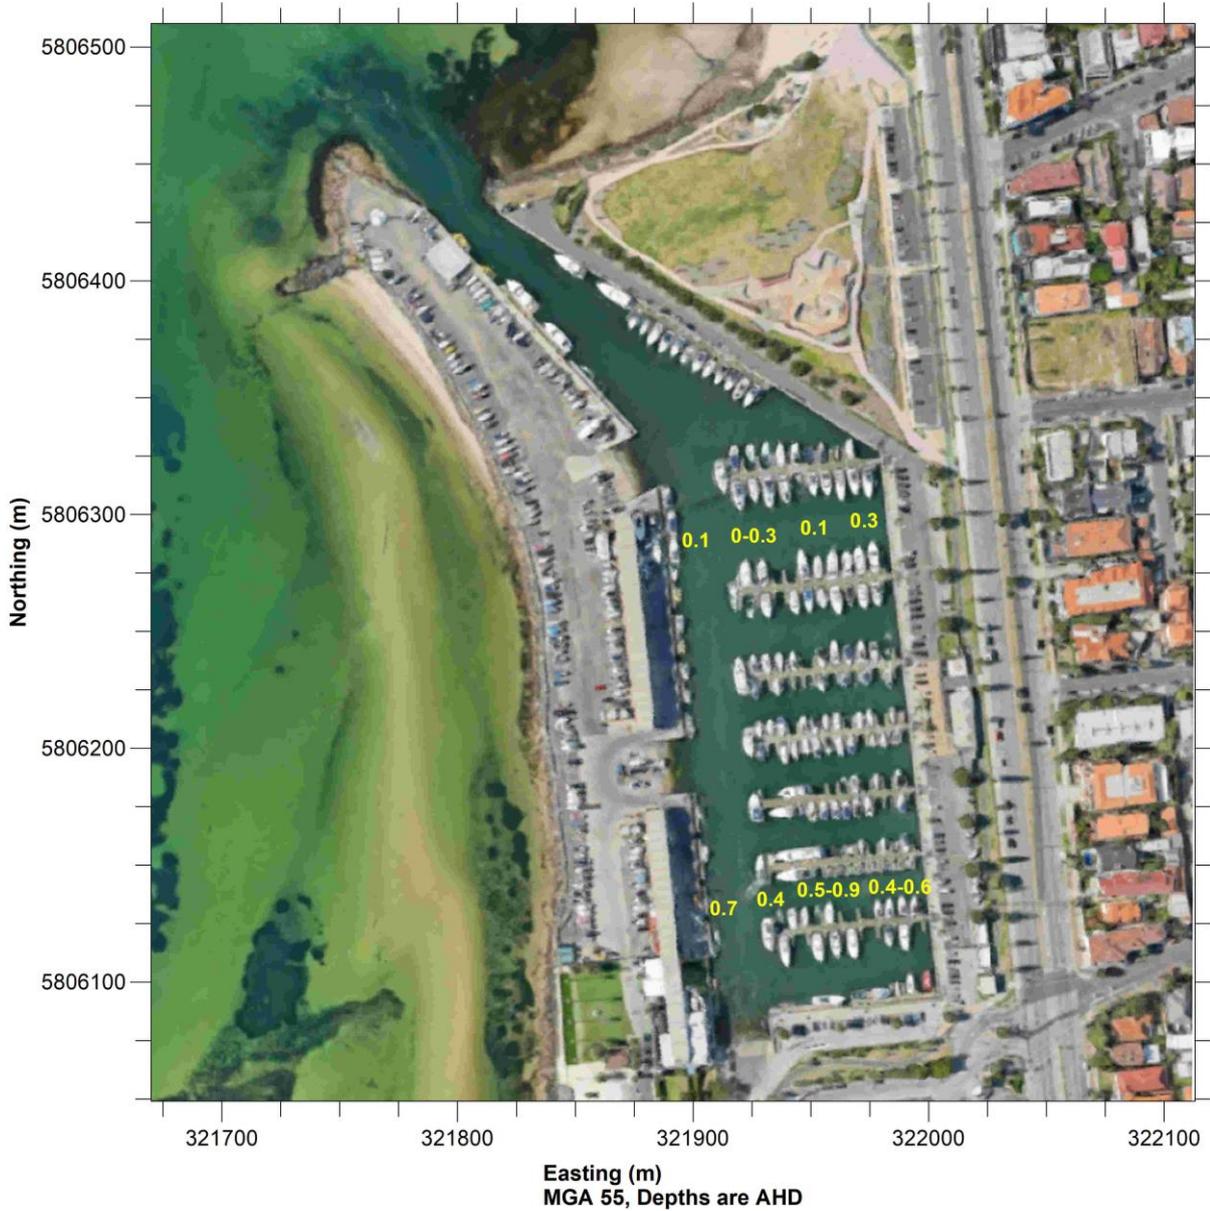
The area inside the marina has no appreciable currents or waves. The seabed within the marina is mostly soft sediment of variable depth over harder clay. The soft sediments have a high proportion of fine silt due to the quiescent conditions. Waters within the marina had very low clarity at the time of the survey and were perhaps murkier than normal due to recent rain. The key species associated with soft sediments within the marina are infauna (a range of small worms, crustaceans and molluscs), microphytobenthos (benthic microalgae), drifting filamentous red algae (*Griffithsia* sp.), the introduced Mediterranean Fan Worm (*Sabella spallanzanii*) and North Pacific Seastar (*Asterias amurensis*) and gobies (burrow dwelling fish). A smooth stingray (*Bathytoshia brevicaudata*) was sighted during the survey – these very large rays are commonly sighted around boat ramps, where they scavenge discarded fish.

FIGURE C-4 SEDIMENT DEPTHS WITHIN ST KILDA MARINA

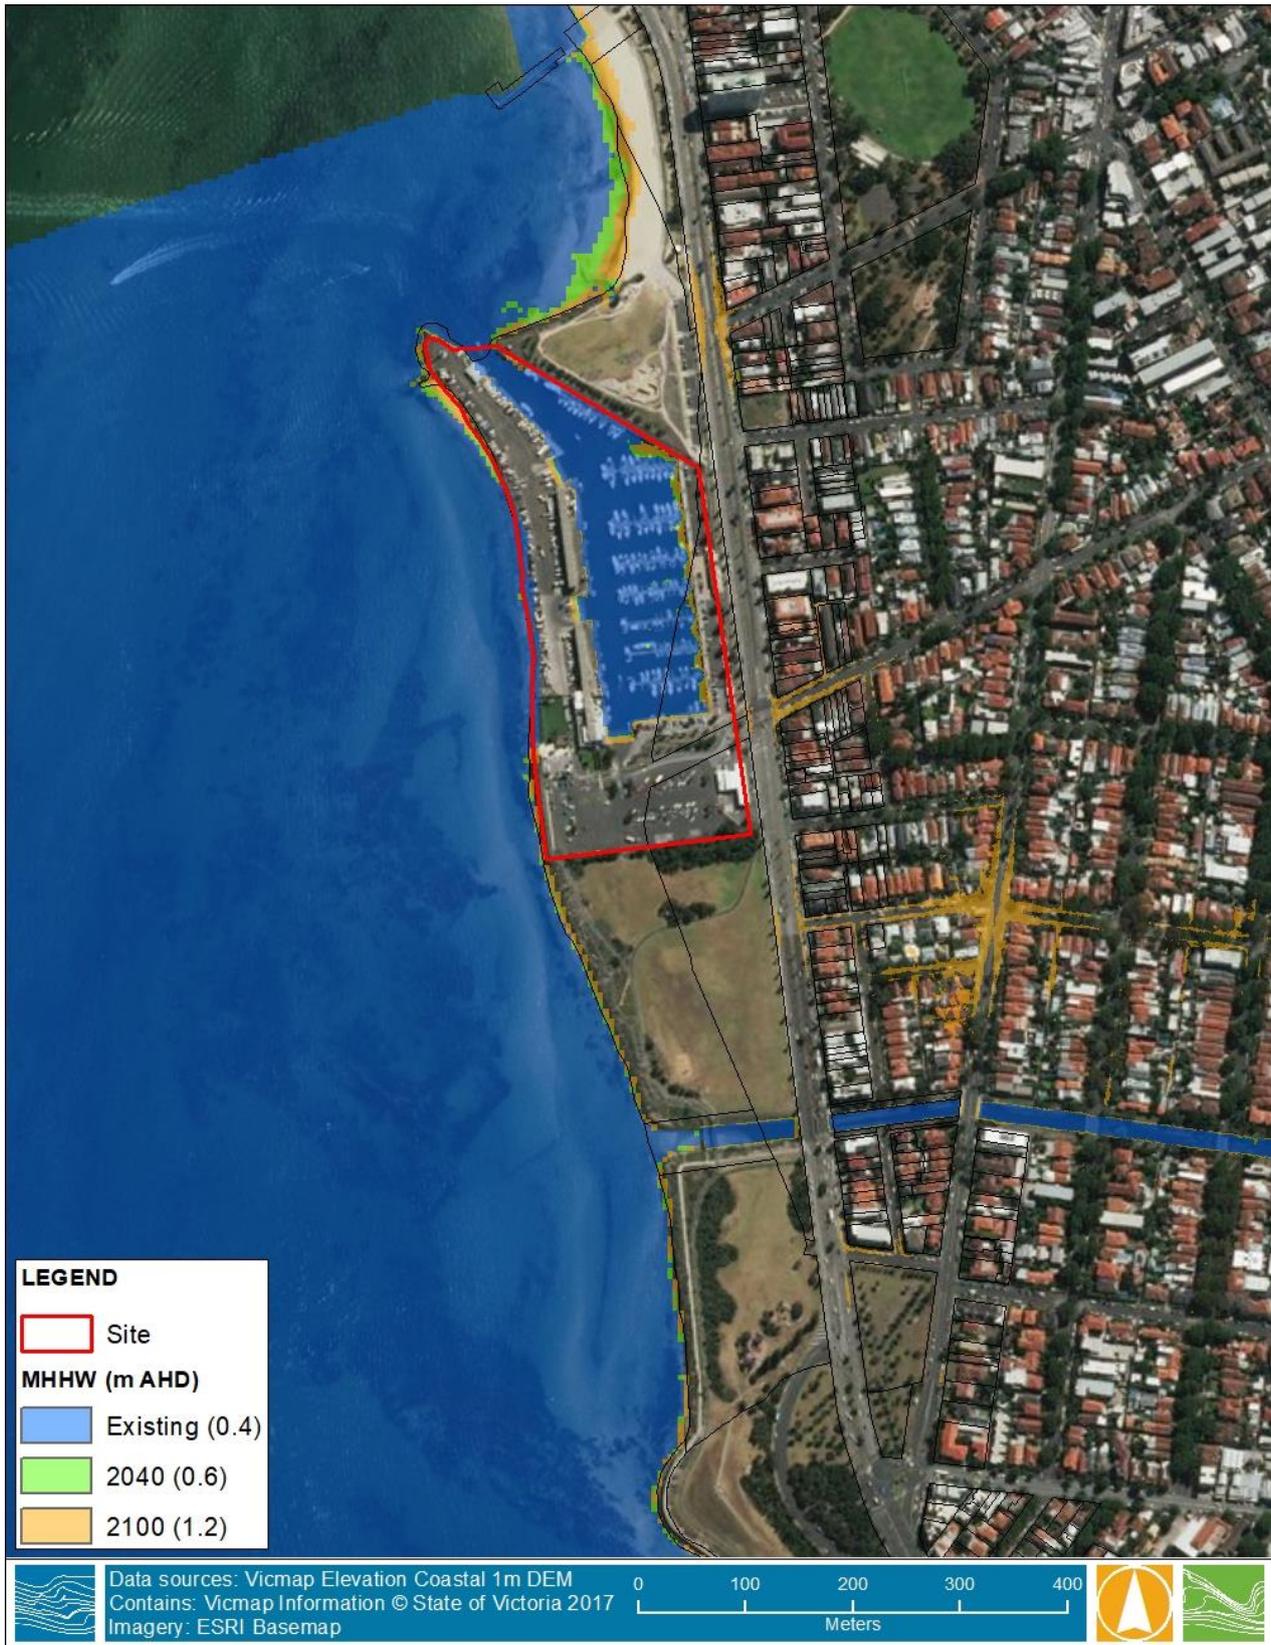
- For present day and 2040 levels, St Kilda Beach is not expected to be inundated. By 2100, the foreshore reserve may be inundated. Depending on flood pathways, the road has the potential to also be impacted.
- Within the marina, hardstand areas may be inundated in the present day. The level of inundation will increase by 2100.
- The car park is predicted to remain dry until 2100, when the western foreshore / portion of the car park may become inundated.
- South of the marina, the seawall and foreshore reserve west of the public pathway may become inundated by 2100

**FIGURE F-6 PREDICTED MHHW EXTENT AT ST KILDA MARINA FOR VARIOUS SEA LEVEL RISE SCENARIOS (USING 2009 LIDAR AND 2017 BATHYMETRY SURVEY)**
