Tree assessment & management plan Proposed fence works Eildon Road Children's Centre 17 Eildon Road, St Kilda

23rd April 2021 | Tree Logic Ref. 011520

Prepared for Jason Sim. Project Manager. Construction, Contracts and Operations. City of Port Phillip.

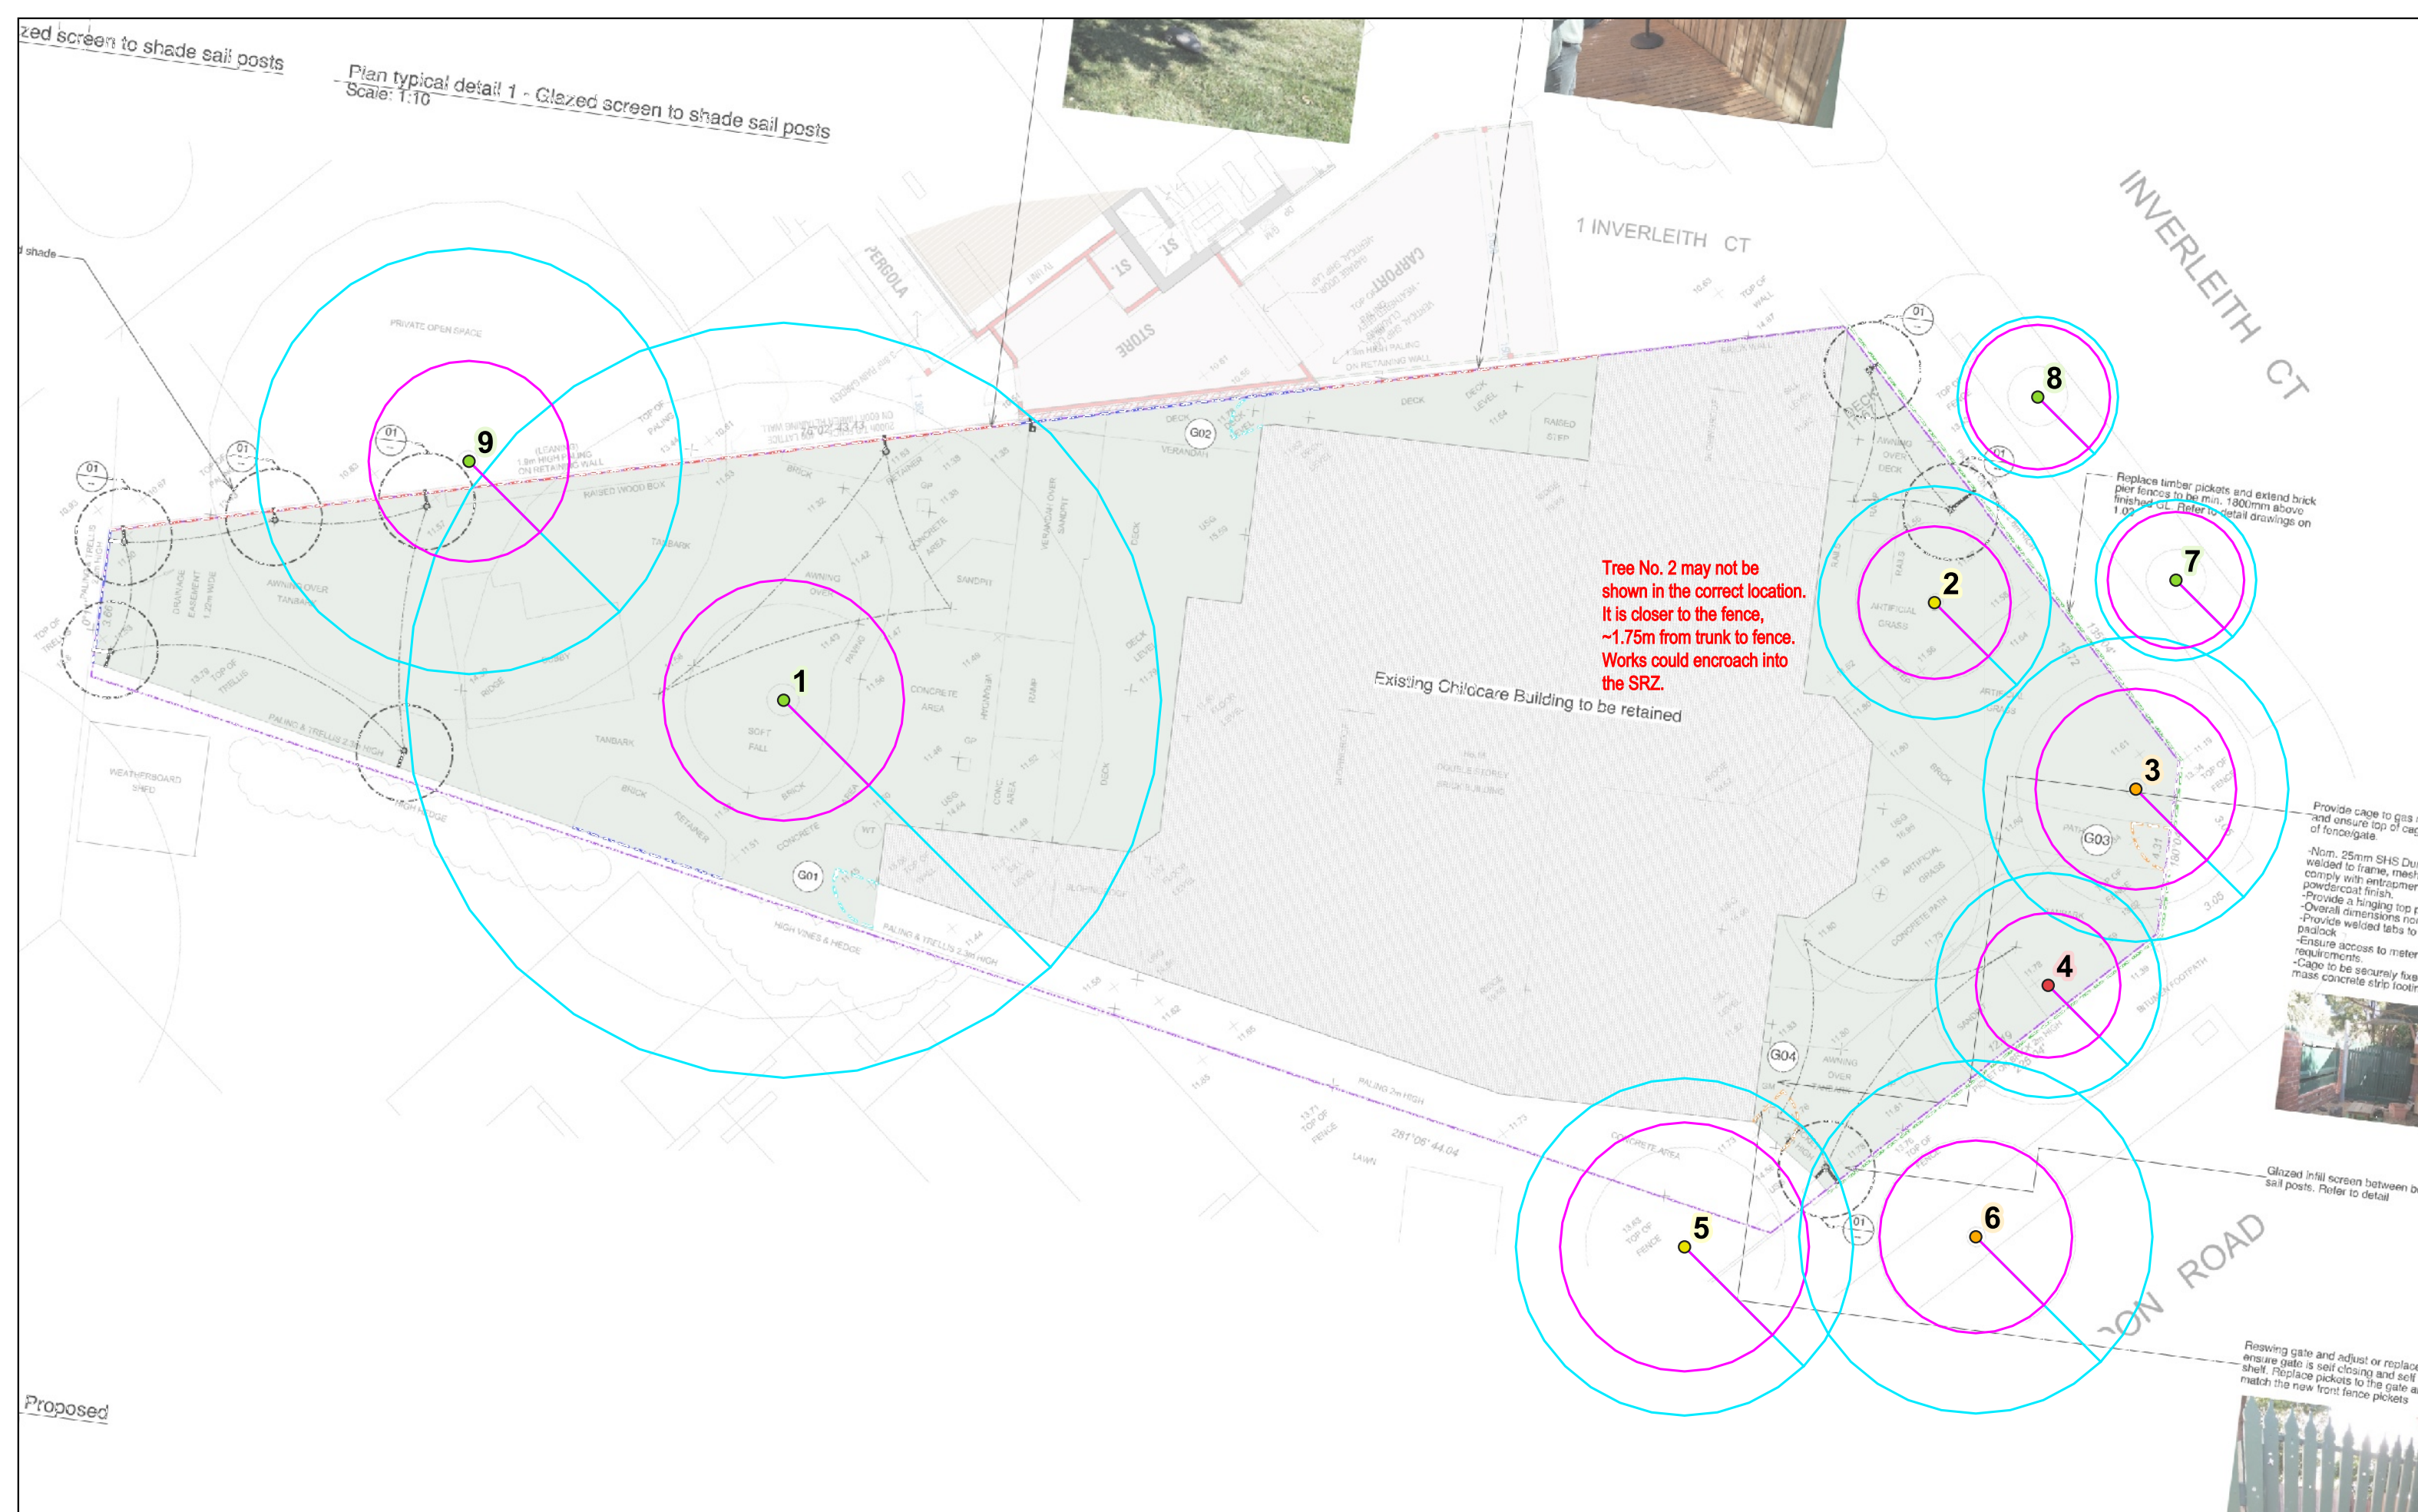
Appendix 2: Tree Locations – Eildon Road Children’s Centre at 17 Eildon Road, St Kilda

Tree ID	Species	Age class	Origin/type	DBH (cm)	Basal (cm)	Ht x Wdth (m)	Health	Structure	Arb. rating	ULE (yrs)	Comments	TPZ r (m)	SRZ r (m)
9	<i>Ulmus parvifolia</i> (Chinese Elm)	Early-mature	Exotic deciduous	44	52	10 x 15	Fair	Fair	Mod.A	21-40	Base of trunk 0.34m from existing retaining wall. Utilise existing post or SRZ distance (whichever greater), span concrete sleepers over the root zone. No drainage in SRZ area (unless already existing).	5.3	2.5
