# REPORT

CONDITION ASSESSMENT:  
17 EILDON RD, ST KILDA, VIC  
18 January 2022

for  
City of Port Phillip

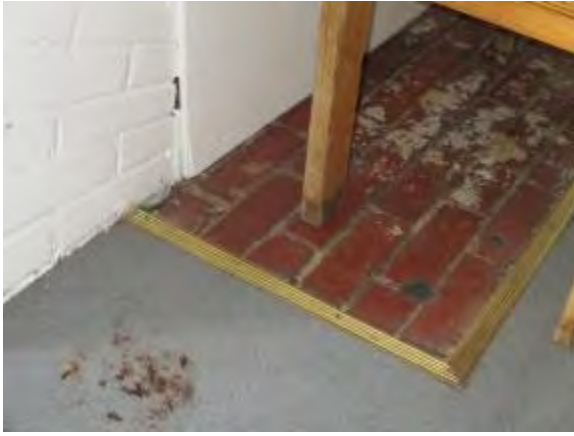
46: IMG\_0458

6.05	Security - Intruder Detection and CCTV Systems	Building	Security systems include alarmed motion sensors, wall and ceiling mounted PIR motion detectors internally.	No maintenance documentation provided. Generally appears in good condition.	2	0458, 0515, 0657

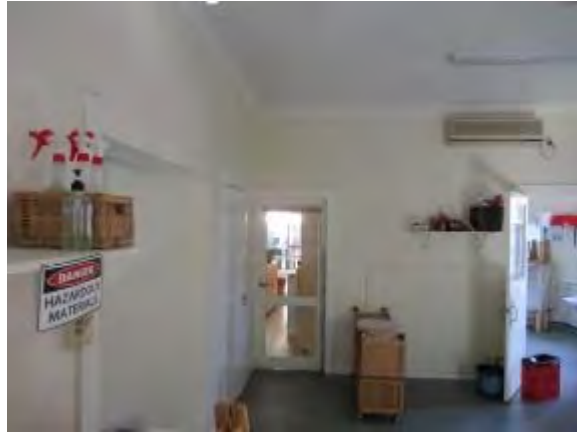
53: IMG\_0465

6.02	General Lighting	Building	Generally the illumination appears adequate for the building. There are a combination of fluorescent and incandescent lighting.	Visually in fair to good condition. No maintenance documentation was provided. Diffusers missing in a number of locations.	2	0444, 0465, 0564, 0605, 0654, 0666, 0703, 0742,

7.00	MECHANICAL SERVICES					
7.01	Split System	Building	The site is provided with heating and cooling via split system air-conditioners in Classroom 1, 4, 5, Office (20 & 21), (22), and Staff Break Room. We were unable to determine the inverter reverse cycle units install dates. All split systems have their remotes located with each internal head units.	The systems appear to be maintained and appeared in fair to good condition with varying assumed manufactured dates. It is assumed that the units will require replacement in the short to medium term. No record of installations or maintenance was available for review.	3	0428, 0429, 0465, 0519, 0546, 0617, 0683,

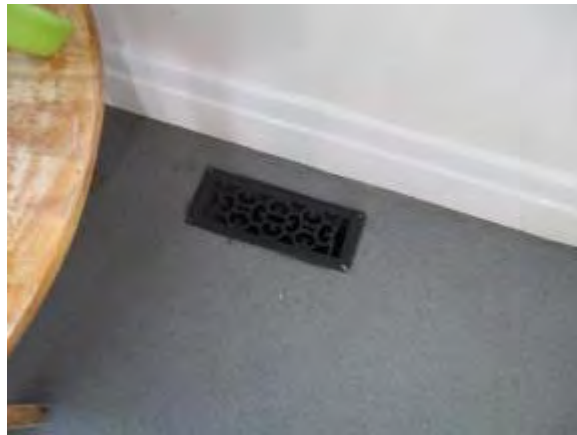
55: IMG\_0467

REF	ELEMENT	LOCATION	DESCRIPTION	COMMENT/CONDITION	RATING	PHOTO REF
6.03	Emergency and Exit Lighting Systems	Throughout building located to suit exit paths	Self-contained Emergency and Exit illuminated light fixtures supplied from local lighting circuits that a failure of the general lighting in the area shall cause emergency lighting to be activated automatically.	No up to date maintenance information was provided. Older style signage. Carry out testing, supply log book to site and address any back log repairs and cleaning as required.	2	0452, 0467,

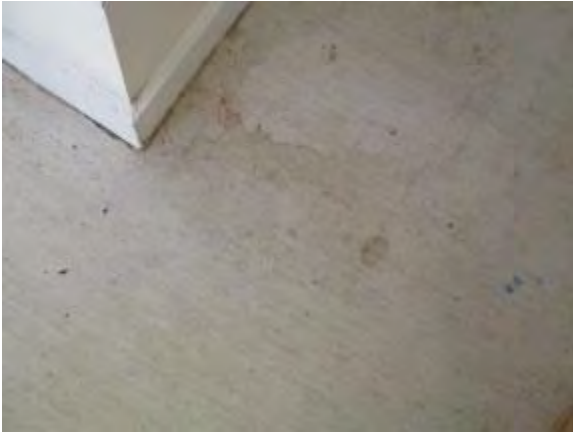
76: IMG\_0508

8.00	HYDRAULIC SERVICES					
8.01	Sanitary Fitments	Amenities	Generally the WCs were vitreous China pans the hand basins were also vitreous China or stainless steel with chrome or stainless steel fixtures.	Amenities were showing their age. General cleanliness was only fair with staining in the to the tiles.	3	0483, 0508, 0531, 0532, 0598, 0599, 0630 - 0632, 0706

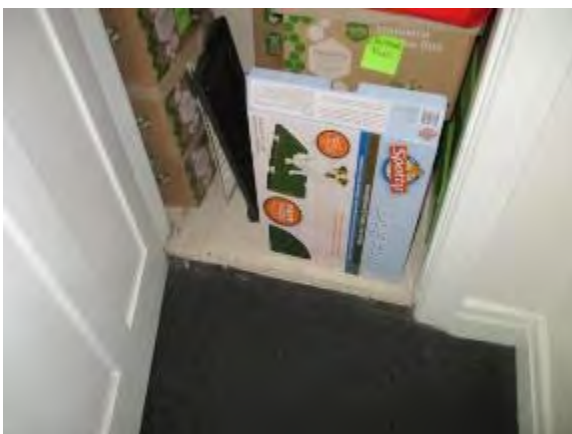
252: IMG\_0687

8.05	Backflow Valves	Hose reels and Fire	Hose reels were not noted to have backflow valves.	The full extent of backflow protection was not clear and a full review should be carried out to ensure all cross flow risk areas are protected and tested.	2	0687

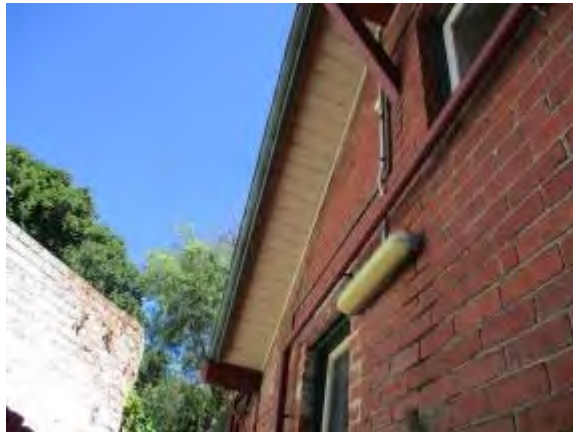
303: IMG\_0741

8.03	Water Supplies (Hot Equipment)	Building	There is a single instantaneous Thermann 26 gas continuous flow hot water unit located on the southern elevation that serves the building.	No maintenance information was provided. The unit appears relatively new and in good condition commensurate with age and use.	2	0741
