CITY OF PORT PHILLIP – 17 EILDON ST – PROPERTY RISK ASSESSMENT

31 JANUARY 2022 | 06613-VIC-PRA

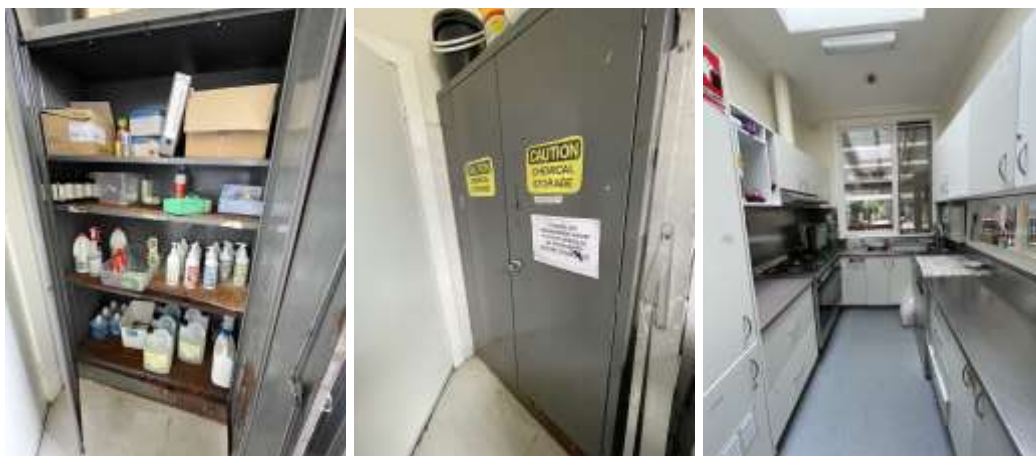
The details of hazardous chemicals are maintained in a register as required by the regulations. Hazardous chemicals are stored in a secure cupboard. No unusual hazardous chemicals were identified on site. No concerns were identified with respect to hazardous chemicals.

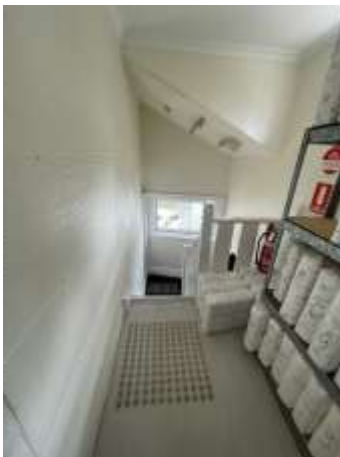
The Site Audit Report details significant concerns regarding access and accessibility. It is noted that in relation to this compliance regard must be had to the age of the facility at the time of construction and the level of subsequent refurbishment and this is detailed in the Site Audit Report.
