CITY OF PORT PHILLIP – 39 THE AVENUE – PROPERTY RISK ASSESSMENT

8 FEBRUARY 2022 | 06614-VIC-PRA

City of Port Phillip – 39 The Avenue – Property Risk Assessment

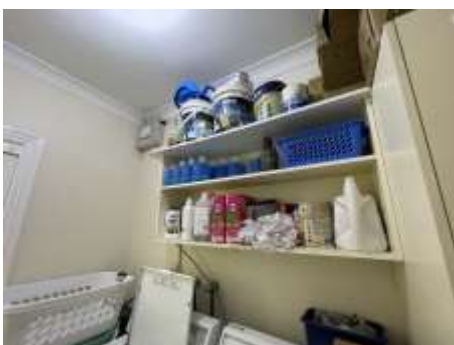
The details of hazardous chemicals are maintained in a register as required by the regulations. Hazardous chemicals are stored in a secure cupboard. No unusual hazardous chemicals were identified on site. No concerns were identified with respect to hazardous chemicals.
