39 THE AVENUE, BALACLAVA

BUILDING CONDITION ASSESSMENT - UPDATE

39 THE AVENUE, BALACLAVA BUILDING CONDITION ASSESSMENT - UPDATE

3 May 2022

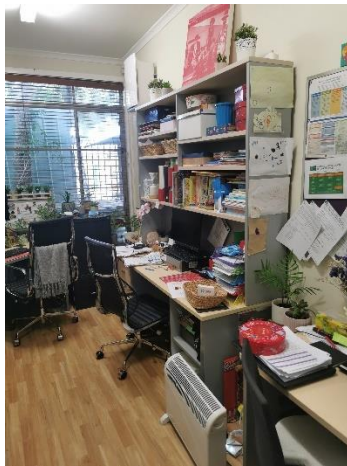
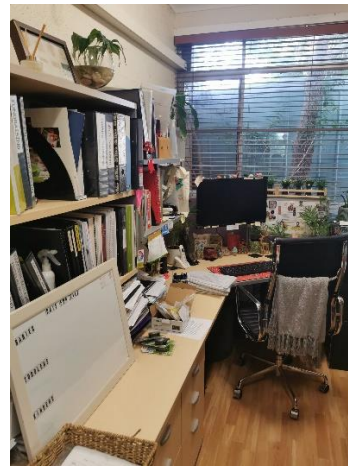
OFFICE ROOM 1

Office room 1 featured a portable heater resting on the timber floor. There was also a wall mounted safety measures logbook underneath the wall mounted air purifying unit.

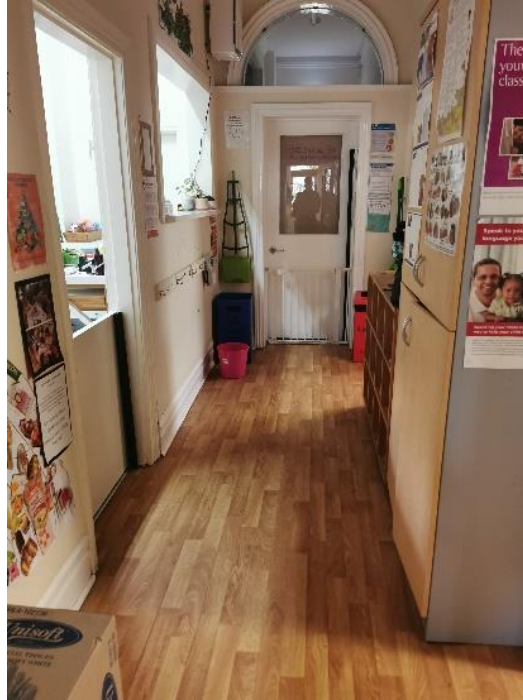
HALL

The internal hall finishes were found in a good condition with no notable observable defects.

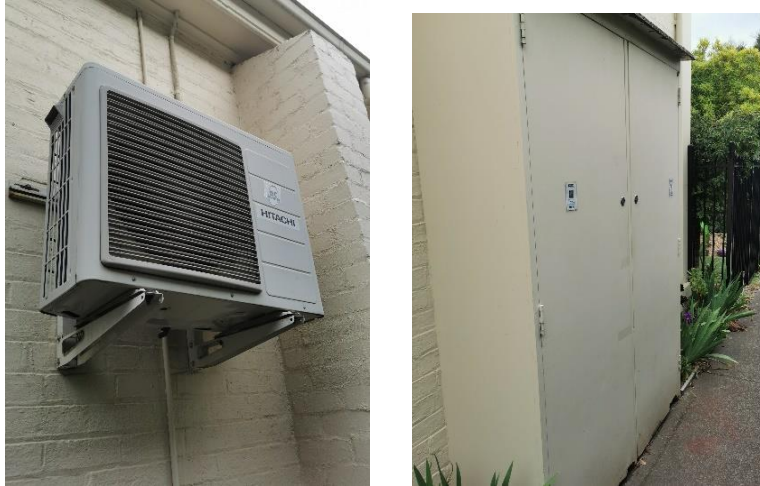
FRONT ENTRANCE SPLIT SYSTEM AND SWITCHBOARD CUPBOARD

The front entrance pathway featured an external split air conditioning unit and outdoor cupboard which appeared to be the housing of the building's main electrical distribution board which was locked.

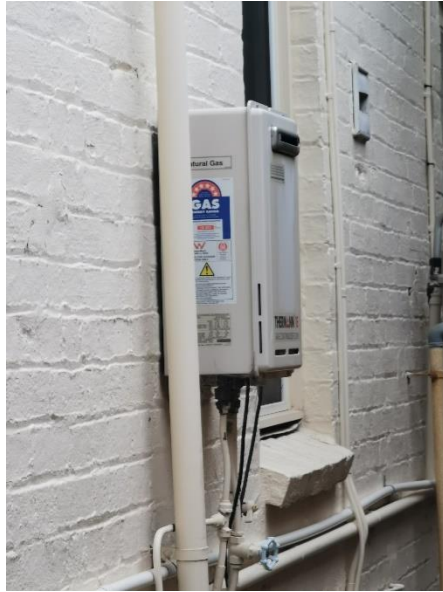
INSTANTANEOUS HOT WATER UNIT

The West external walls of the building featured three split air conditioning units. Each of the units appeared to be in good visual condition, as was the instantaneous hot water unit in the West pathway. Due to the height of the assets the nameplate of each unit was not visible to obtain the age of these assets. There was also an instantaneous hot water unit at ground level in the West pathway.

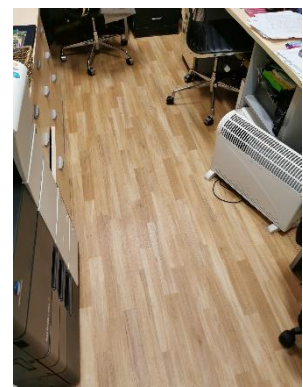
REFERENCE	ELEMENT	LOCATION	DESCRIPTION	COMMENT/CONDITION	RATING	PHOTO REF
129	Building Fabric	Office 1	Work Station/ Desk		2 - Good	OFFICE ROOM 1 - 1
130	Building Fabric	Office 1	Work Station/ Desk		2 - Good	OFFICE ROOM 1 - 2
131	Building Fabric - Ceiling Finish	Office 1	Plasterboard		2 - Good	OFFICE ROOM 1 - 1
132	Building Fabric - Floor Finish	Office 1	Timber Look Vinyl		2 - Good	OFFICE ROOM 1 - 1
133	Building Fabric - Wall Finish	Office 1	Painted Blockwork		2 - Good	OFFICE ROOM 1 - 7
134	Building Fabric - Wall Finish	Office 1	Plasterboard		2 - Good	OFFICE ROOM 1 - 1
135	Electrical	Office 1	Lighting	Baton tube fixtures	2 - Good	OFFICE ROOM 1 - 1
136	Fire Services	Office 1	Smoke Detector		2 - Good	NO PHOTO
137	Mechanical Service	Office 1	Air Purifying Unit		1 - Excellent	OFFICE ROOM 1 - 2
138	Building Fabric - Doors	Office 1 to 2	Door	Timber	3 - Fair	OFFICE ROOM 2 - 3
139	Building Fabric - Doors	Office 1 to Entry Hall	Door	Timber - Dirt ingrained on the door	4 - Poor	OFFICE ROOM 1 - 4

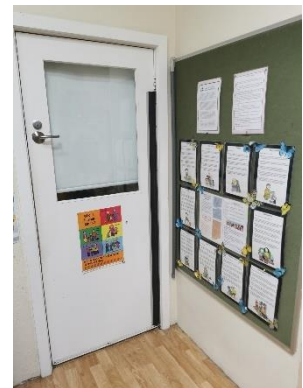
121	Building Fabric - Wall Finish	Multipurpose Room	Painted Blockwork		2 - Good	MULTIPURPOSE 2
122	Electrical	Multipurpose Room	Ceiling Fan		3 - Fair	MULTIPURPOSE 2
123	Electrical	Multipurpose Room	Lighting	Baton tube fixtures	2 - Good	MULTIPURPOSE 5
124	Fire Services	Multipurpose Room	Extinguisher (Water)		2 - Good	MULTIPURPOSE
125	Fire Services	Multipurpose Room	Smoke Detector		2 - Good	NO PHOTO
126	Mechanical Service	Multipurpose Room	Air Conditioning Inverter Unit		2 - Good	MULTIPURPOSE 5
127	Building Fabric - Doors	Multipurpose Room to Backyard	Door	Timber - Dirt ingrained on the door	4 - Poor	MULTIPURPOSE
128	Building Fabric	Office 1	Window Blinds		2 - Good	OFFICE ROOM 1 - 2

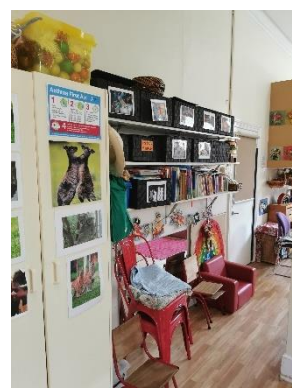
11	Mechanical Service	Bathroom & Toilets	Air Conditioning Inverter Unit		2 - Good	BATHROOM & TOILET 3
12	Mechanical Service	Bathroom & Toilets	Air Purifying Unit		2 - Good	BATHROOM & TOILET 4
13	Building Fabric	Children Playroom	Air Conditioning Inverter Unit		3 - Fair	CHILDREN PLAYROOM 1
14	Building Fabric	Children Playroom	Cupboard		2 - Good	CHILDREN PLAYROOM 2
15	Building Fabric	Children Playroom	Fireplace	Decommissioned and filled	2 - Good	CHILDREN PLAYROOM 1
16	Building Fabric	Children Playroom	Fireplace	Decommissioned and filled	2 - Good	CHILDREN PLAYROOM 1
17	Building Fabric	Children Playroom	Timber Painted Skirting Board		3 - Fair	CHILDREN PLAYROOM 3
18	Building Fabric	Children Playroom	Wall Shelf		2 - Good	CHILDREN PLAYROOM 1
19	Building Fabric	Children Playroom	Wall Shelf		2 - Good	CHILDREN PLAYROOM 2
20	Building Fabric	Children Playroom	Wooden Box Shelf		2 - Good	CHILDREN PLAYROOM 1
21	Building Fabric - Ceiling Finish	Children Playroom	Plasterboard		2 - Good	CHILDREN PLAYROOM 1

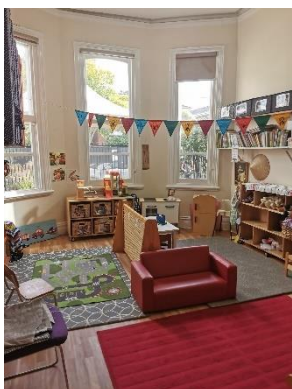
REFERENCE	ELEMENT	LOCATION	DESCRIPTION	COMMENT/CONDITION	RATING	PHOTO REF
33	Building Fabric - Doors	Children Playroom to Hall	Door	Timber	2 - Good	CHILDREN PLAYROOM 2
34	Building Structure	Chimney	Chimney	No visual signs of any issues	3 - Fair	CHIMNEY
35	Building Fabric	Entry Hall (Entrance)	Timber Sign-In Desk		2 - Good	ENTRY HALL 4
36	Building Fabric	Entry Hall (Entrance)	Wooden Box Shelf		2 - Good	ENTRY HALL 3
37	Building Fabric - Ceiling Finish	Entry Hall (Entrance)	Plasterboard		2 - Good	ENTRY HALL 4
38	Building Fabric - Doors	Entry Hall (Entrance)	Door	Main Entry - Timber Glazed	3 - Fair	ENTRY HALL 1
39	Building Fabric - Floor Finish	Entry Hall (Entrance)	Timber Look Vinyl		3 - Fair	ENTRY HALL 5
40	Building Fabric - Wall Finish	Entry Hall (Entrance)	Painted Blockwork		2 - Good	ENTRY HALL 2
41	Electrical	Entry Hall (Entrance)	Lighting	Recessed Spotlight	2 - Good	ENTRY HALL
42	Electrical	Entry Hall (Entrance)	Lighting	Exit Lighting	2 - Good	ENTRY HALL 1

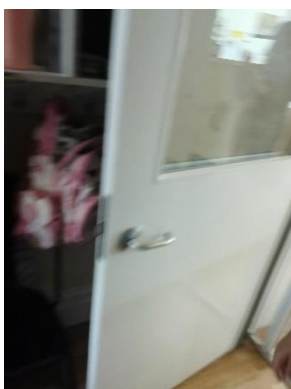
REFERENCE	ELEMENT	LOCATION	DESCRIPTION	COMMENT/CONDITION	RATING	PHOTO REF
161	Building Fabric - Wall Finish	Sleeping Room	Plasterboard		2 - Good	SLEEPING ROOM 3
162	Electrical	Sleeping Room	Lighting	Baton tube fixture	2 - Good	SLEEPING ROOM 5
163	Electrical	Sleeping Room	Lighting	Exit Lighting	2 - Good	SLEEPING ROOM 5
164	Electrical	Sleeping Room	Switchboard	Adjacent to exit door	3 - Fair	SLEEPING ROOM 8
165	Fire Services	Sleeping Room	Smoke Detector		2 - Good	NO PHOTO
166	Mechanical Service	Sleeping Room	Air Conditioning Inverter Unit		1 - Excellent	SLEEPING ROOM 6
167	Mechanical Service	Sleeping Room	Air Purifying Unit 1		1 - Excellent	SLEEPING ROOM 6
168	Mechanical Service	Sleeping Room	Air Purifying Unit 2		1 - Excellent	SLEEPING ROOM 7
169	Mechanical Service	Sleeping Room	Microwave		3 - Fair	SLEEPING ROOM 8
170	Building Fabric	Sleeping Room to Front Play Area	Blinds		3 - Fair	SLEEPING ROOM 10
171	Building Fabric	Sleeping Room to Front Play Area	Timber Ramp	Finishes worn	3 - Fair	SLEEPING ROOM 9

172	Building Fabric - Doors	Sleeping Room to Front Play Area	Door	Timber	2 - Good	SLEEPING ROOM 3
173	Building Fabric - Doors	Sleeping Room to Kitchen	Door	Timber	2 - Good	KITCHEN 1
174	Building Structure	Windows	Windows	Windows and glazing in fair condition throughout	3 - Fair	WINDOWS - TYPICAL
175	Building Structure	External Roof	General	Rated by external consultant Redd Zebra - See Section 5.2 of WT's report for summary of the commentary	3.5 - Fair to Poor	Ref. Redd Zebra Report - Appendix C
176	Building Structure	Roof	Profile Metal Sheeting	Rated by external consultant Redd Zebra - See Section 5.2 of WT's report for summary of the commentary	3 - Fair	Ref. Redd Zebra Report - Appendix C
177	Building Structure	Internal Roof	General	Rated by external consultant Redd Zebra - See Section 5.2 of WT's report for summary of the commentary	4 - Poor	Ref. Redd Zebra Report - Appendix C
178	Building Structure	Internal Roof	Interior (Ceiling)	Rated by external consultant Redd Zebra - See Section 5.2 of WT's report for summary of the commentary	3 - Fair	Ref. Redd Zebra Report - Appendix C
