39 THE AVENUE, BALACLAVA

BUILDING CONDITION ASSESSMENT - UPDATE

39 THE AVENUE, BALACLAVA BUILDING CONDITION ASSESSMENT - UPDATE

3 May 2022

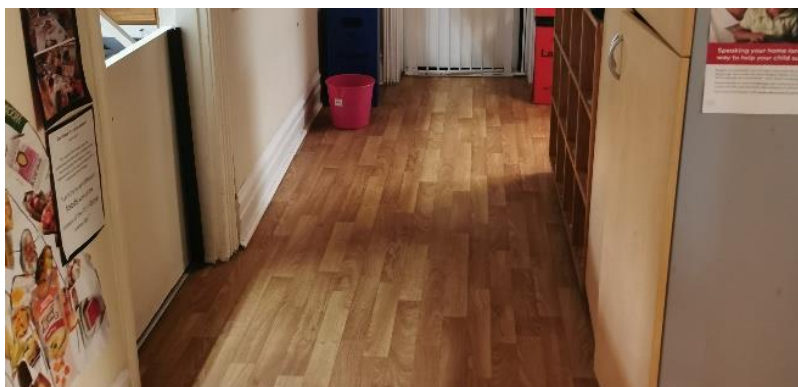
HALL FLOORING

The internal hall finishes were found in a good condition with no notable observable defects.

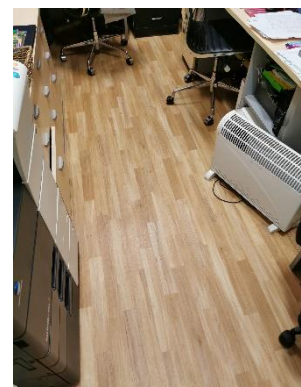
REFERENCE	ELEMENT	LOCATION	DESCRIPTION	COMMENT/CONDITION	RATING	PHOTO REF
129	Building Fabric	Office 1	Work Station/ Desk		2 - Good	OFFICE ROOM 1 - 1
130	Building Fabric	Office 1	Work Station/ Desk		2 - Good	OFFICE ROOM 1 - 2
131	Building Fabric - Ceiling Finish	Office 1	Plasterboard		2 - Good	OFFICE ROOM 1 - 1
132	Building Fabric - Floor Finish	Office 1	Timber Look Vinyl		2 - Good	OFFICE ROOM 1 - 1
133	Building Fabric - Wall Finish	Office 1	Painted Blockwork		2 - Good	OFFICE ROOM 1 - 7
134	Building Fabric - Wall Finish	Office 1	Plasterboard		2 - Good	OFFICE ROOM 1 - 1
135	Electrical	Office 1	Lighting	Baton tube fixtures	2 - Good	OFFICE ROOM 1 - 1
136	Fire Services	Office 1	Smoke Detector		2 - Good	NO PHOTO
137	Mechanical Service	Office 1	Air Purifying Unit		1 - Excellent	OFFICE ROOM 1 - 2
138	Building Fabric - Doors	Office 1 to 2	Door	Timber	3 - Fair	OFFICE ROOM 2 - 3
139	Building Fabric - Doors	Office 1 to Entry Hall	Door	Timber - Dirt ingrained on the door	4 - Poor	OFFICE ROOM 1 - 4

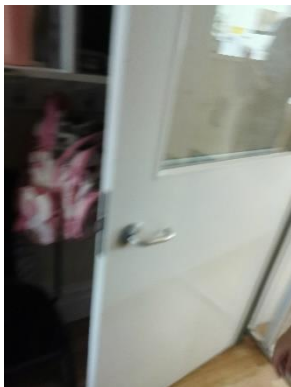
REFERENCE	ELEMENT	LOCATION	DESCRIPTION	COMMENT/CONDITION	RATING	PHOTO REF
161	Building Fabric - Wall Finish	Sleeping Room	Plasterboard		2 - Good	SLEEPING ROOM 3
162	Electrical	Sleeping Room	Lighting	Baton tube fixture	2 - Good	SLEEPING ROOM 5
163	Electrical	Sleeping Room	Lighting	Exit Lighting	2 - Good	SLEEPING ROOM 5
164	Electrical	Sleeping Room	Switchboard	Adjacent to exit door	3 - Fair	SLEEPING ROOM 8
165	Fire Services	Sleeping Room	Smoke Detector		2 - Good	NO PHOTO
166	Mechanical Service	Sleeping Room	Air Conditioning Inverter Unit		1 - Excellent	SLEEPING ROOM 6
167	Mechanical Service	Sleeping Room	Air Purifying Unit 1		1 - Excellent	SLEEPING ROOM 6
168	Mechanical Service	Sleeping Room	Air Purifying Unit 2		1 - Excellent	SLEEPING ROOM 7
169	Mechanical Service	Sleeping Room	Microwave		3 - Fair	SLEEPING ROOM 8
170	Building Fabric	Sleeping Room to Front Play Area	Blinds		3 - Fair	SLEEPING ROOM 10
171	Building Fabric	Sleeping Room to Front Play Area	Timber Ramp	Finishes worn	3 - Fair	SLEEPING ROOM 9

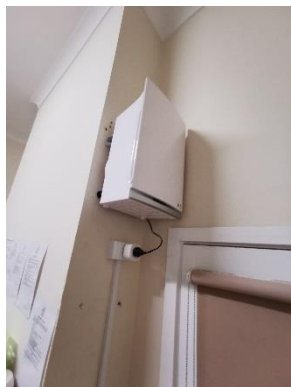
11	Mechanical Service	Bathroom & Toilets	Air Conditioning Inverter Unit		2 - Good	BATHROOM & TOILET 3
12	Mechanical Service	Bathroom & Toilets	Air Purifying Unit		2 - Good	BATHROOM & TOILET 4
13	Building Fabric	Children Playroom	Air Conditioning Inverter Unit		3 - Fair	CHILDREN PLAYROOM 1
14	Building Fabric	Children Playroom	Cupboard		2 - Good	CHILDREN PLAYROOM 2
15	Building Fabric	Children Playroom	Fireplace	Decommissioned and filled	2 - Good	CHILDREN PLAYROOM 1
16	Building Fabric	Children Playroom	Fireplace	Decommissioned and filled	2 - Good	CHILDREN PLAYROOM 1
17	Building Fabric	Children Playroom	Timber Painted Skirting Board		3 - Fair	CHILDREN PLAYROOM 3
18	Building Fabric	Children Playroom	Wall Shelf		2 - Good	CHILDREN PLAYROOM 1
19	Building Fabric	Children Playroom	Wall Shelf		2 - Good	CHILDREN PLAYROOM 2
20	Building Fabric	Children Playroom	Wooden Box Shelf		2 - Good	CHILDREN PLAYROOM 1
21	Building Fabric - Ceiling Finish	Children Playroom	Plasterboard		2 - Good	CHILDREN PLAYROOM 1
