SITE INSPECTION REPORT

Attention:	██████████	Date:	9/05/2022
Company:	City of Port Phillip		
Phone Number:		Inspection Date:	27/04/2022
Email Address:	██████████@portphillip.vic.gov.au		
Site Address:	39 The Avenue, Balaclava		
Job Number:	187501 PRJ725471	Client Reference:	
Instruction Description:	Structural Remediation of Roof Rafter

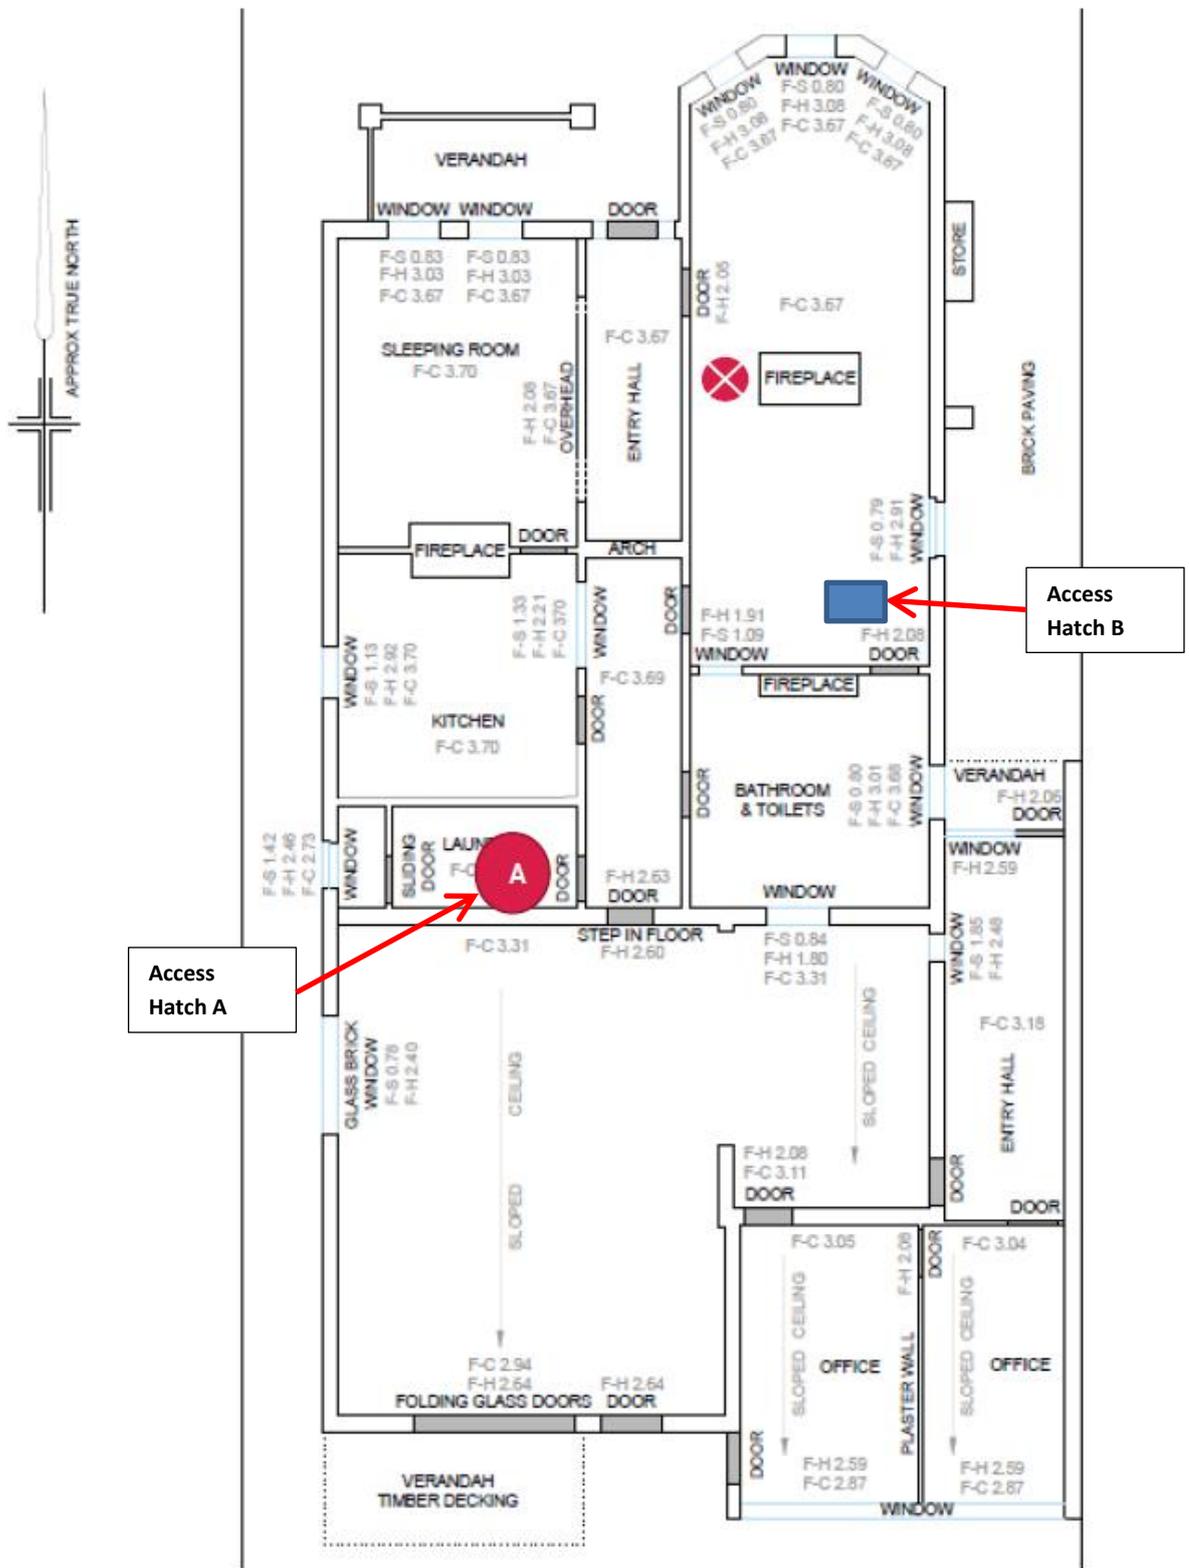
An inspection of the building was carried out on 27 April 2022. Access to the roof space was facilitated by a tradesperson arranged by the City of Port Philip. Despite the provision of access ladders, access could not be safely or adequately gained into the roof space and the split rafters were not viewed or inspected. Refer to Figures 4 to 6 for photographs taken at the inspection from access hatch A and B and Figure 7 for access hatch locations.

Figure 7. Reference Plan excerpted from the RZ Report.
