46 TENNYSON STREET, ELWOOD

BUILDING CONDITION ASSESSMENT - UPDATE

46 TENNYSON STREET, ELWOOD BUILDING CONDITION ASSESSMENT - UPDATE

2 May 2022

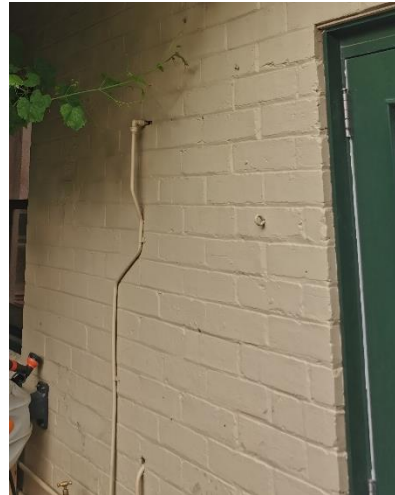
EXTERNAL PAINTED BRICKWORK

The timber veranda roof in the South Yard was notably heavily covered by plant growth.

Minor cracking to the brickwork in the South Yard was also evident.

WT did note that the timber veranda in the South Yard of the building was bearing significant weight from plant growth on the veranda roof. Whilst there were no signs of any structural issues WT recommend that the plant growth and structural integrity of the veranda should be monitored in future going forward.

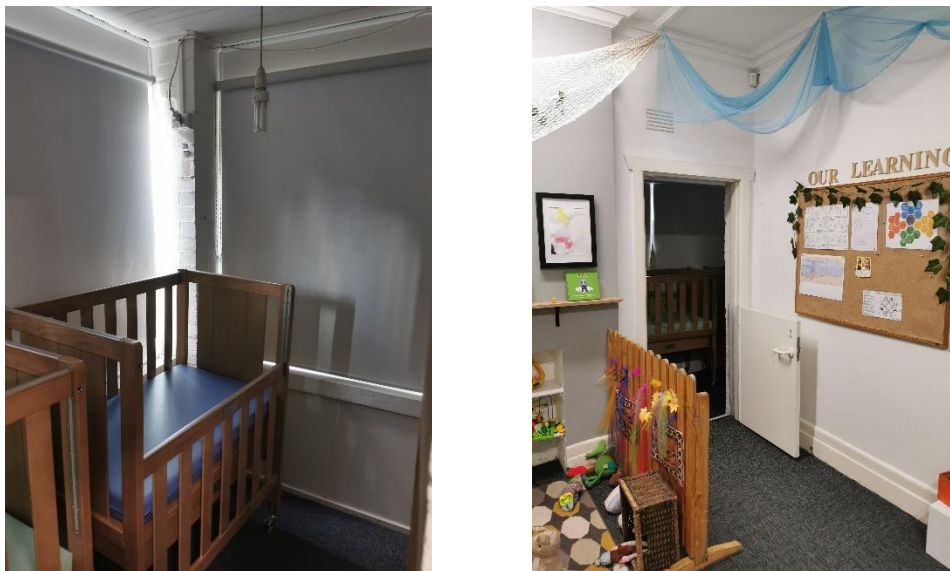
COT ROOM AND ACCESS TO HALL

WT note that at the time of the second inspection the smoke detector in the cot room was in need of a battery replacement.

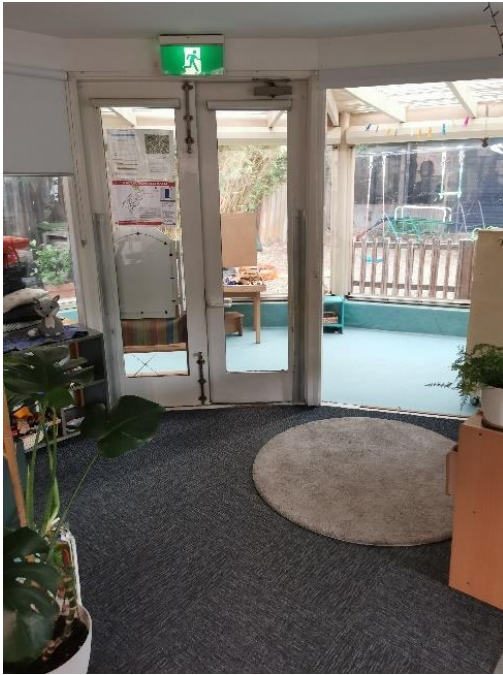
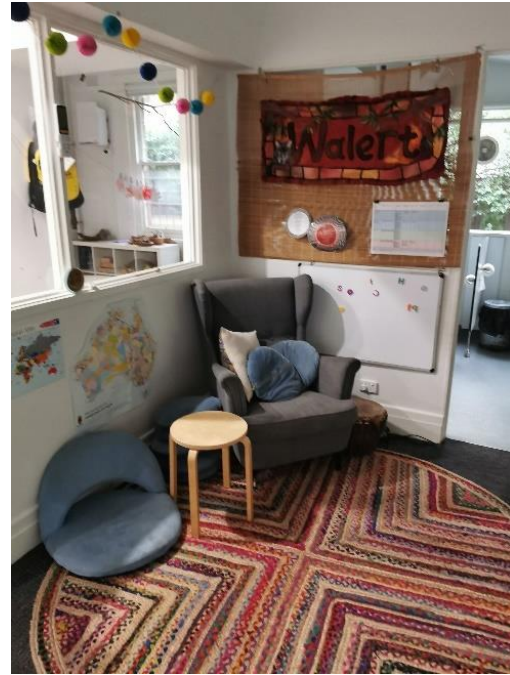
KINDER PLAYROOM

The timber double doors providing access to the rear playground were jarred shut and unable to be opened at the time of the site visit by the member of staff on site.

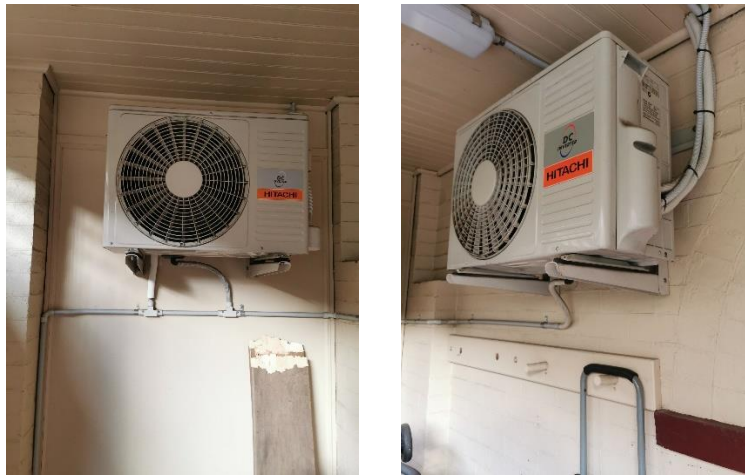
AIR CONDITIONING UNITS

In the entry porch area of the building there were two Hitachi split air conditioning units.

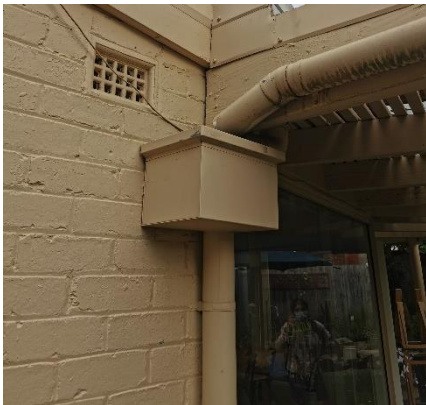
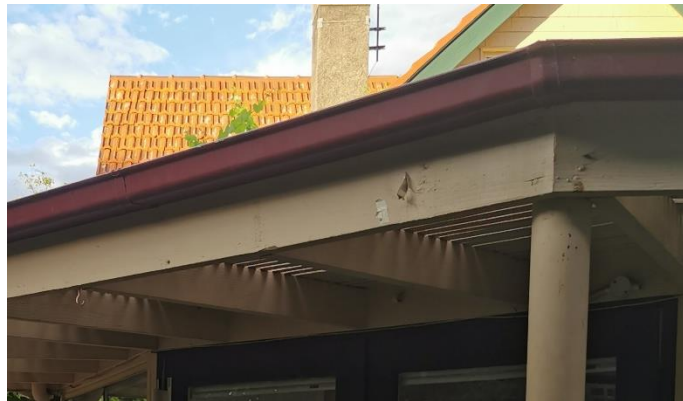
DRAINPIPES AND GUTTERING

Drainpipes and guttering were observed to be of plastic (PVC) material throughout.

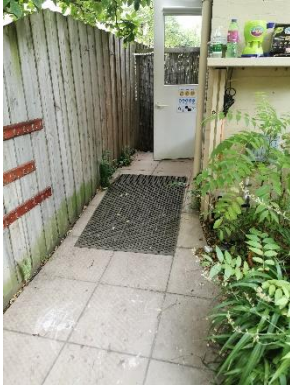
REFERENCE	ELEMENT	LOCATION	DESCRIPTION	COMMENT/CONDITION	RATING	PHOTO REF
87	Building Fabric	Front Play Area	Timber Fencing		2 - Good	FRONT PLAY AREA 7
88	Building Fabric	Kinder Playroom Annex	Blinds	Clear Plastic Blinds	3 - Fair	KINDER PLAYROOM 24
89	Building Fabric	Kinder Playroom Annex	Wooden Box Shelf		2 - Good	KINDER PLAYROOM 3
90	Building Fabric - Floor Finish	Kinder Playroom Annex	Vinyl	Asset coming towards end of life	4 - Poor	KINDER PLAYROOM 25
91	Building Fabric - Doors	Kinder Playroom Annex to Children's W/C	Door	Timber door with glazed panel	2 - Good	KINDER PLAYROOM 2
92	Building Fabric - Doors	Kinder Playroom Annex to Kinder Playroom 2	Door	Timber door with glazed panel	3 - Fair	KINDER PLAYROOM 1
93	Building Fabric	Kinder Playrooms	Box Shelf		2 - Good	KINDER PLAYROOM 10
94	Building Fabric	Kinder Playrooms	Built-In Cupboards		2 - Good	KINDER PLAYROOM 9
95	Building Fabric	Kinder Playrooms	Built-In Cupboards		2 - Good	KINDER PLAYROOM 14

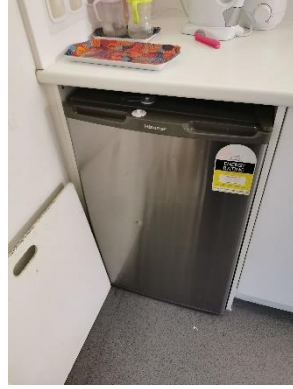
REFERENCE	ELEMENT	LOCATION	DESCRIPTION	COMMENT/CONDITION	RATING	PHOTO REF
116	Mechanical Services	Kinder Playrooms	Mini Bar Fridge		2 - Good	KINDER PLAYROOM 16
117	Building Fabric	Kitchen	Built-In Cabinetry		2 - Good	KITCHEN 1
118	Building Fabric	Kitchen	Sink		2 - Good	KITCHEN 3
119	Building Fabric - Ceiling Finish	Kitchen	Plasterboard		2 - Good	KITCHEN 4
120	Building Fabric - Doors	Kitchen	Door	Timber door with glazed panel	2 - Good	KITCHEN 5
121	Building Fabric - Floor Finish	Kitchen	Vinyl		2 - Good	KITCHEN 3
122	Building Fabric - Wall Finish	Kitchen	Plasterboard		2 - Good	KITCHEN 4
123	Building Fabric - Wall Finish	Kitchen	Tiles		2 - Good	KITCHEN 3
124	Electrical	Kitchen	Lighting	Baton tube fixture	2 - Good	KITCHEN 5
125	Fire Services	Kitchen	Extinguisher (Dry Chem)		2 - Good	KITCHEN 5
126	Kitchen Services	Kitchen	Dishwasher		2 - Good	KITCHEN 4
127	Kitchen Services	Kitchen	Refrigerator (Chiq)		1 - Excellent	KITCHEN 1

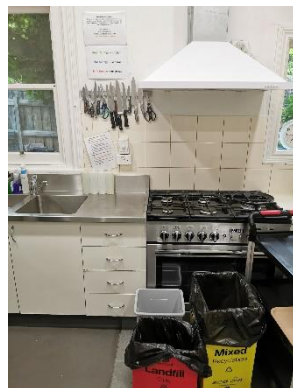
128	Kitchen Services	Kitchen	Stainless Steel Canopy		2 - Good	KITCHEN 3
129	Kitchen Services	Kitchen	Stove/ Gas Burner		2 - Good	KITCHEN 2
130	Kitchen Services	Kitchen	Toaster		2 - Good	KITCHEN 2
131	Building Fabric	Laundry	Built-In Cupboards		2 - Good	LAUNDRY 3
132	Building Fabric - Ceiling Finish	Laundry	Plasterboard		2 - Good	LAUNDRY 2
133	Building Fabric - Doors	Laundry	Door	Timber	3 - Fair	LAUNDRY 1
134	Building Fabric - Floor Finish	Laundry	Vinyl		2 - Good	LAUNDRY 1
135	Building Fabric - Wall Finish	Laundry	Plasterboard		2 - Good	LAUNDRY 2
136	Electrical	Laundry	Lighting	Baton tube fixture	3 - Fair	LAUNDRY 2
137	FF&E	Laundry	Dryer Machine		2 - Good	LAUNDRY 1
138	FF&E	Laundry	Washing Machine		2 - Good	LAUNDRY 1
139	Building Fabric	Rear Playground	External Matt Flooring		2 - Good	REAR PLAYGROUND 1
140	Building Fabric	Rear Playground	External Paving		2 - Good	REAR PLAYGROUND 5
141	Building Fabric	Rear Playground	Rainwater Tank		3 - Fair	REAR PLAYGROUND 6

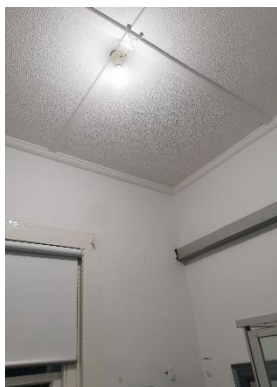
213	Building Fabric - Wall Finish	Upstairs Storage	Wallpapered plasterboard	Poor condition but back of house area	4 - Poor	UPSTAIRS STORAGE AREA 1
214	Building Fabric	W/C	Basin		2 - Good	W/C 1
215	Building Fabric	W/C	Toilet		2 - Good	W/C
216	Building Fabric - Ceiling Finish	W/C	Plasterboard		2 - Good	W/C 2
217	Building Fabric - Doors	W/C	Door	Timber	2 - Good	W/C 2
218	Building Fabric - Floor Finish	W/C	Vinyl		2 - Good	W/C
219	Building Fabric - Wall Finish	W/C	Plasterboard		3 - Fair	W/C 2
220	Building Fabric - Wall Finish	W/C	Tiles	Ceramic	3 - Fair	W/C
221	Building Structure	External Roof	General	Rated by external consultant Redd Zebra - See Section 5.2 of WT's report for summary of the commentary	3.5 - Fair to Poor	Ref. Redd Zebra Report - Appendix C
222	Building Structure	Roof	Profile Metal Sheeting	Rated by external consultant Redd Zebra - See Section 5.2 of WT's report for summary of the commentary	3 - Fair	Ref. Redd Zebra Report - Appendix C

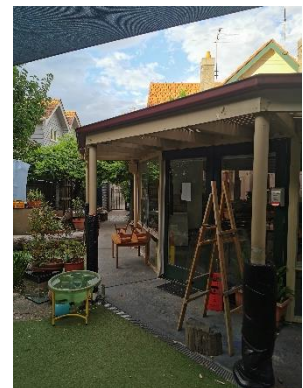
142	Building Fabric	Rear Playground	Shades	Shades and steel pillars all in good condition	2 - Good	REAR PLAYGROUND 12
143	Building Fabric	Rear Playground	Storage Shed		1 - Excellent	REAR SHED
144	Building Fabric	Rear Playground	Storage Shed		1 - Excellent	REAR SHED 1

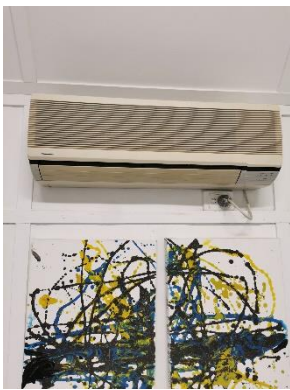
REFERENCE	ELEMENT	LOCATION	DESCRIPTION	COMMENT/CONDITION	RATING	PHOTO REF
203	Electrical	Upstairs Office	Fire Alarm		3 - Fair	UPSTAIRS OFFICE AREA 8
204	Electrical	Upstairs Office	Lighting	Baton tube fixtures	2 - Good	UPSTAIRS OFFICE AREA 11
205	Fire Services	Upstairs Office	Smoke Alarm		2 - Good	No Photo
206	Mechanical Services	Upstairs Office	Air Conditioning Inverter Unit		2 - Good	UPSTAIRS OFFICE AREA 3
207	Mechanical Services	Upstairs Office	Air Conditioning Inverter Unit		2 - Good	UPSTAIRS OFFICE AREA 5
208	Mechanical Services	Upstairs Office	Heating Unit		2 - Good	UPSTAIRS OFFICE AREA 5
209	Mechanical Services	Upstairs Office	Printer/ Photocopier Unit		2 - Good	UPSTAIRS OFFICE AREA 13
210	Building Fabric	Upstairs Storage	Shelving	Timber Shelving	3 - Fair	UPSTAIRS STORAGE AREA 1
211	Building Fabric - Doors	Upstairs Storage	Door	Timber	2 - Good	UPSTAIRS OFFICE AREA 4
212	Building Fabric - Floor Finish	Upstairs Storage	Timber Look Vinyl		2 - Good	UPSTAIRS STORAGE AREA 2

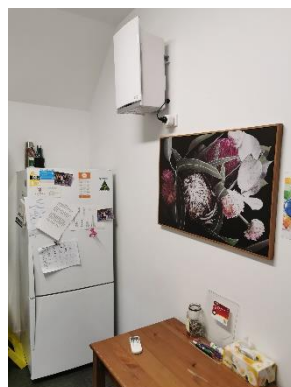
154	Building Fabric	South Yard	Internal Entry Gate	Lock hardware also in good condition	2 - Good	FRONT GATE
155	Building Fabric	South Yard	Storage Shed		2 - Good	SOUTH YARD 1
156	Building Fabric	South Yard	Veranda	Timber veranda to South Yard subject to heavy growth from plants on the structural roof	5 - Very Poor	VERANDA
157	Building Fabric - Floor Finish	South Yard	Tiles		2 - Good	SOUTH YARD 1
158	Electrical	South Yard	Electronic Intercom - Access Control	System confirmed to be in working order	2 - Good	SOUTH YARD 1
159	Building Fabric	Staff Room	Built-In Cupboards		2 - Good	STAFF ROOM 2
160	Building Fabric	Staff Room	Locker		2 - Good	STAFF ROOM 1
161	Building Fabric	Staff Room	Sink		2 - Good	STAFF ROOM 2
162	Building Fabric - Ceiling Finish	Staff Room	Plasterboard		2 - Good	STAFF ROOM 2
163	Building Fabric - Doors	Staff Room	Door	Timber	3 - Fair	STAFF ROOM 4
164	Building Fabric - Floor Finish	Staff Room	Carpet		2 - Good	STAFF ROOM 2

165	Building Fabric - Wall Finish	Staff Room	Plasterboard		2 - Good	STAFF ROOM 2
166	Electrical	Staff Room	Lighting	Baton tube fixture	2 - Good	STAFF ROOM 2
167	Fire Services	Staff Room	Smoke Alarm		2 - Good	No Photo
168	Mechanical Services	Staff Room	Air Conditioning Inverter Unit		2 - Good	STAFF ROOM 1
169	Mechanical Services	Staff Room	Coffee Machine		2 - Good	STAFF ROOM 2
170	Mechanical Services	Staff Room	Heating Unit		2 - Good	STAFF ROOM 3
171	Mechanical Services	Staff Room	Heating Unit		2 - Good	STAFF ROOM
172	Mechanical Services	Staff Room	Microwave		2 - Good	STAFF ROOM 2
173	Mechanical Services	Staff Room	Refrigerator (Westinghouse)		2 - Good	STAFF ROOM 2
