Division 6 Asbestos & Hazardous Materials Assessment

**Eildon Road Childcare and Kindergarten Centre
17 Eildon Road,
St Kilda, Victoria**

**City of Port Phillip
November 2021**

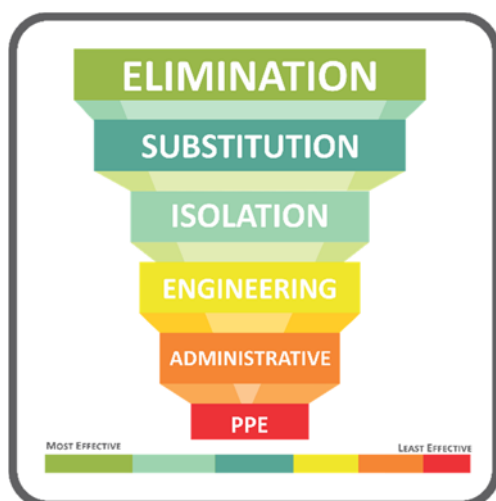
As per state legislation, materials suspected of containing asbestos must be identified and recorded in a register. Furthermore, a risk assessment must be conducted of each hazardous building material and appropriate control measures implemented. The control measures have been determined based on reducing the risk of exposure, so far as is reasonably practicable. The control measures, which were determined by a competent person and/or hygienist, need to reflect the hierarchy of control outlined in specific state legislation and is as follows:

1. **Elimination/removal** (most preferred);
2. **Substitution**;
3. **Isolation**, such as erection of permanent enclosures encasing the material;
4. **Engineering** controls, such as negative air pressure enclosures for removal works, HEPA filtration systems;
5. **Administrative** controls – including the incorporation of registers and management plans, the use of signage, personnel training, safe work procedures, regular re-inspections and registers; and
6. The use of **Personal Protective Equipment (PPE)** (least preferred).
