ROOF CONDITION ASSESSMENT: 46 TENNYSON ST, ELWOOD, VIC 3184

3 May 2022

for
City of Port Phillip

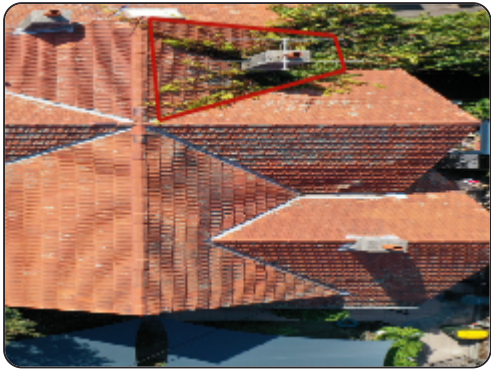
Issue #52

MEDIUM RISK Awaiting Action

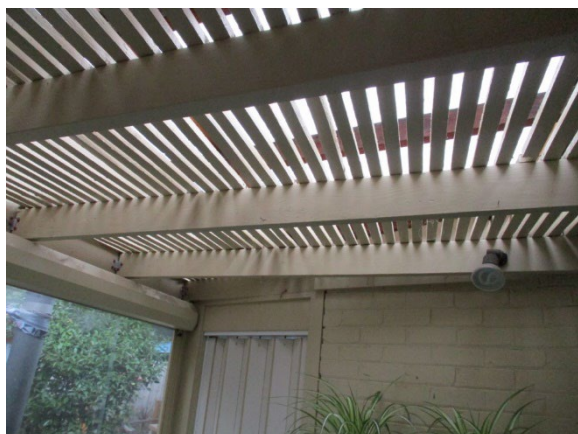
5: Exterior - covered area (1)

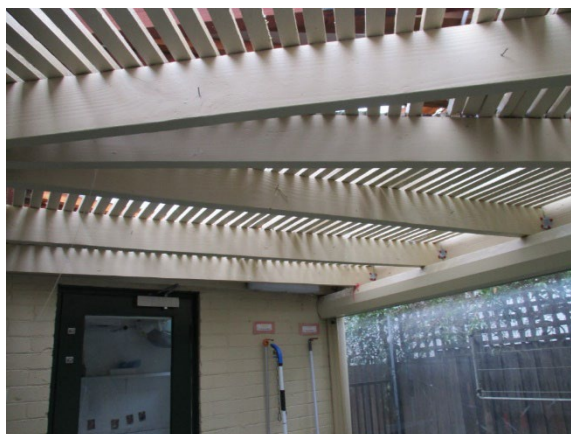
6: Exterior - covered area (2)

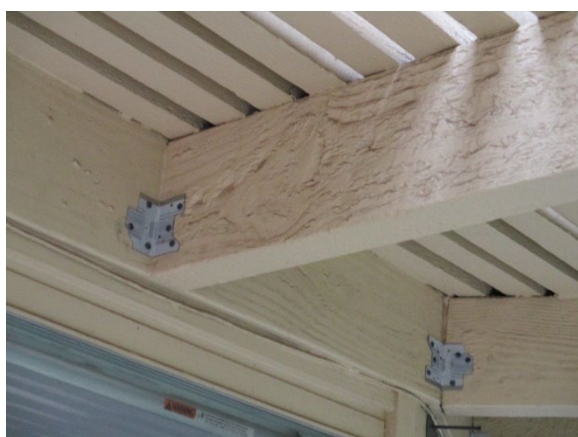
7: Exterior - covered area (3)

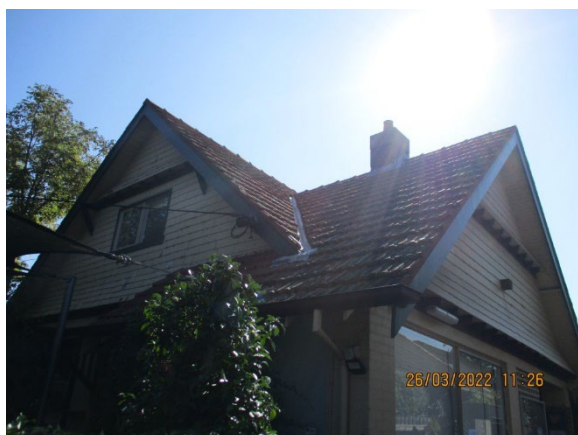
9: Exterior - Elevations (1)

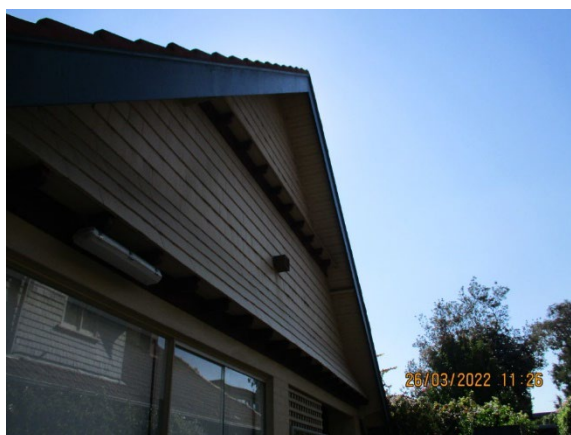
10: Exterior - Elevations (2)

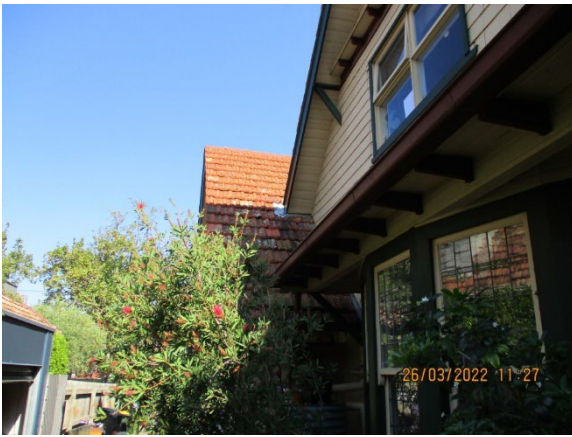
11: Exterior - Elevations (3)

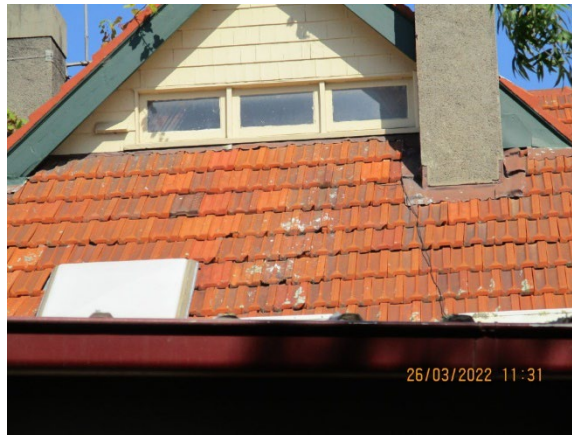
12: Exterior - Elevations (4)

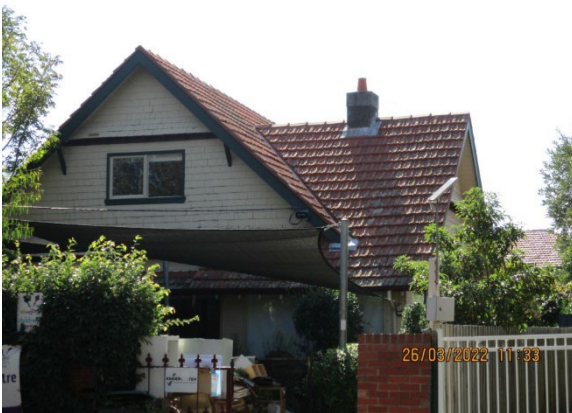
13: Exterior - Elevations (5)

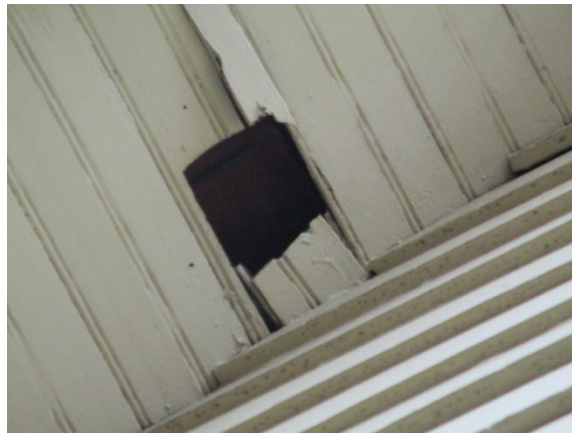
14: Exterior - hole in eaves

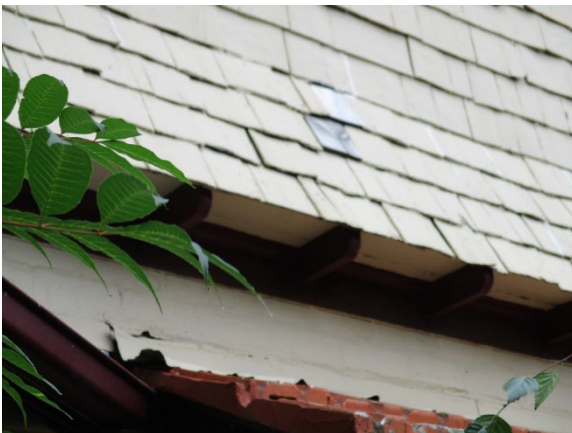
15: Exterior - misaligned flashing and shingles

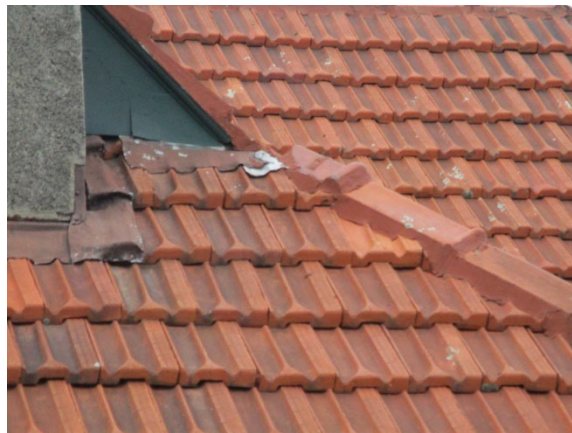
16: Exterior - misaligned flashing and tiles

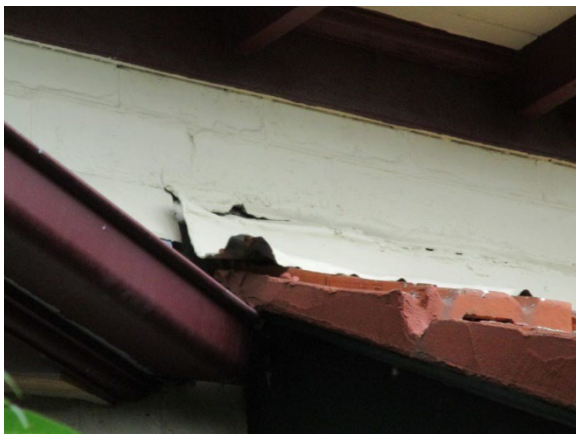
17: Exterior - misaligned flashing

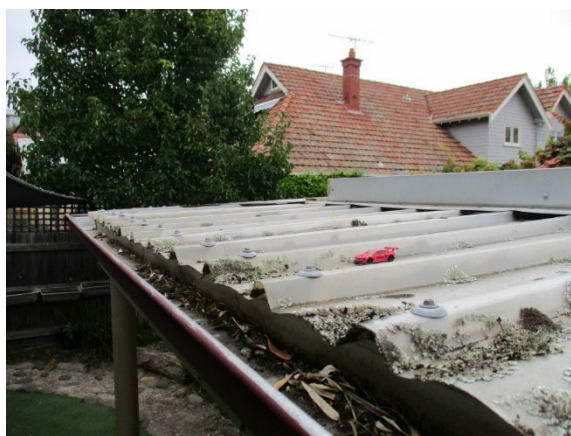
20: Exterior - profile metal sheet extension (1)

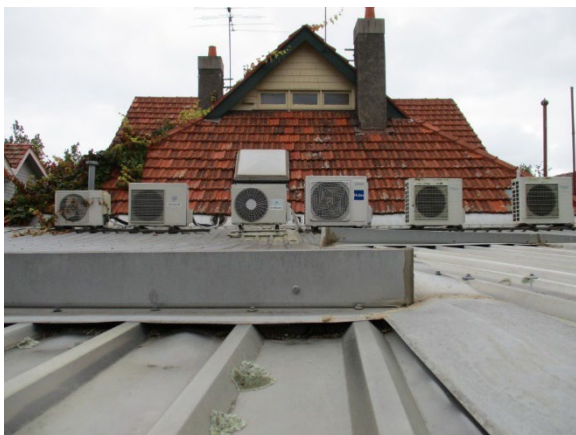
21: Exterior - profile metal sheet extension (2)

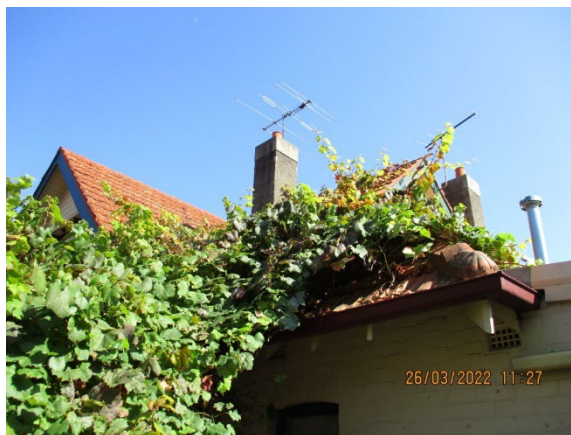
22: Exterior - Vegetative Growth (1)

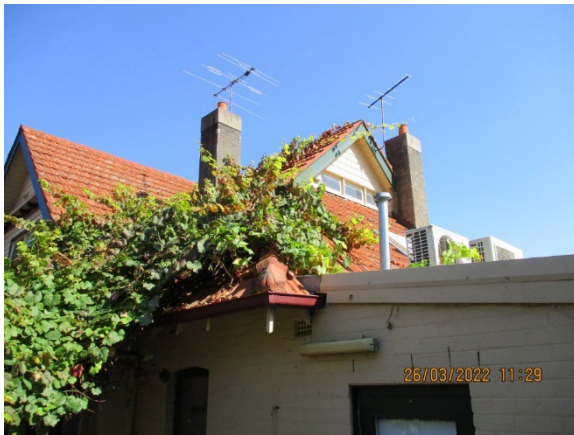
23: Exterior - Vegetative Growth (2)

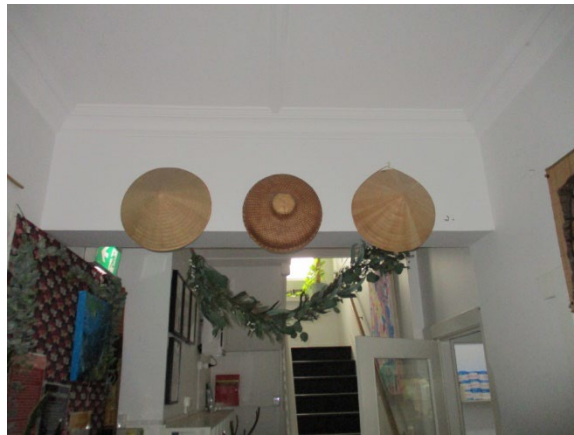
24: Interior - Ceiling - Bottom of Stairs

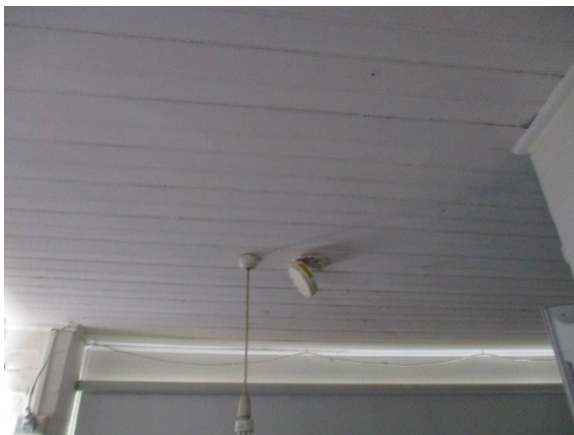
25: Interior - Ceiling - Porch (1)

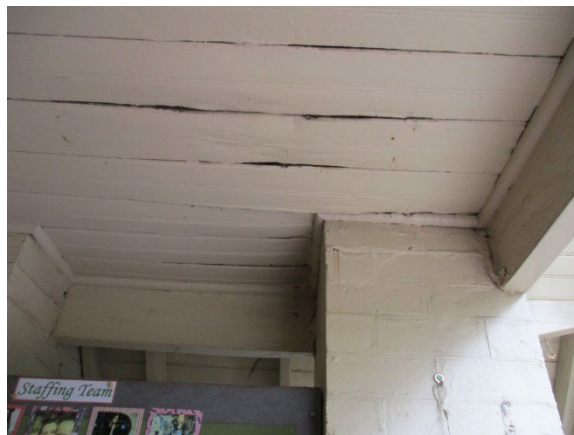
26: Interior - Ceiling - Porch (2)

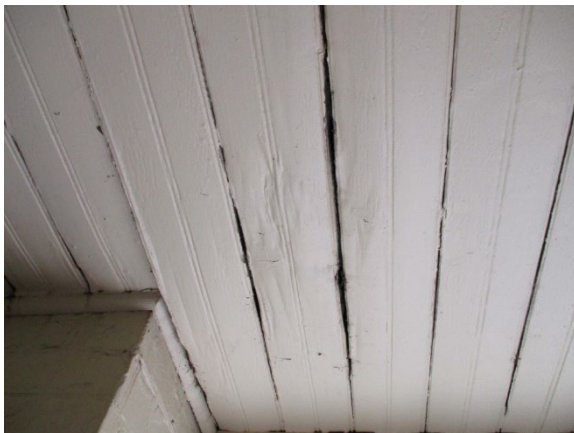
27: Interior - Ceiling - Porch (3)

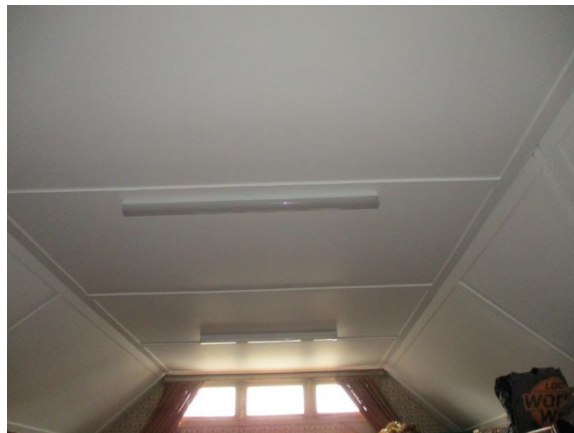
28: Interior - ceilings (1)

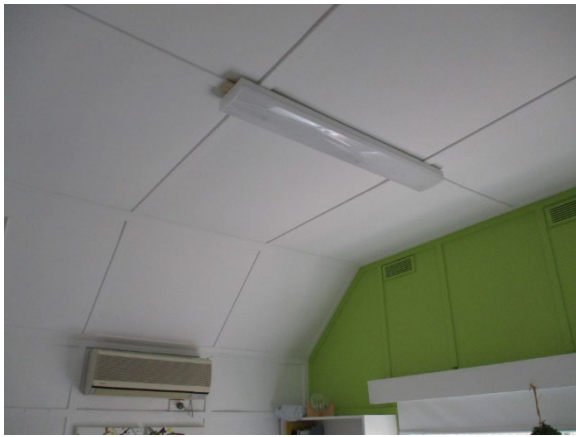
29: Interior - ceilings (2)

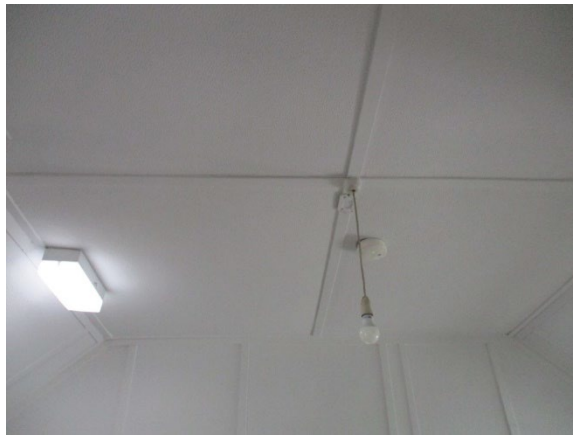
30: Interior - ceilings (3)

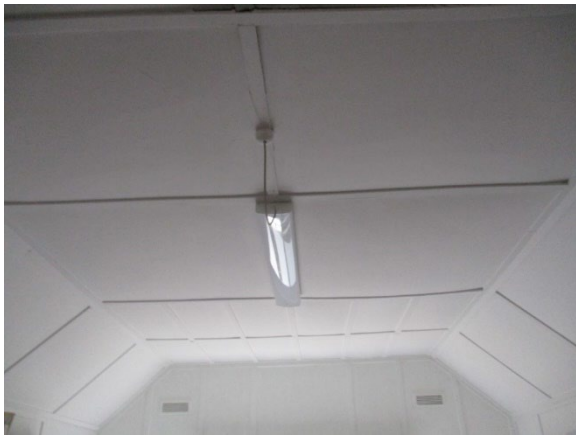
31: Interior - ceilings (4)

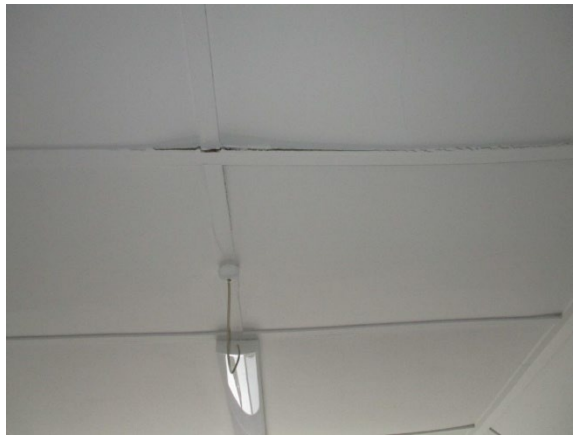
32: Interior - ceilings (5)

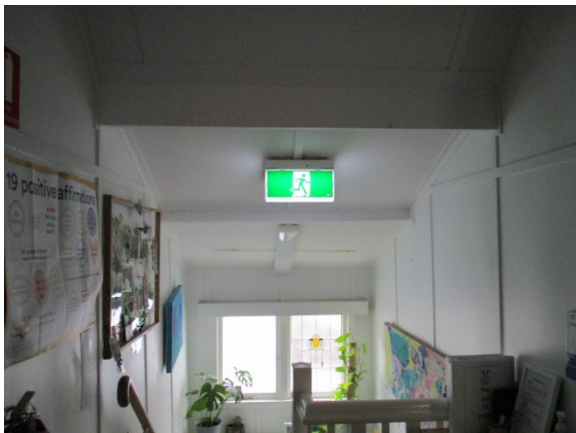
33: Interior - ceilings (6)

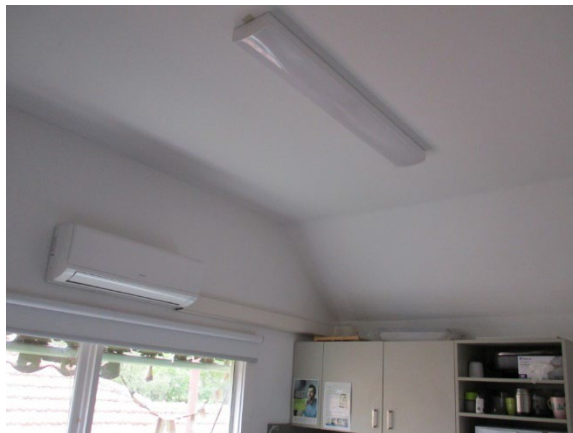
34: Interior - ceilings (7)

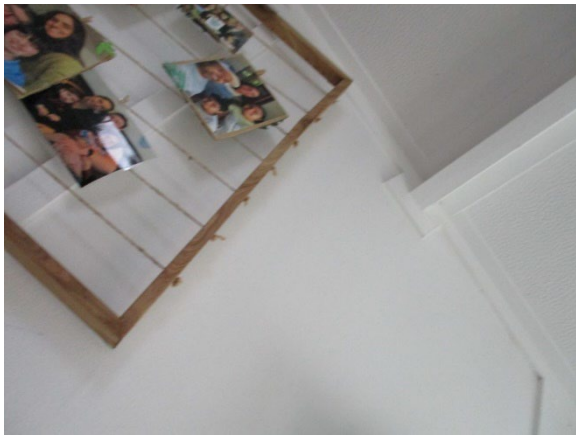
35: Interior - ceilings (8)

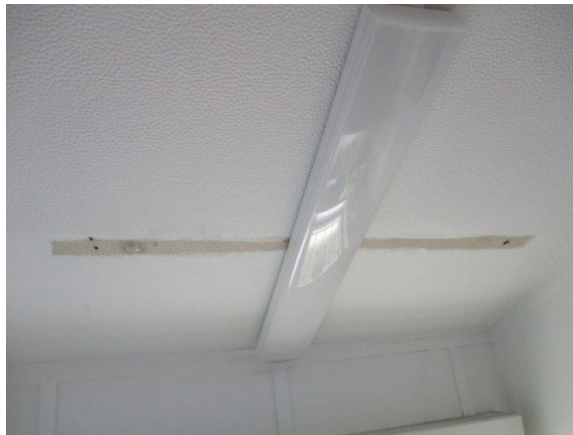
36: Interior - ceilings (9)

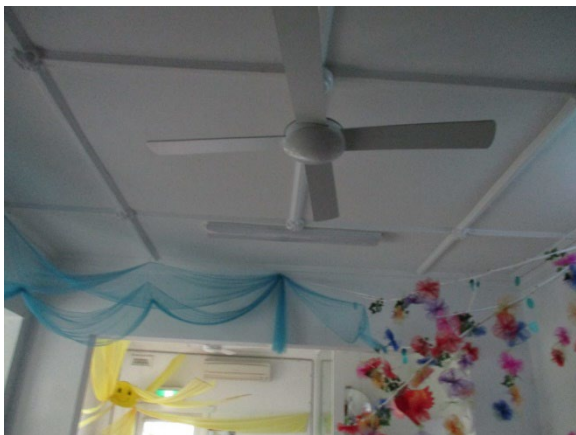
37: Interior - ceilings (10)

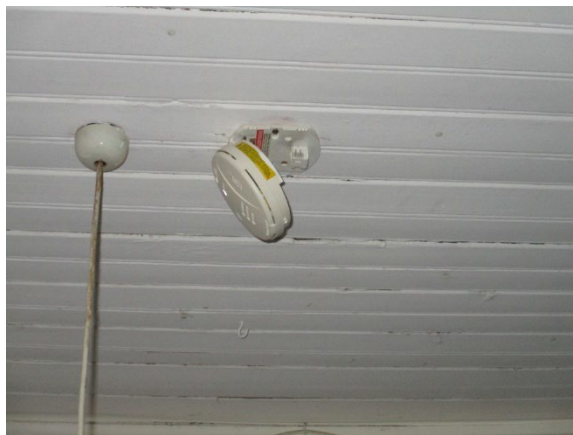
38: Interior - ceilings (11)

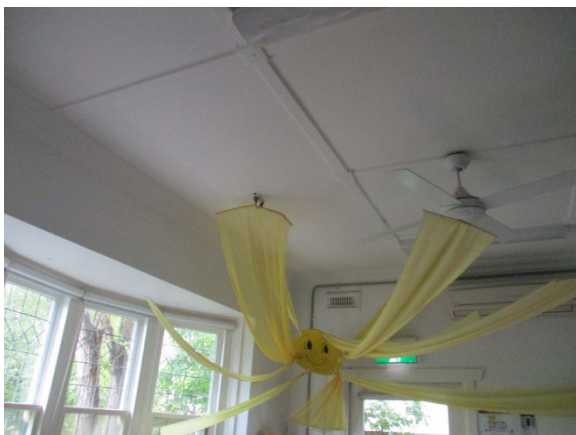
39: Interior - ceilings (12)
